STAFF REPORT: 7/13/2022 REGULAR MEETING

APPLICATION NUMBER: #22-7908

ADDRESS: 1620 ATKINSON

SCOPE: DEMOLISH GARAGE, FENCE, REAR BALCONY AND DECK, (WORK COMPLETED WITHOUT APPROVAL), ERECT NEW GARAGE

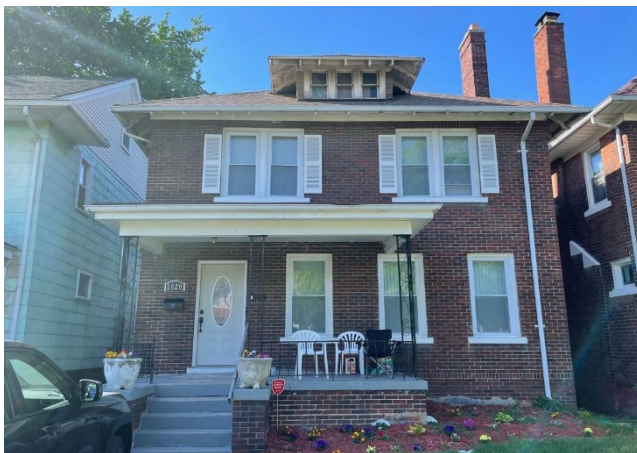
Site Photo 1, by Staff June 23, 2022: (South) Front elevation, showing original casement windows.

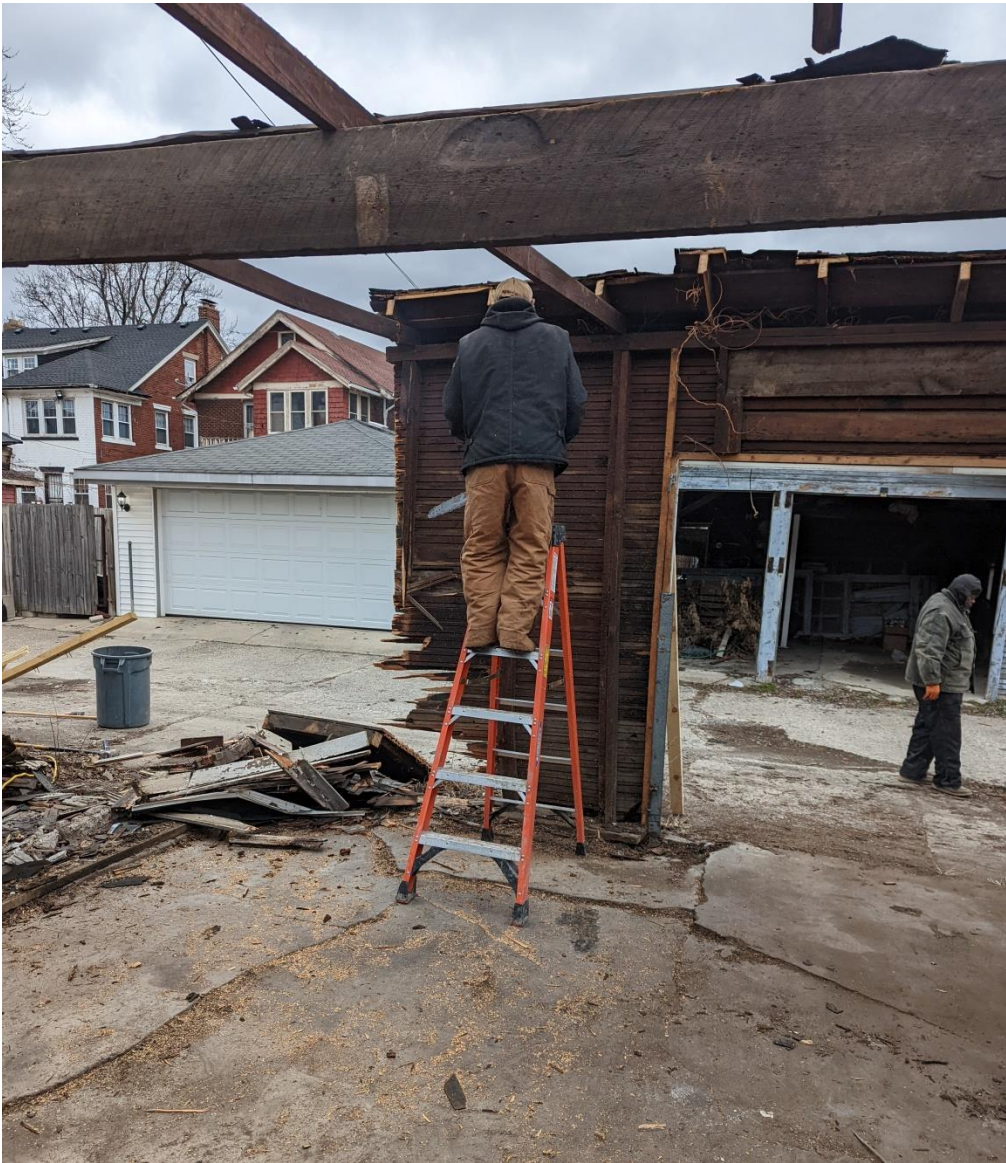
Figure 11 - Nearing demolition completion

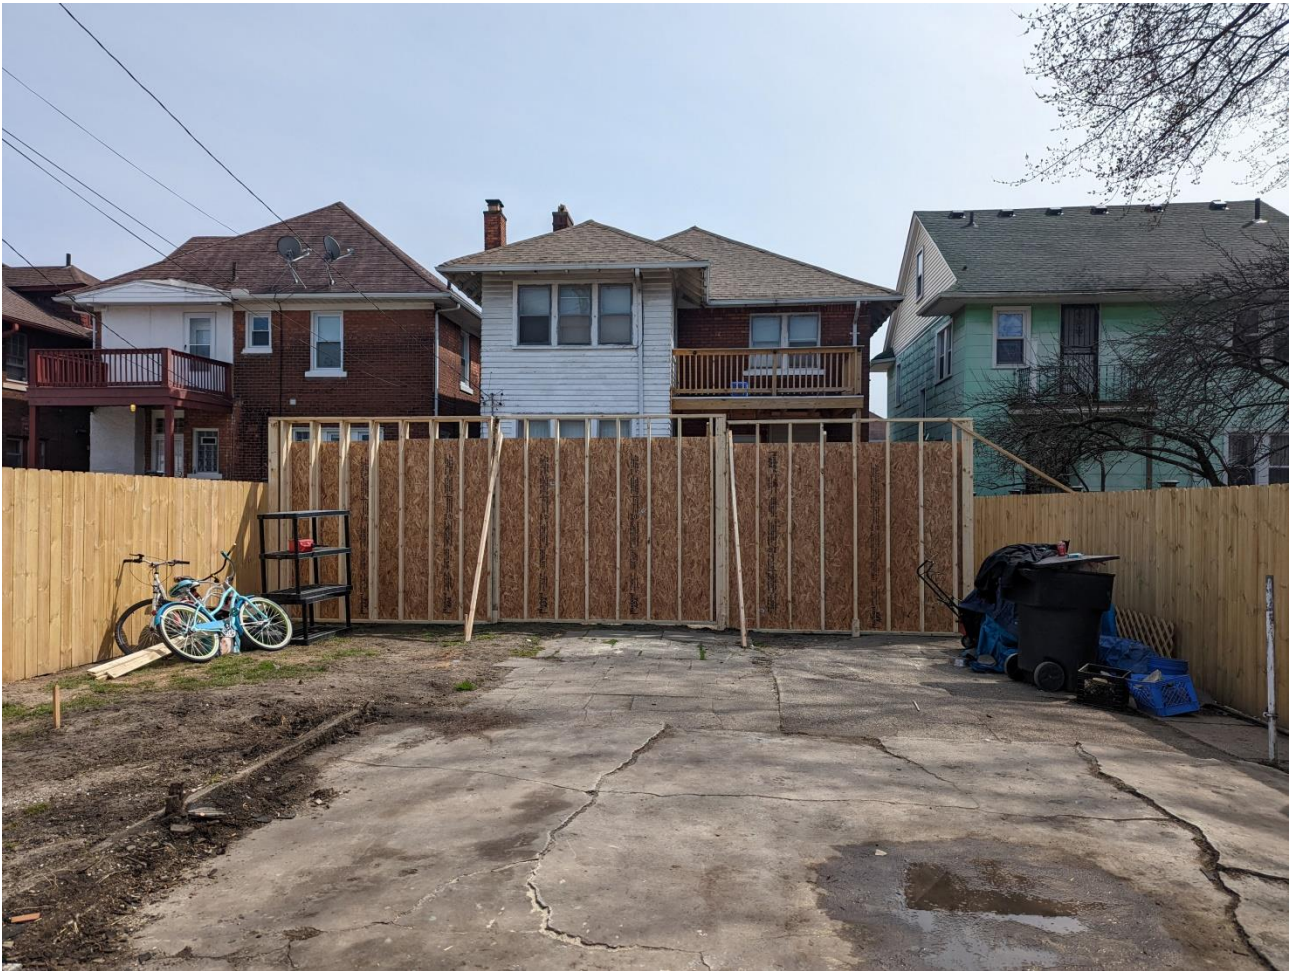
Figure 15 - Completed Demolition - Temporary Fence to limit access for property
