STAFF REPORT: SEPTEMBER 12, 2022 MEETING PREPARED BY: A. DYE

**APPLICATION NUMBER: 22-8012**

**ADDRESS: 1556 BAGLEY**

SCOPE: REHABILITATE DWELLING, ERECT REAR DECK

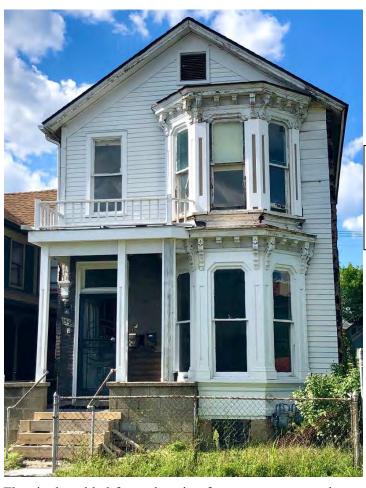
Left: Existing Conditions, HDC Staff photo, 08/31/22 Above: Sanborn Map, v. 1, 1884. The property (130 Baker) is outlined in red.

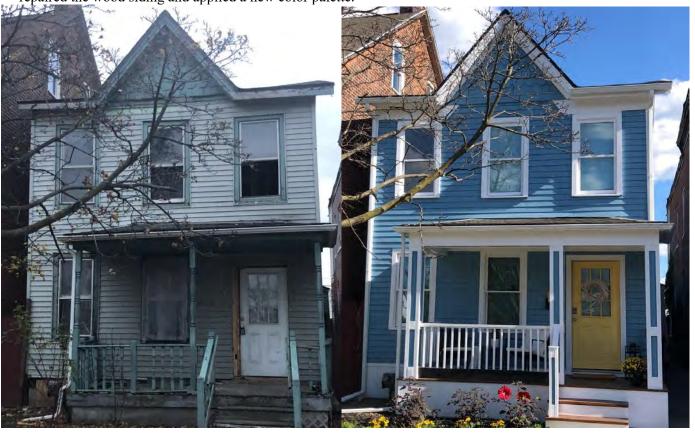
1409 Bagley

At the December 8, 2021 meeting, the Commission denied the installation of new vinyl siding. The applicant ultimately repaired the wood siding and applied a new color palette.

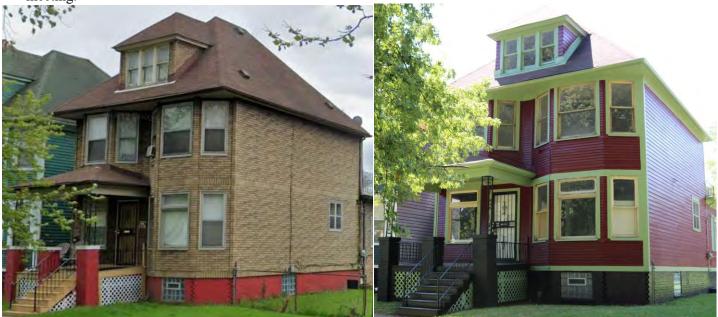
#### 1773 Parker

Removal of Insulbrick as part of the building's rehabilitation was approved by the Commission at its November 12, 2020 meeting.

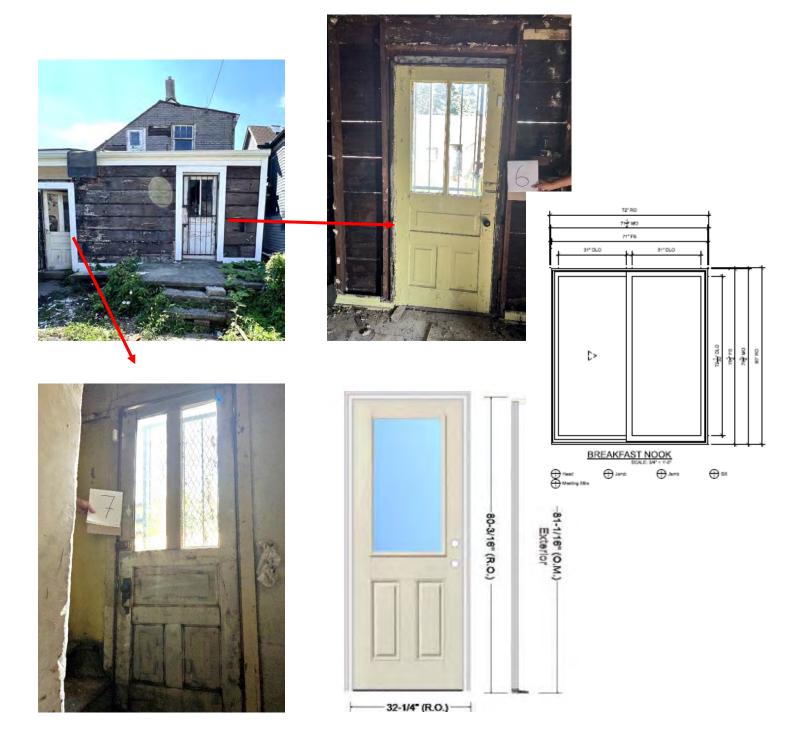
# **REAR ELEVATION - DOORS**

The outlines illustrate the approximate change to the rear wall for the sliding door, as well as the  $10' \times 13'$  wood deck with steps extending down on east and north sides. Door #7 is to be replaced with a half-panel/half-glass steel door.

- The rear elevation sliding door shall be wood, aluminum-clad wood or fiberglass frame; the cut sheet confirming all details, dimensions and finishes will be submitted for staff review.
- A site plan confirming the footprint of the deck, and a dimensioned detail of the railing to be constructed at the deck's west edge, will be submitted for staff review.
- Elevation drawings that detail the proposed extended wall at the second floor, as well as the enclosure of the second-floor door and related roof work, will be submitted to staff for review.
