STAFF REPORT: 2/9/2022 MEETING

APPLICATION NUMBER: #22-7664

ADDRESS: 2485 BURNS

SCOPE: ALTER FRONT PORCH; ALTERATIONS AT REAR PORCH AND SECOND FLOOR SLEEPING PORCH COMPLETED WITHOUT APPROVAL

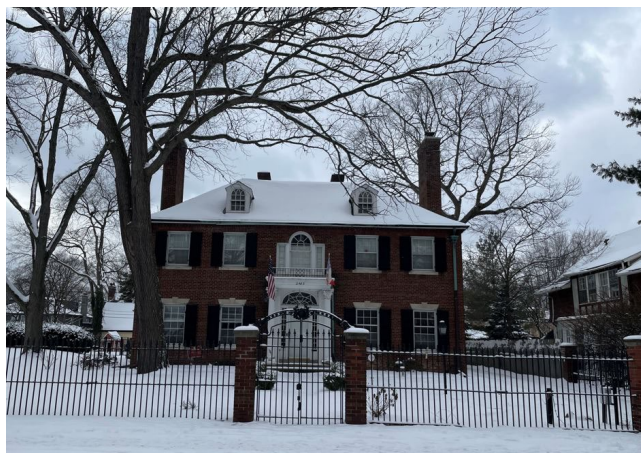
Site Photo 1, by Staff January 25, 2022: (Northeast) front elevation.

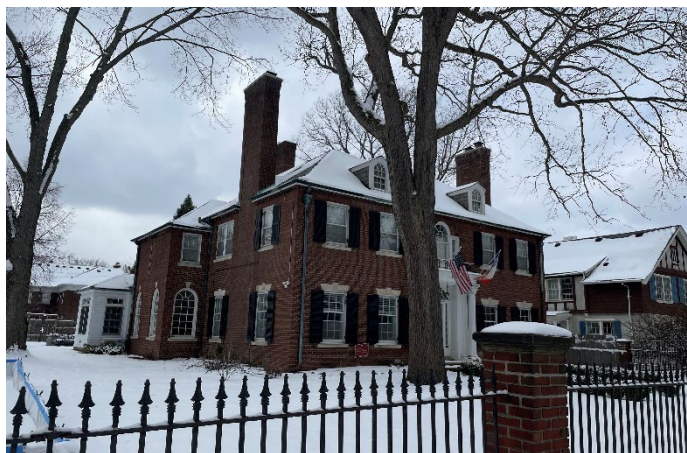
Site Photo 2, by Staff January 25, 2022: (Southeast) front and side elevations showing rear, former screen-in porch.

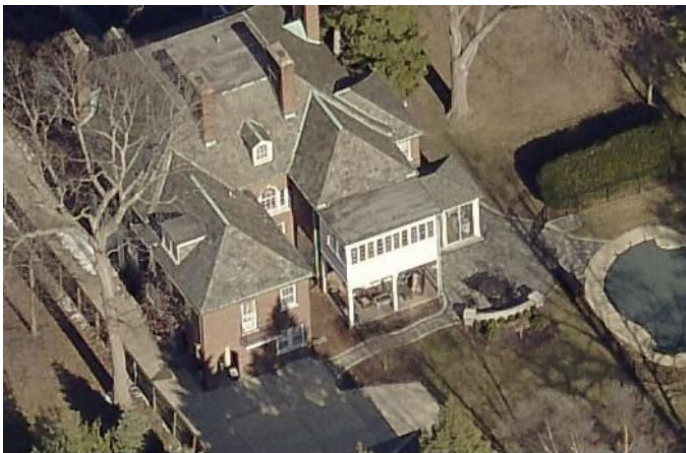
Aerial 2, by All Pictometry March 2018: (Southeast) rear elevation showing original windows of sleeping porch and screen-in porch.

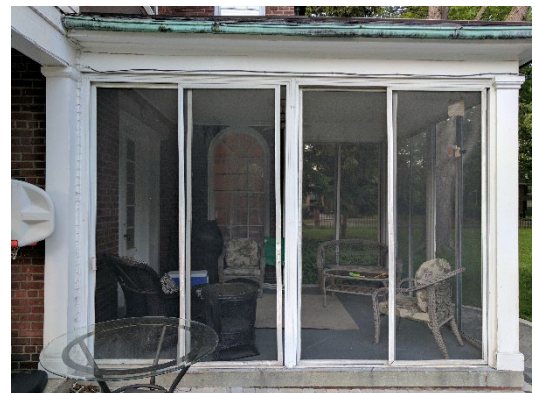
Site Photo 4, by Applicant of 2017: (Southeast) rear elevation showing original screened porch, rear house window and door, and view to yard.

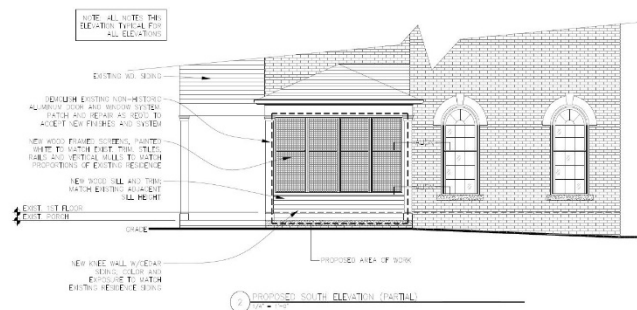
Drawing 1, by Applicant: (Southeast) side elevation excerpt from 2017 COA showing approved new knee wall and original columns.

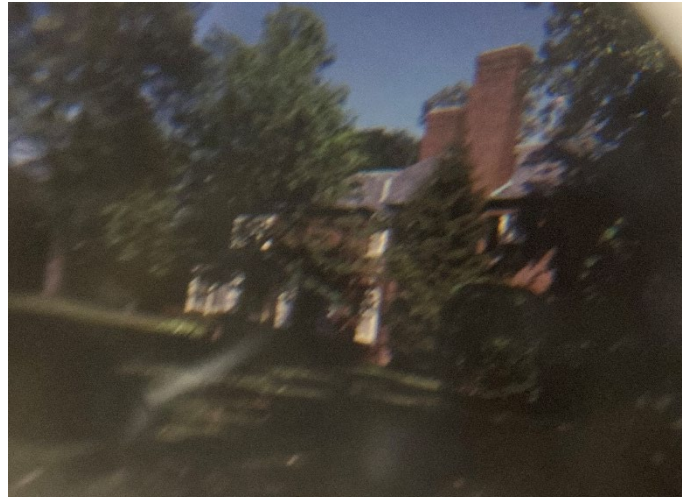
*Designation Photo, by Historic District Advisory Board, 1971:
(Southeast) side elevation showing rear screen porch with original
columns in white, center-left of this photo.*

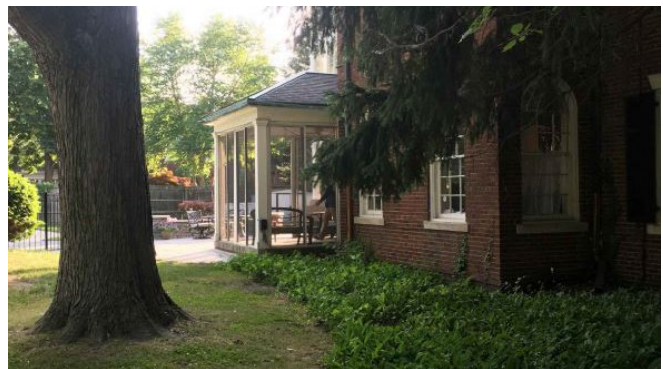
- Staff has the opinion that the open-air quality of the rear, first story screen-in porch, which was approved to introduce a modest knee wall and approved by the HDC in 2017 is a distinctive, character-defining structure. This porch, publicly viewed from the front, had a quality of light transparency with matching character-defining columns that was destroyed by the construction of the solid block massing. This impervious form hides the rear French doors and arched windows (see photos 2-4 & 7) and reads like an addition rather than a porch. Staff also observed that the corner columns of the screen-in porch have been removed on the southwest wall panel and not retained as described in this application. The addition of vinyl transoms over the 2x3 double hung wood windows introduces a new material and pattern that does not complement the existing 3x3 configuration of existing windows of the house.

*Site Photo 7, by Applicant: (Southeast) side elevation view from
sidewalk showing original screen in porch.*

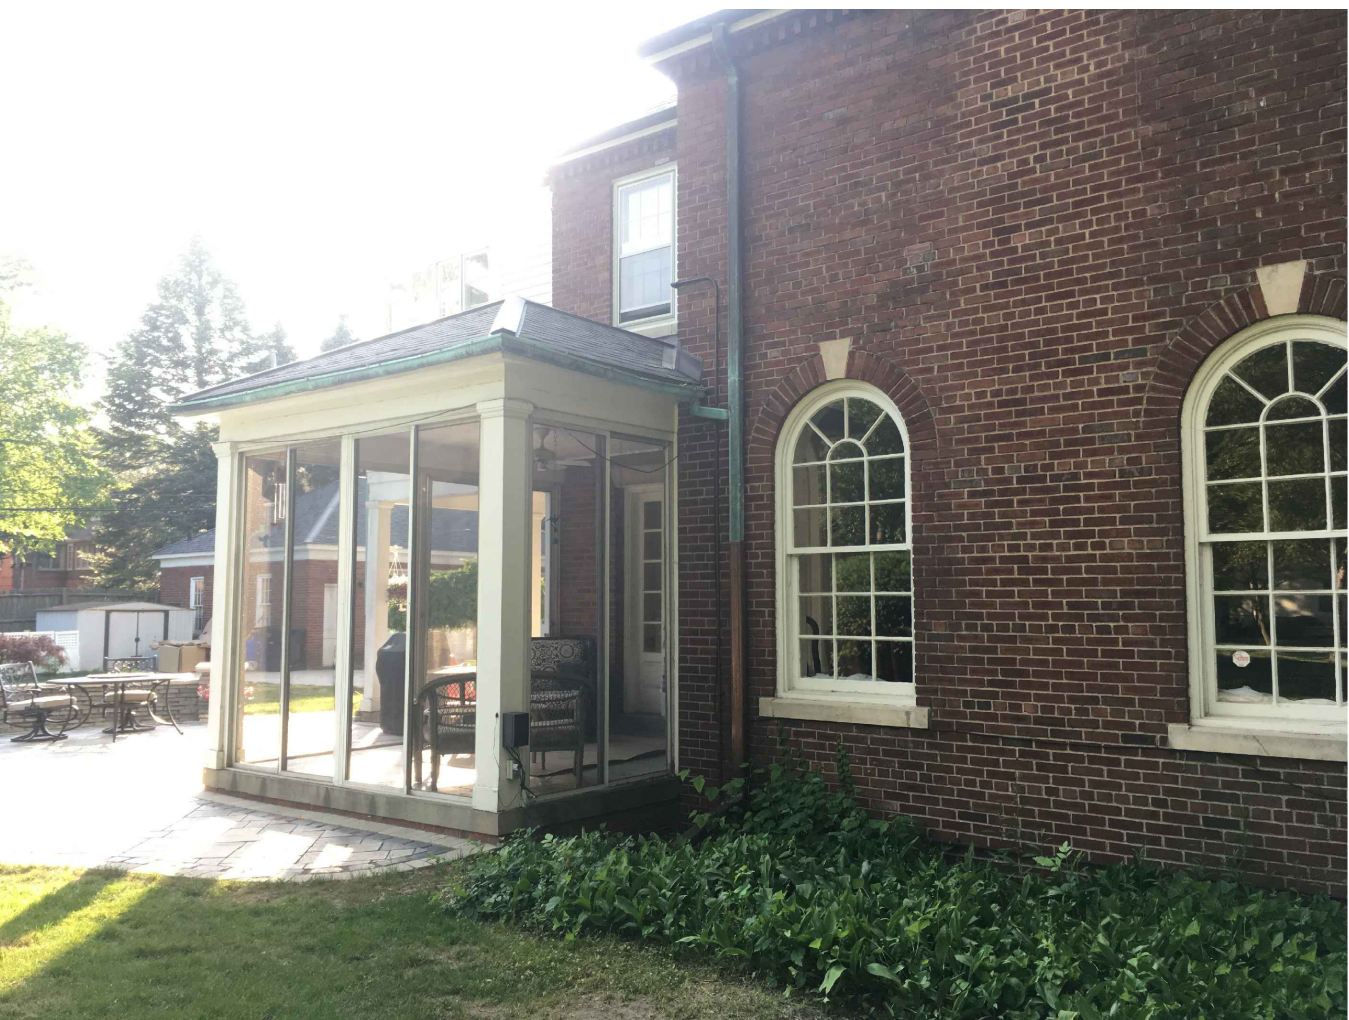
A EXISTING CONDITIONS PHOTOGRAPH
SEE ELEVATIONS 2 AND 3

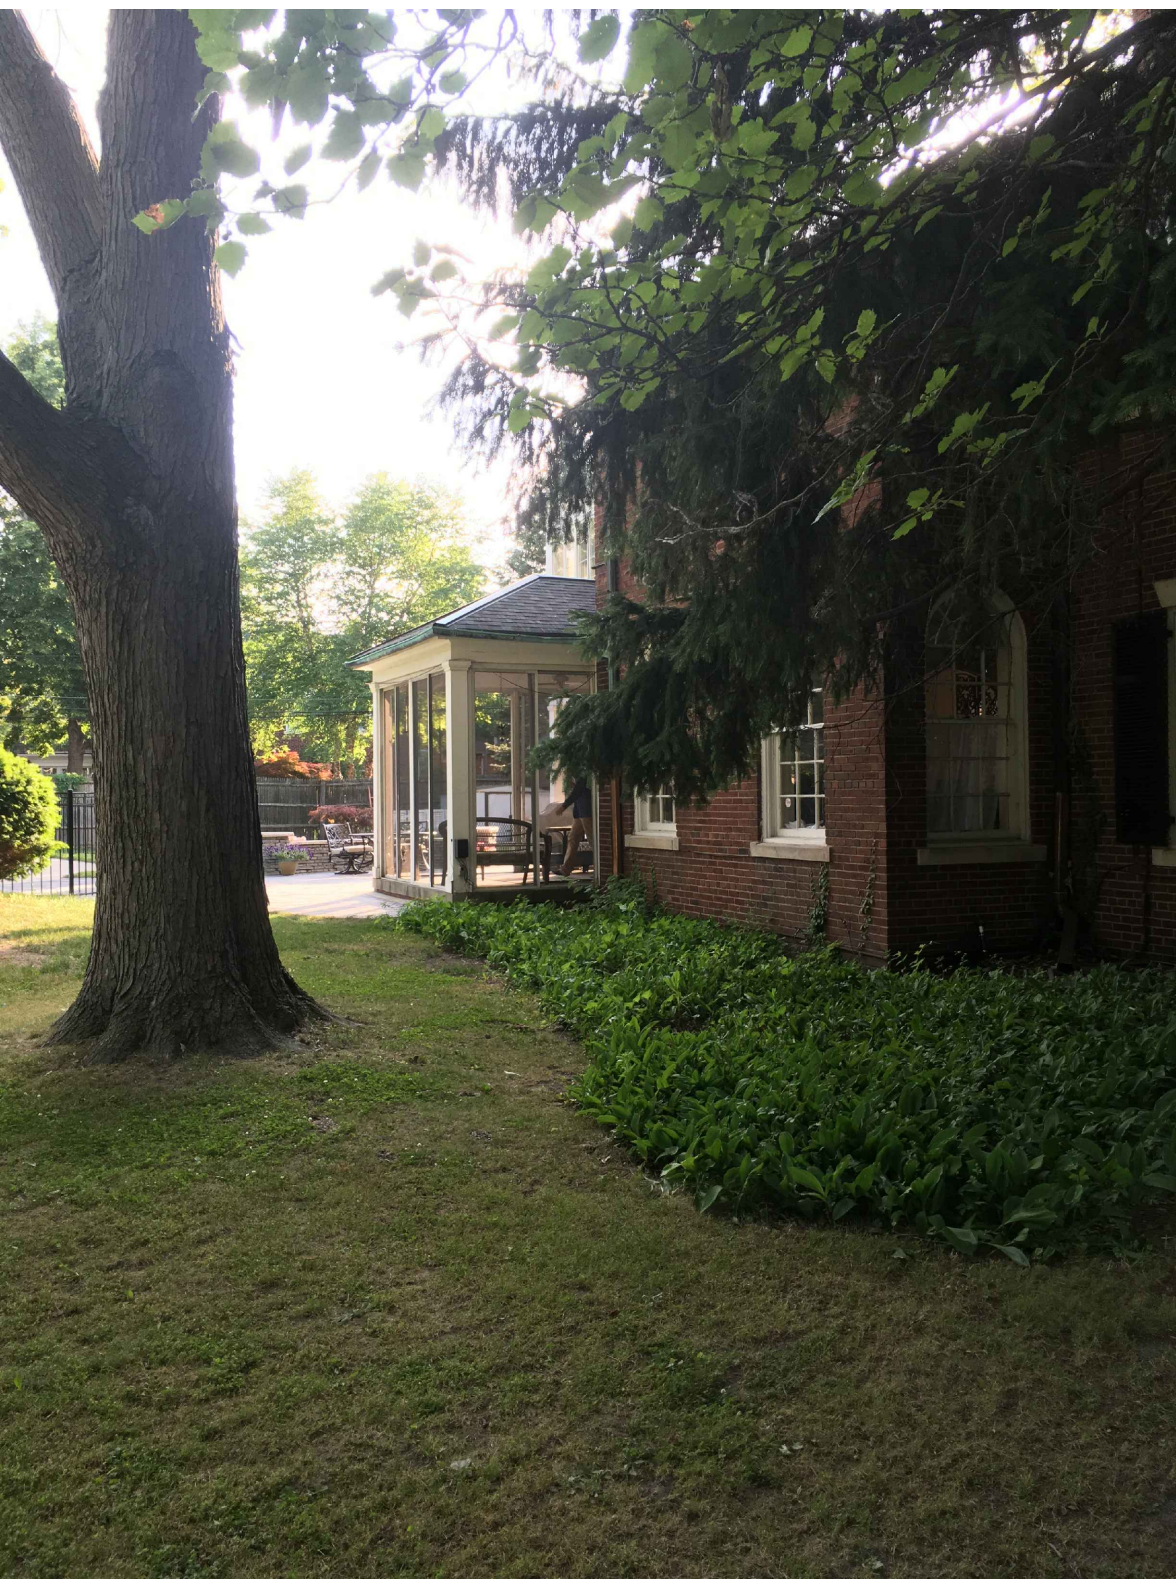
C EXISTING CONDITIONS PHOTOGRAPH - VIEW FROM SIDEWALK
SEE ELEVATION 1

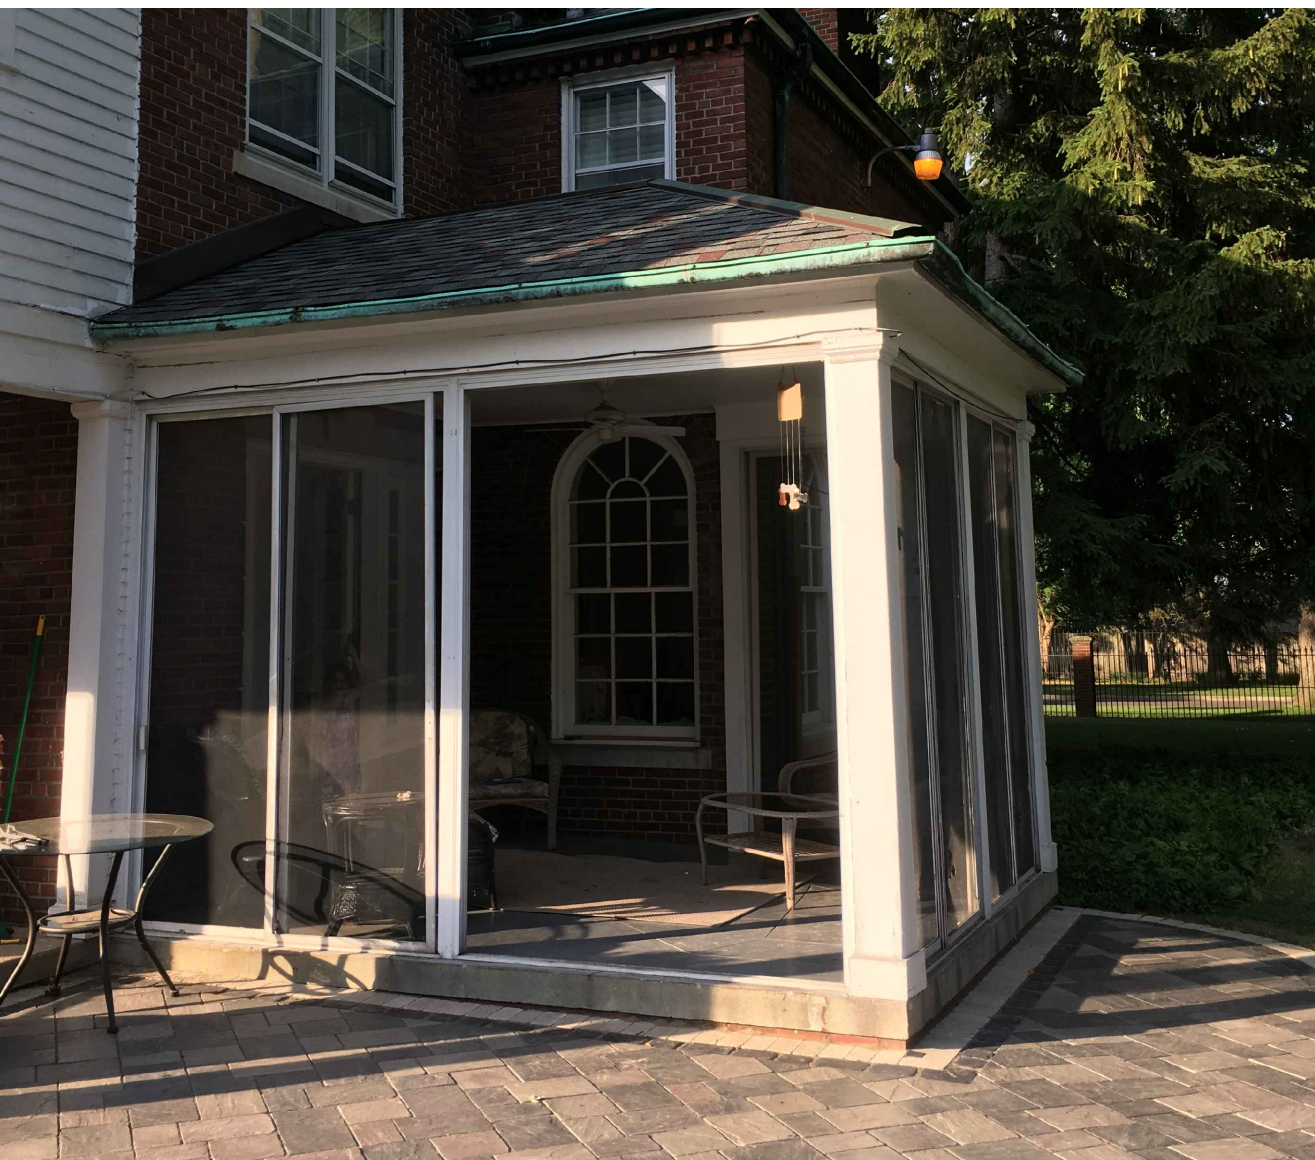
B EXISTING CONDITIONS PHOTOGRAPH
SEE ELEVATION 1
