STAFF REPORT: 10/12/22 REGULAR MEETING PREPARED BY: T. BOSCARINO

APPLICATION NUMBER: 22-8047

ADDRESS: 1991 CHICAGO

SCOPE: REHABILITATE FRONT PORCH, RECONSTRUCT REAR PORCH

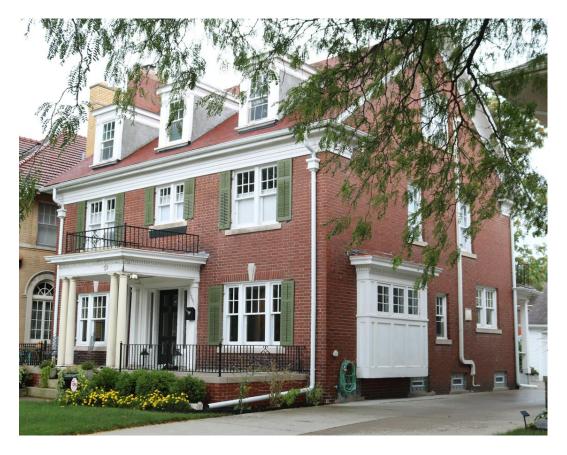
1991 Chicago Boulevard is a two-and-a-half story, red brick, Colonial Revival house built in 1919. It faces north onto its street in the Boston-Edison Historic District. The house is comparable to the other houses in the district in age and scale. A prominent feature of the three-bay façade is a full-width front porch with poured concrete deck. The central bay contains a covered portico with paired columns, engaged pilasters, and a broad Classical entablature with a denticulated cornice. The entablature is matched on a bay window on the east elevation, and a box window on the west elevation. The lack of dentils on a cornice at the roofline suggests that these features may have been removed.
