STAFF REPORT: OCTOBER 12, 2022 MEETING PREPARED BY: A. DYE

APPLICATION NUMBER: 22-8049 **ADDRESS**: 15135 FAUST AVENUE

HISTORIC DISTRICT: ROSEDALE PARK

SCOPE: DEMOLISH GARAGE

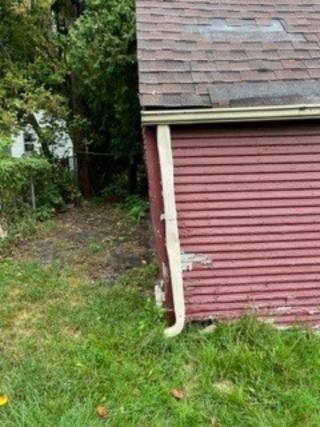
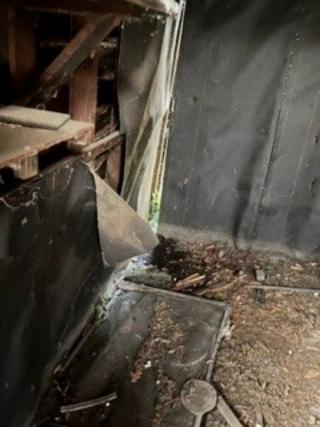
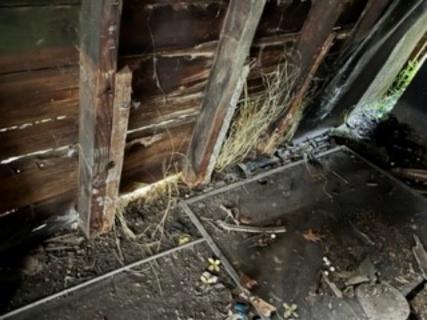
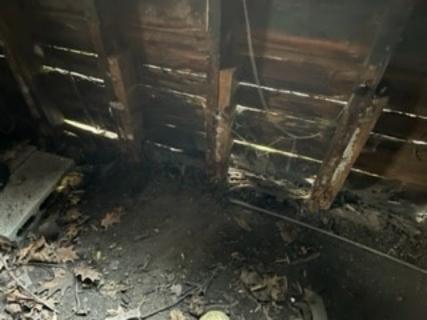
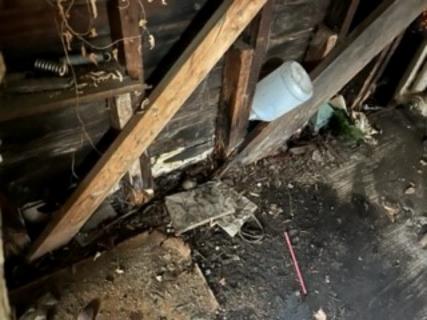
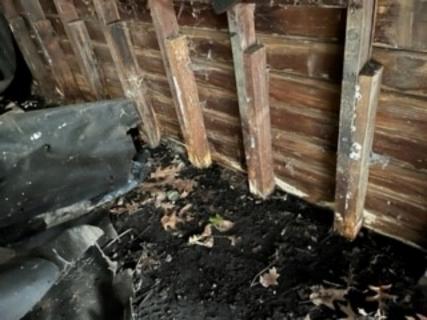
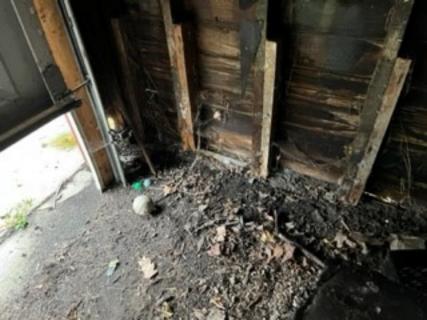
• The submitted photos show two walls are leaning, and staff agrees the interior lower wall construction shows a high level of deterioration. However, the remaining walls, roof and windows are intact. Staff questions if the

Hello Audra, this is Charles Voden with Voden Construction. In regard to the condition of this garage, I didn't submit a quote to repair because in my opinion it is not possible to repair. There are no sill plates left on the walls and no visible foundation. This garage has been repaired numerous times over the years and is now beyond repair. It is leaning badly in two directions and is about to fall over. My client would like it removed from his property this year and would like to build a new one in the next year or two. I will send additional photos in my next correspondence shortly hereafter.

walls can be repaired through the installation of new sill plates and additional vertical framing. Adding in the refurbishment of the wood siding, windows and roof, and a new overhead door, the cost of the rehabilitation might be less expensive than the combined cost for this proposed demolition and future erection of another garage, especially when wood/fiber cement siding and wood/fiberglass windows are considered, as the Commission doesn't often approve vinyl siding and vinyl windows for new construction.
