STAFF REPORT: NOVEMBER 16, 2022 MEETING

APPLICATION NUMBER: 22-8103

ADDRESS: 2475 CHICAGO

SCOPE: INSTALL ALUMINUM RAILINGS & SLIDING DOOR, INSTALL VINYL WINDOWS AT REAR DORMER (*WORK COMPLETED WITHOUT APPROVAL*), REVISION OF PREVIOUSLY APPROVED ERECTION OF REAR TWO-STORY PORCH (*WORK COMPLETE*), REPLACE WOOD WINDOWS WITH VINYL & GLASS BLOCK WINDOWS,

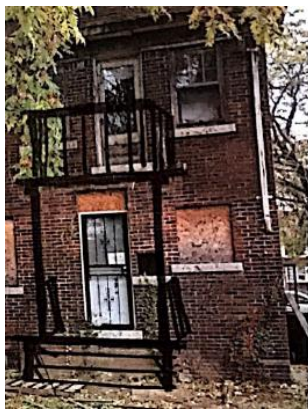
balcony 8' x 4'

10 feet.

2.5 feet from the ground.

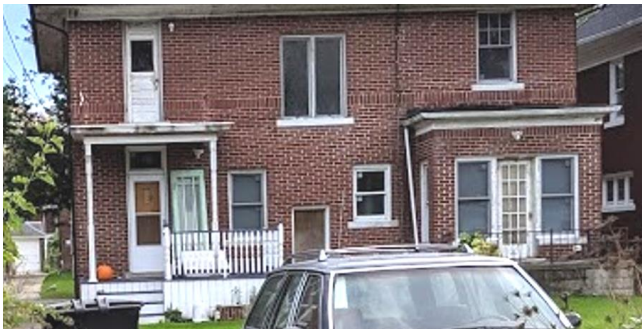
The four holes of the floor joists are still happening in the brick wall of the house. Panel lines are still showing where was the previous wood balcony. I took pictures of neighbors to give an idea of this basic balcony. My balcony collapsed 3-4 years ago it was rotten.

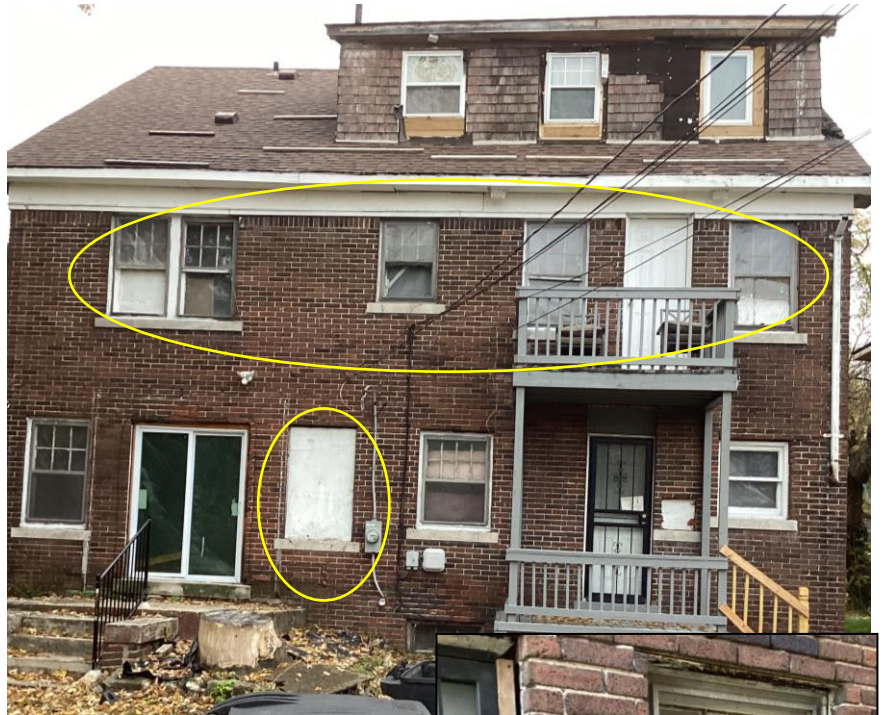
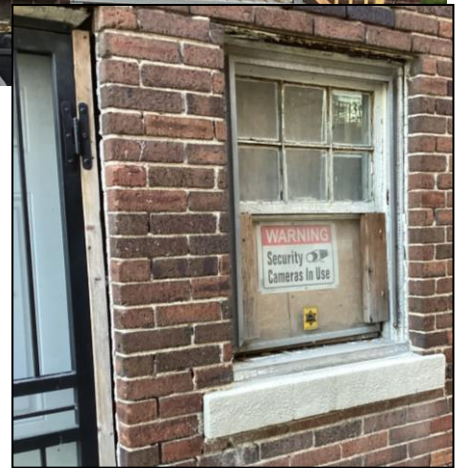
East elevation – applicant photo

- The sliding door opening measures 80" h x 64" w.
 - The side elevation window opening measures 44" h x 36" w. It appears the lower sash is missing.
 - The applicant expanded the number of openings for replacement windows after the Home Depot work order was submitted with his initial application, so the window count is off.

- Based on the applicant's photographs, the basement windows are located on the east and rear elevations. The applicant states the dimensions for the basement openings are 17" h x 38" w. Staff doesn't consider these openings character-defining features of the dwelling.

- Staff doesn't believe the applicant has demonstrated that the existing windows are beyond repair. Therefore, the discussion of replacement windows, regardless of proposed replacement design, is premature.

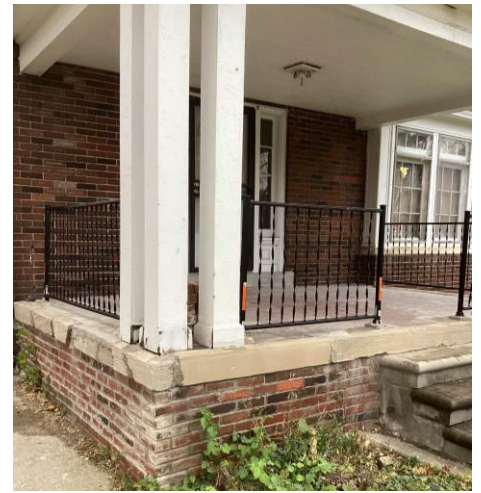
- The 1980 photo shows the first-floor railing was slightly taller than the upper story railing

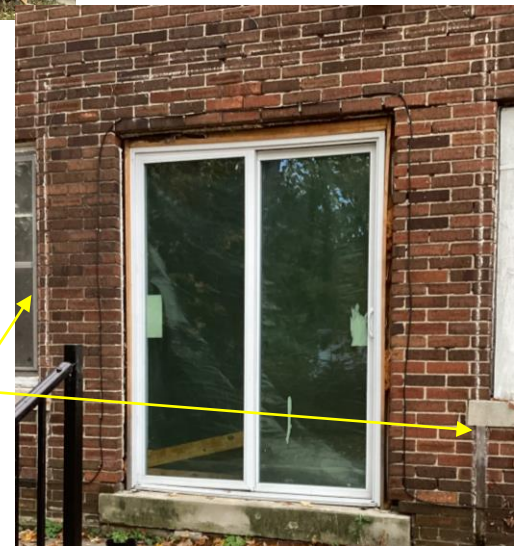
- The raised porch with centrally placed steps flanked by brick wing walls with stone (or concrete) caps are a distinctive character-defining feature of the rear elevation. The outline of painted trim gives evidence that there was some decorative detailing that further accentuated this rear porch.

- Originally, the door leading to the open raised patio would likely have been French doors, or a single door with flanking sidelights (like the front door). The frame of the replacement door appears to be vinyl. The operation and materiality of the sliding doors is a contemporary design and their uneven glass walls are not appropriate for historic structures in the Boston-Edison historic district.

It is staff's opinion the installation of vinyl windows, installation of metal railings, and installation of the sliding door would alter the features and spaces that characterize the property. Staff therefore recommends the Commission deny a Certificate of Appropriateness for the work as proposed because it does not meet the Secretary of the Interior Standards for Rehabilitation and the Elements of Design for the district, specifically Standards:
