STAFF REPORT: 2/9/2022 MEETING

APPLICATION NUMBER: #22-7664

ADDRESS: 2485 BURNS

SCOPE: ALTER FRONT PORCH; ALTERATIONS AT REAR PORCH AND SECOND FLOOR SLEEPING PORCH COMPLETED WITHOUT APPROVAL

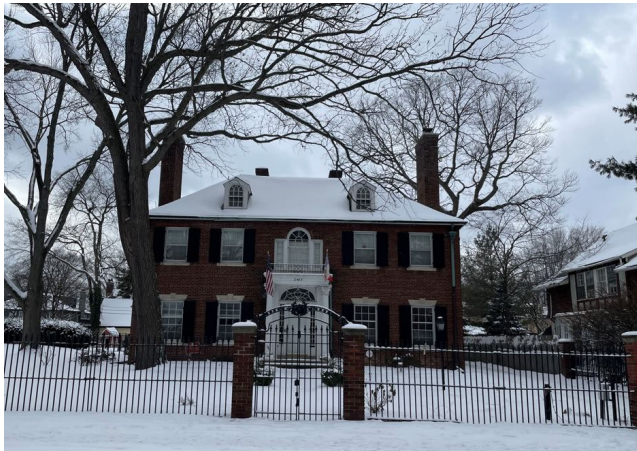
Site Photo 1, by Staff January 25, 2022: (Northeast) front elevation.

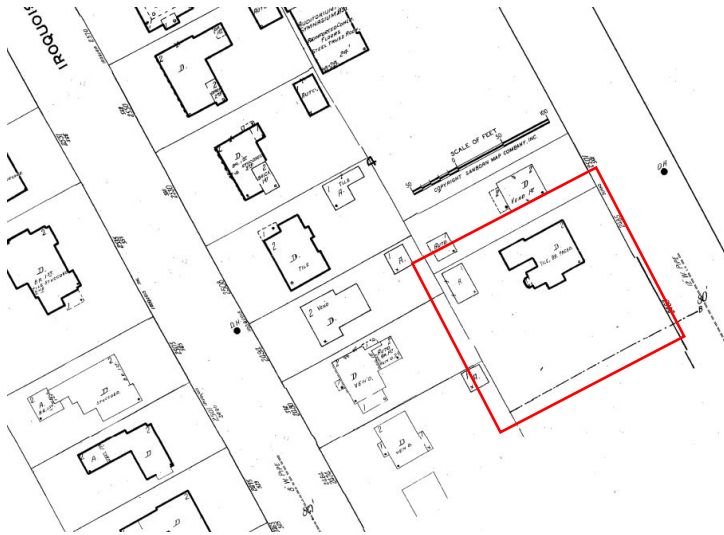
Sanborn V8, P065.

- Indian Village Historic District was established in 1971.
- Staff observed that the Sanborn map of this property shows that both the rear porch and the rear sleeping room are not shown as part of the original structures to the house. Staff found a hard copy of the designation slide for this property on file, showing the rear porch. Also, due to the method of the construction, Staff has the opinion that the rear sleeping porch was likely present at the time of historic designation. The owner stated that they did not know the construction of these additions as they predate their previous owner, but they offered the opinion that they were likely constructed in the 1960s or 1970s, as stated by their window restoration consultant.

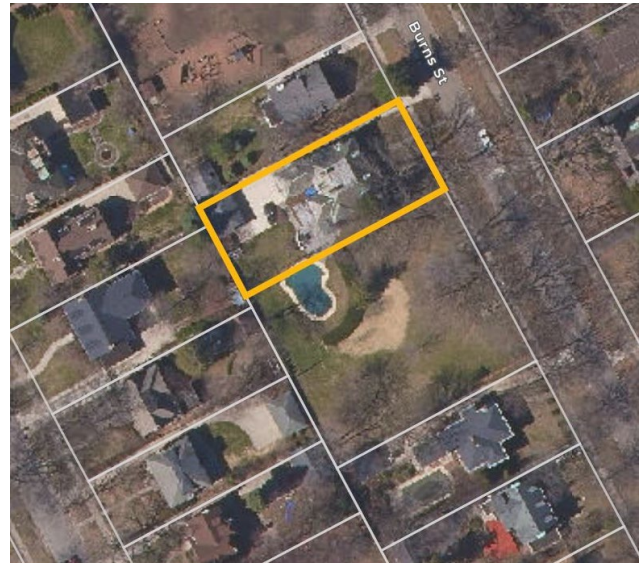
Aerial 1 of Parcel # 17006629 by Detroit Parcel Viewer, highlighting property with adjacent lot (not highlighted).
