STAFF REPORT 02-08-2023 REGULAR MEETING

APPLICATION NUMBER: 23-8206

ADDRESS: 415 WEST GRAND BOULEVARD

SCOPE: ALTER FRONT AND REAR PORCH, REPLACE WALKWAYS (WORK COMPLETED WITHOUT APPROVAL), INSTALL FENCE

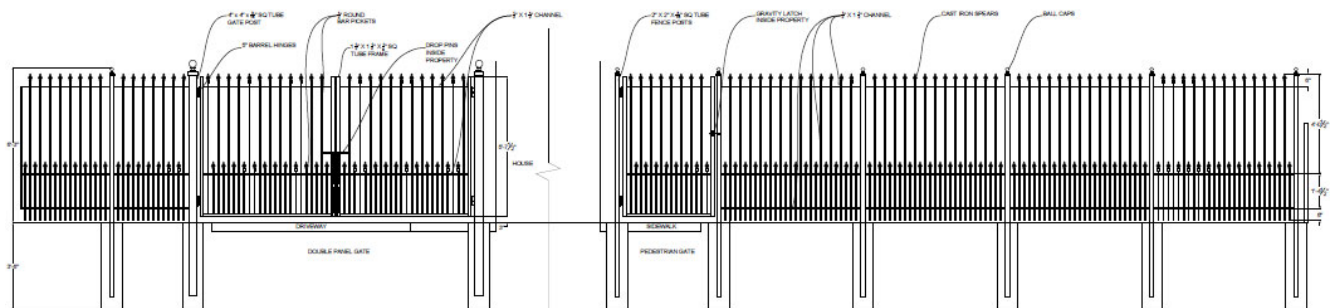
B ELEVATION VIEW
SCALE: 1/4" = 1'-0"

Front elevation and fence fabrication details from the applicant's submitted materials, above and below.

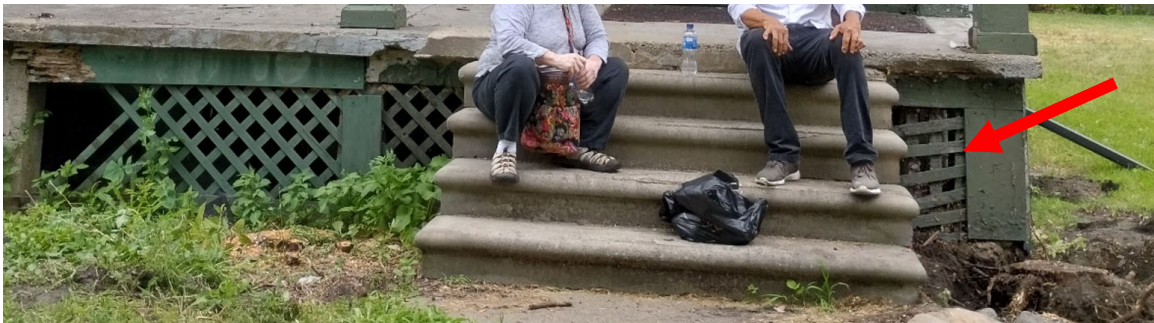
- Wood frame houses of this type often have wood frame porches; when brick appears it is most often an extension of the foundation. Historic-age roofs over wood porches in our climate, with rare exceptions, *cover the entire wooden floor* to slow deterioration. Looking carefully at the “before” photographs submitted by the applicant, staff observes that the portion of the porch to the right of the steps, below the concrete slab (see red arrow) appears to show original conditions in the form of a rectilinear lattice pattern. Note the juxtaposition with the lattice on the opposite (south) side, which shows X-shaped lattice, a modern product widely available in home centers and often incorrectly applied to historic porches.
