**STAFF REPORT: FEBRUARY 8, 2023 MEETING**

**APPLICATION NUMBER: 23-8204**

**ADDRESS: 7908 – 7912 ST. PAUL**

**SCOPE: REMOVE WOOD SIDING\*, INSTALL SYNTHETIC SIDING, REPLACE WINDOWS AND DOORS, REBUILD PORCH**

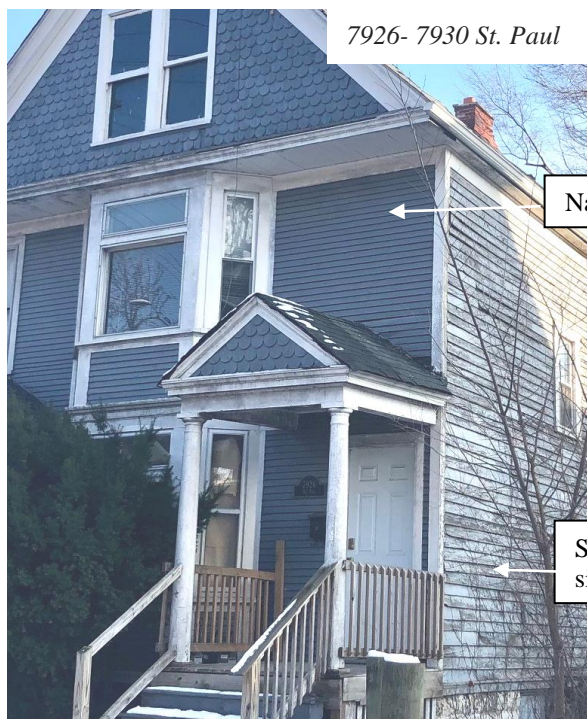
7926- 7930 St. Paul

Narrow siding

Standard wide siding

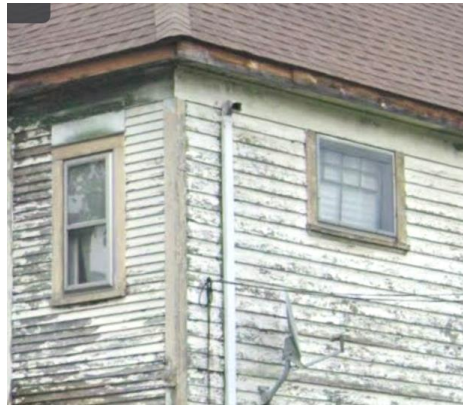
- Staff is also concerned about the possible loss of detail at each window opening with the installation of the Hardie Product. The below photo, which is of a portion of the west elevation before the historic siding was removed, shows window casings with narrow protruding headers and sills at each opening.

*Applicant photo, west-side elevation*

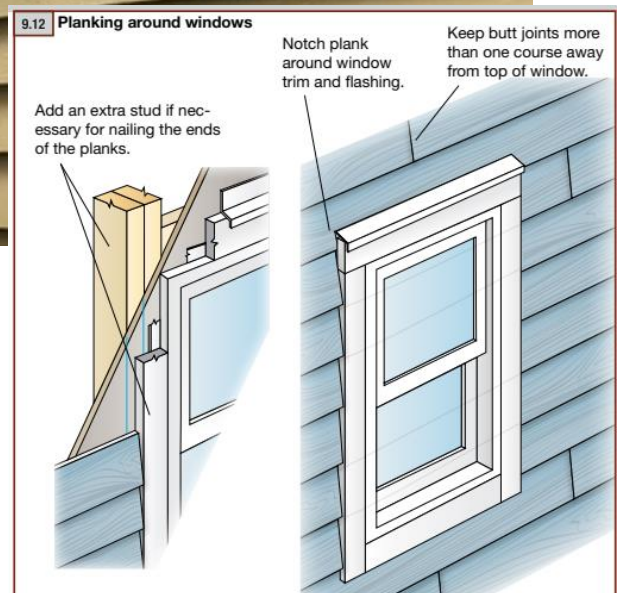
- The diagram at right is from a HardiePlank product brochure. It shows a uniformity of width for each side of the window opening and flat surface.

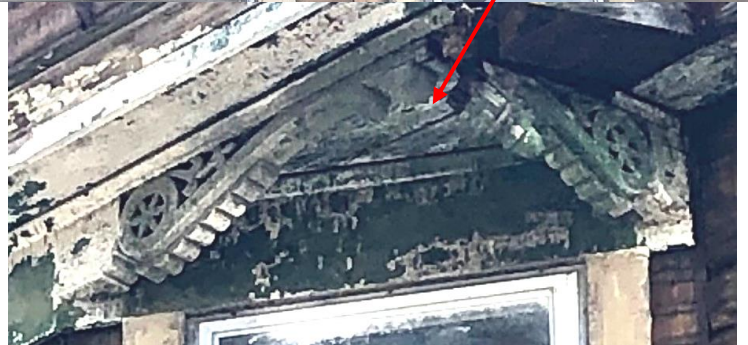
- These pictures show ornament that remains in place and is unique to 7908-7912 St. Paul. These are distinctive character-defining features. One bracket is missing from the left side, but three remain intact and can be used to fabricate the missing bracket.

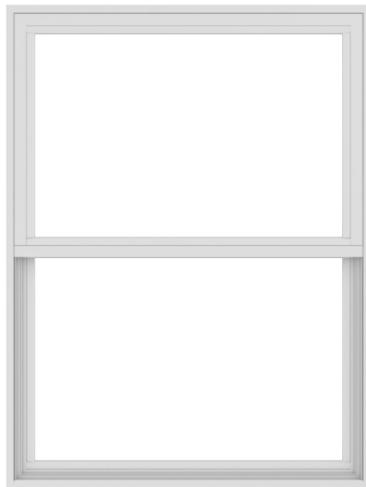
*Anderson 100 series single-hung unit*

The upper sash is outlined, yet is fabricated in the same plane as the outer frame. This makes the upper sash appear to be a component of the frame.

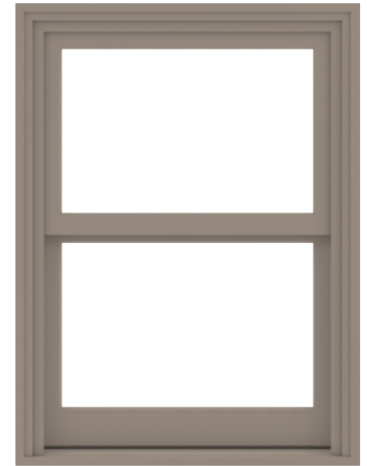
*Anderson A series double-hung unit*

The star identifies the operable upper sash. It is recessed from the window frame and adds a dimensional relationship similar to historic window units.
