**STAFF REPORT: MAY 10, 2023 MEETING**

**APPLICATION NUMBER: 23-8331**

**ADDRESS: 4071 LESLIE**

**SCOPE: REPLACE ORIGINAL WINDOWS WITH WOOD ALUMINUM-CLAD WINDOWS**

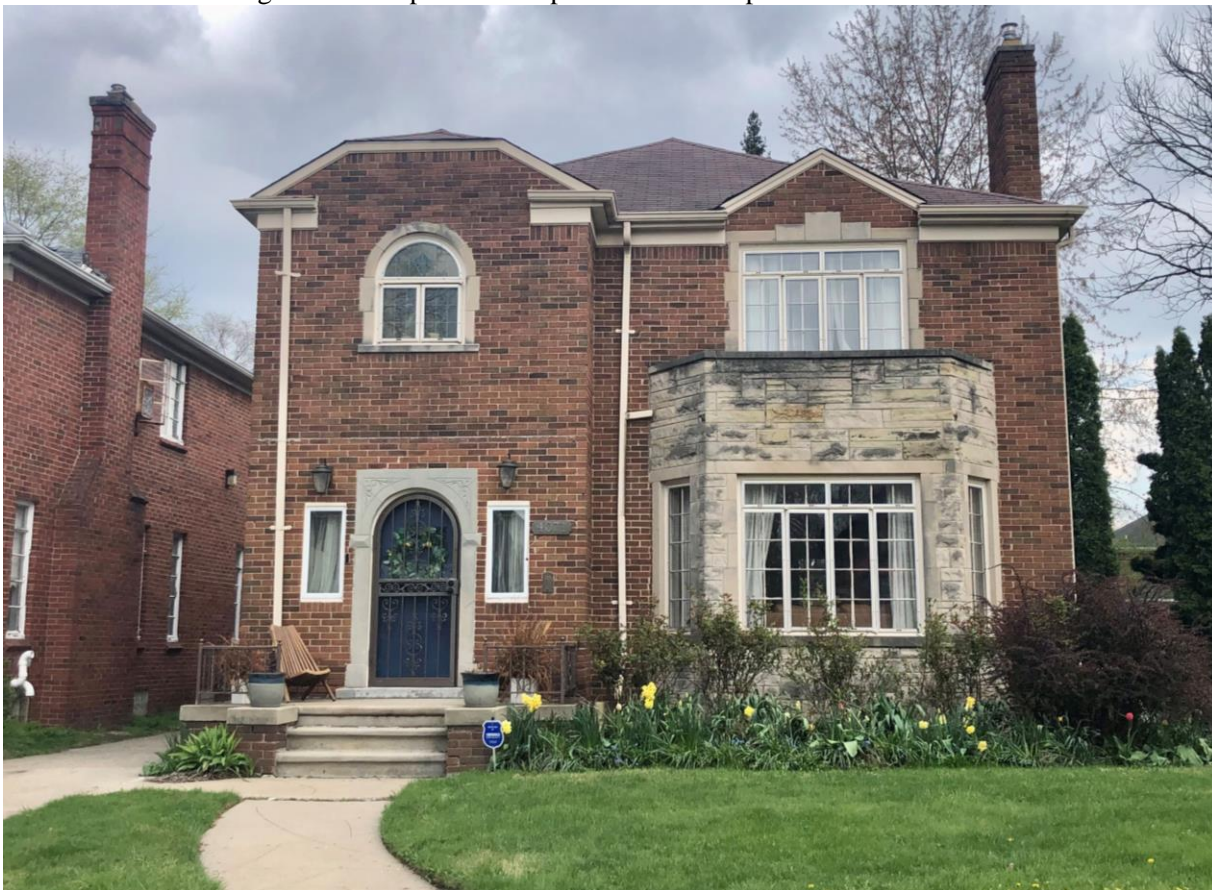
The two-story residence at 4071 Leslie is located on the south side of Leslie, between Petoskey and Holmur. The building permit was issued on May 1, 1941. The variegated brown brick was laid in a running bond pattern and stone covers the walls of the tall, flat roofed bay window. Cast stone quoins were used for the window surround at the second floor, while at the front entrance carved panels accentuate the arch topped entry door. The wood front door with asymmetrical leaded glass window, a common detail for houses of this era and architectural style, is likely original. The front door is accessed by an open raised porch. Brick wing walls with stone caps enclose the stairs and the historic iron railing remains in place at the perimeter of the porch floor.

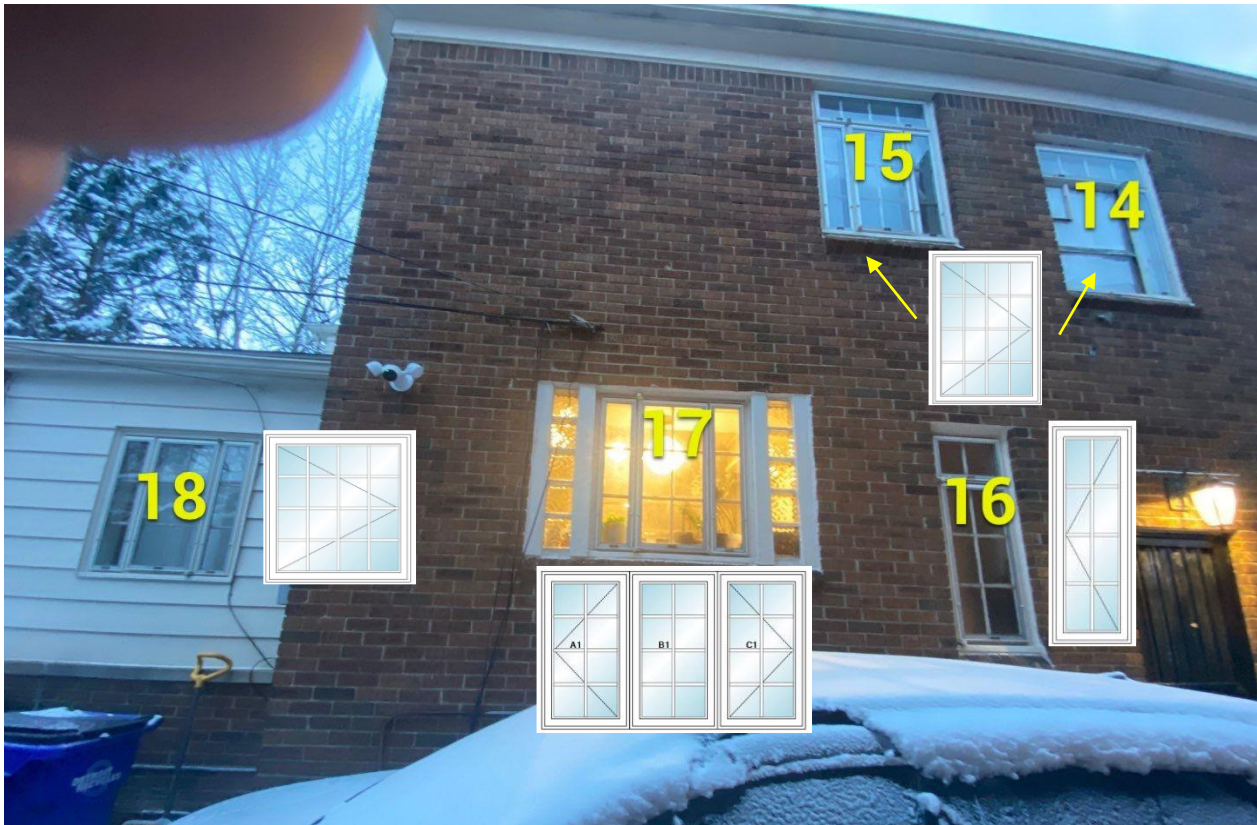
**EAST ELEVATION**

- The existing historic windows are steel, which means the frames, muntins, and mullions are exceptionally thin due to the inherent strength of steel. This is a distinctive character-defining feature of these windows, and important to the property and the district. The outfacing hinges of the casement units offer an additional dimensionality to the openings and identification of material and sash age.
