**STAFF REPORT: AUGUST 9, 2023 MEETING**

**APPLICATION NUMBER: 23-8404**

**ADDRESS: 8022 KERCHEVAL**

**SCOPE: WINDOW REPLACEMENT ON SIDE AND REAR ELEVATIONS**

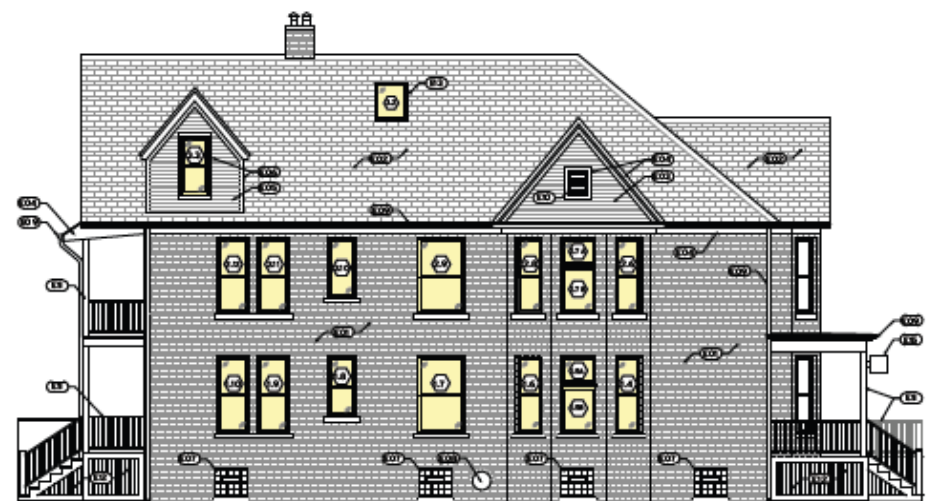
1 SIDE ELEVATION (EAST)  
SCALE: 3/16" = 1'-0"

- *The two double-hung openings at the second floor, near the rear wall, are missing windows.*
- Applicant proposes to replace all the windows on this wall.

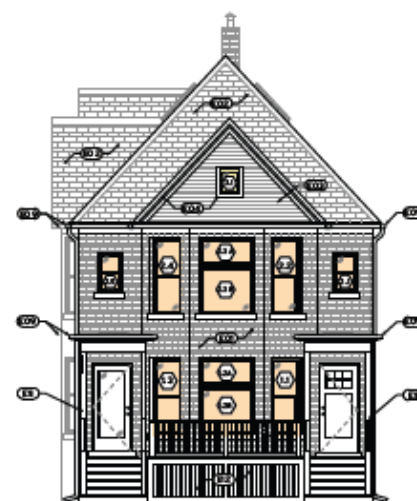
2 FRONT ELEVATION (KERCHEVAL AVE.)  
SCALE: 3/16" = 1'-0"

- A new window is planned for the third-floor front gable, replacing a vent. A window was in this location at the time of designation.
- *The lower sash of the second-floor fixed bay window is missing.*
- Remaining window sash are proposed to be repaired.

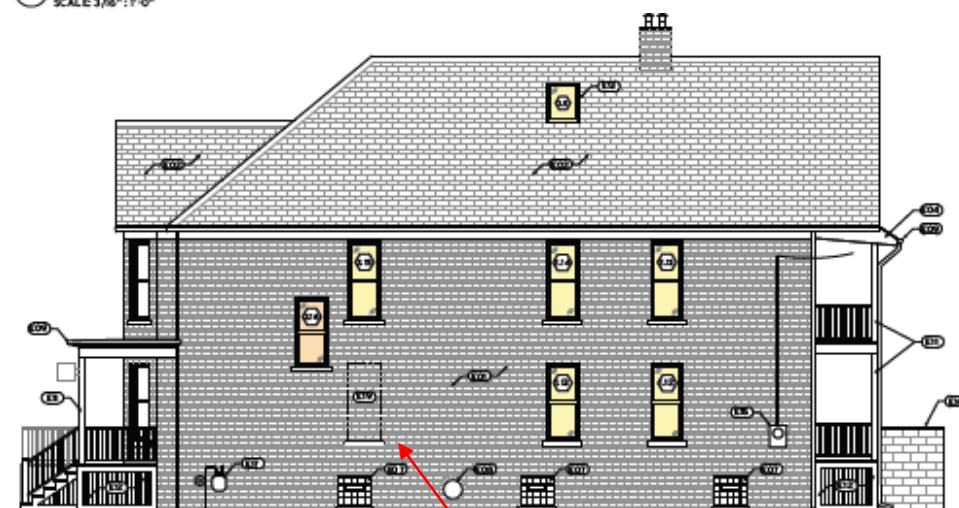
3 SIDE ELEVATION (WEST)  
SCALE: 3/16" = 1'-0"

- The window openings are minimally visible from the right-of-way- due to the proximity of the adjacent property.
- *The window openings at the second floor are each missing the lower sash.*
- The applicant intends to retain and repair the window sash in the opening that is halfway between the first and second floor.
- The first-floor window opening closest to Kercheval is intended to be bricked-in; the specification calls for brick to be placed flush with the exterior masonry wall.

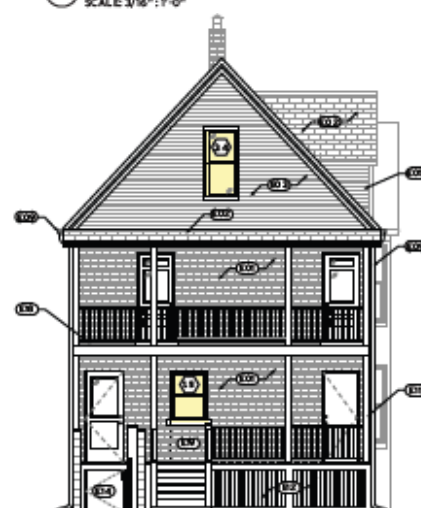
4 REAR ELEVATION (ALLEY)  
SCALE: 3/16" = 1'-0"

- The elevation includes two window openings; one new opening and one historic opening in the gable (which is proposed for replacement).
