**STAFF REPORT: OCTOBER 11, 2023 MEETING**

**APPLICATION NUMBER: HDC2023-00055**

**ADDRESS: 9120 DWIGHT**

**SCOPE: REPLACE WOOD WINDOWS WITH COMPOSITE WINDOWS**

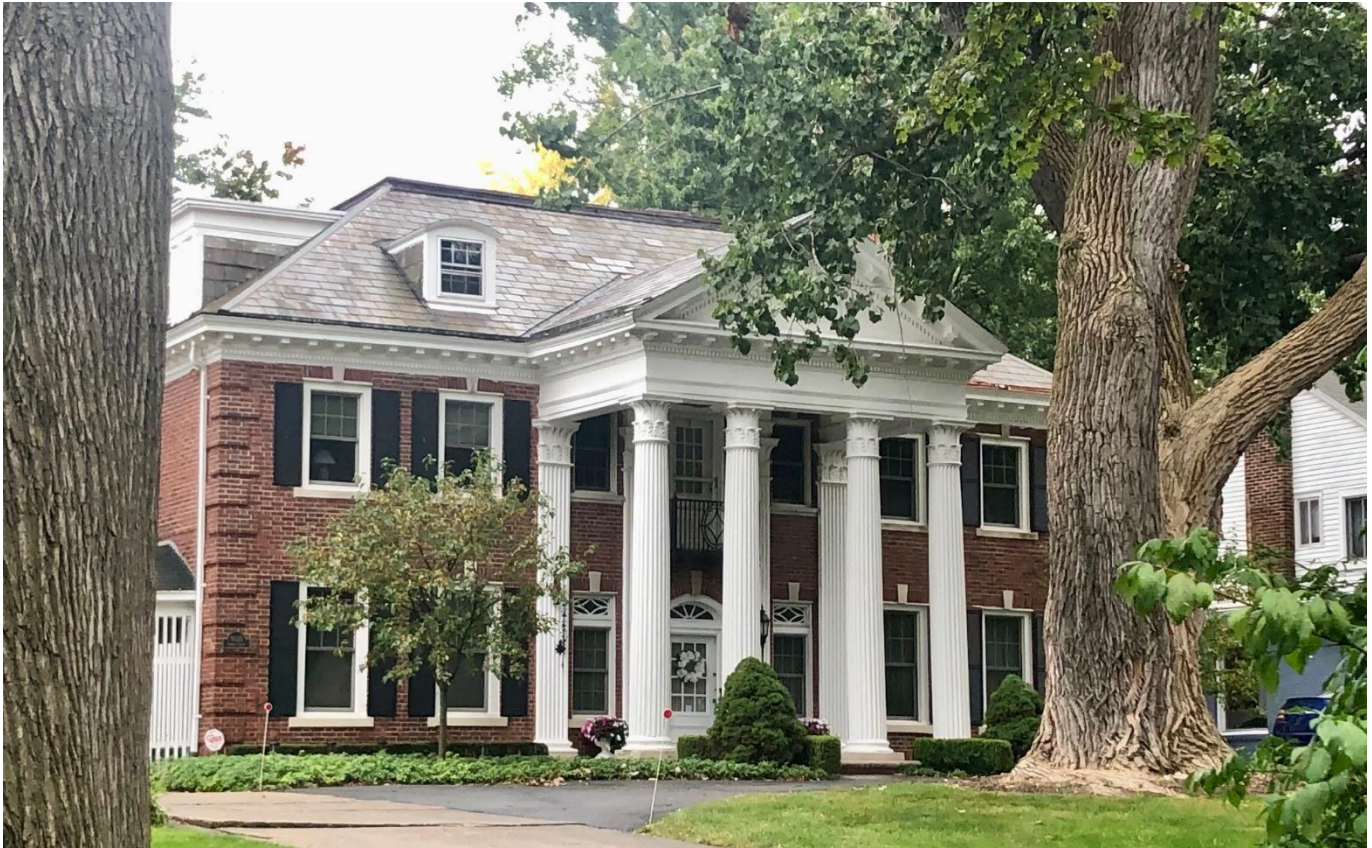
*Staff photo, September 26, 2023.*

The front lawn is dominated by a very large tree, whose central location further accentuates the symmetrical house design. A straight driveway at the left side of the lot is shared with the property to the east, and an extended drive across the front of the house joins the neighboring house's (to the west) circular driveway.

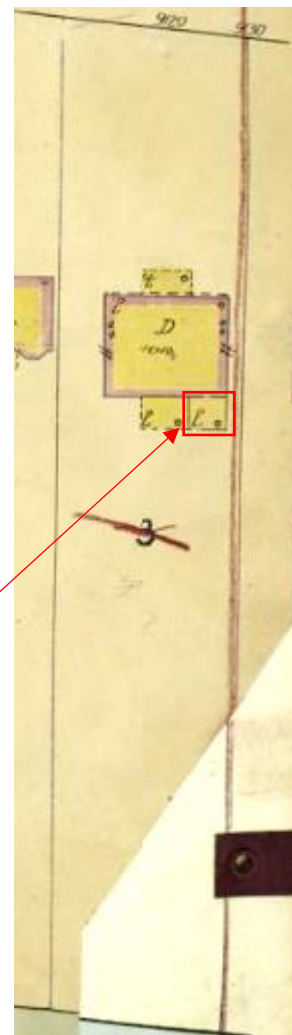
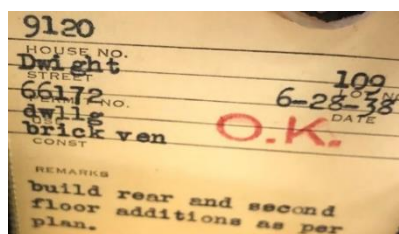
Sanborn map, 1915 – 1951.

- The Berry Subdivision Historic District was enacted on June 13, 1978.
- BSEED's historic building permit files documents that a rear two-story addition was erected in 1938. In 1941, a dormer was erected as part of a third floor renovation to create two bedrooms and one bathroom. Staff assumes the large, shed dormer is the result of the 1941 scope of work. Submitted interior photos show that two of the four windows in the east-facing dormer are for a bathroom.
