STAFF REPORT: OCTOBER 11, 2023 MEETING

APPLICATION NUMBER: HDC2023-00024

ADDRESS: 2244 WABASH

**SCOPE: DEMOLISH REAR OF HOUSE* (WORK COMPLETED WITHOUT APPROVAL);
ERECT REAR ADDITION**

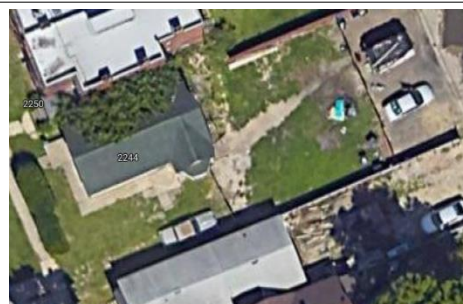
--The location and number of windows were not noted on any map.
 --The composite roof symbol is shown at the three porches on the 1921 map, identifying each porch had a roof.

The drawing depicts a wood framed structure with a wider than deep rear area that possibly was an addition.

The former addition is integrated into the body of the structure (now identified as a dwelling). Another rear addition was erected, as well as another outbuilding at the alley.

It is possible the rear addition was enlarged, and a front, side and rear porch were added.

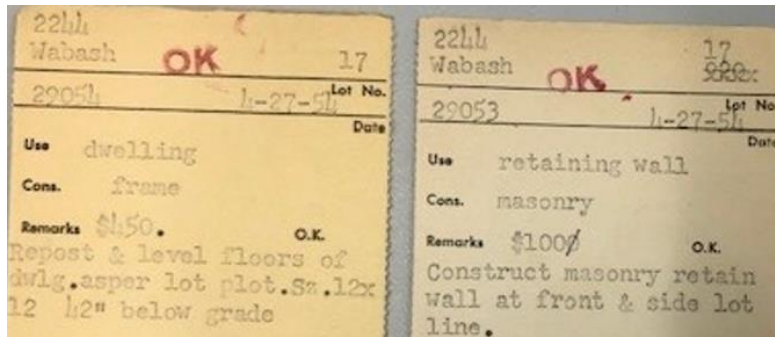
- Two permits were issued in April 1954 to:
 - Level the dwelling's floors and install supporting posts below grade, and
 - Construct masonry retaining walls at the front and side lot line, which in staff's opinion hints to the raising of the yard.

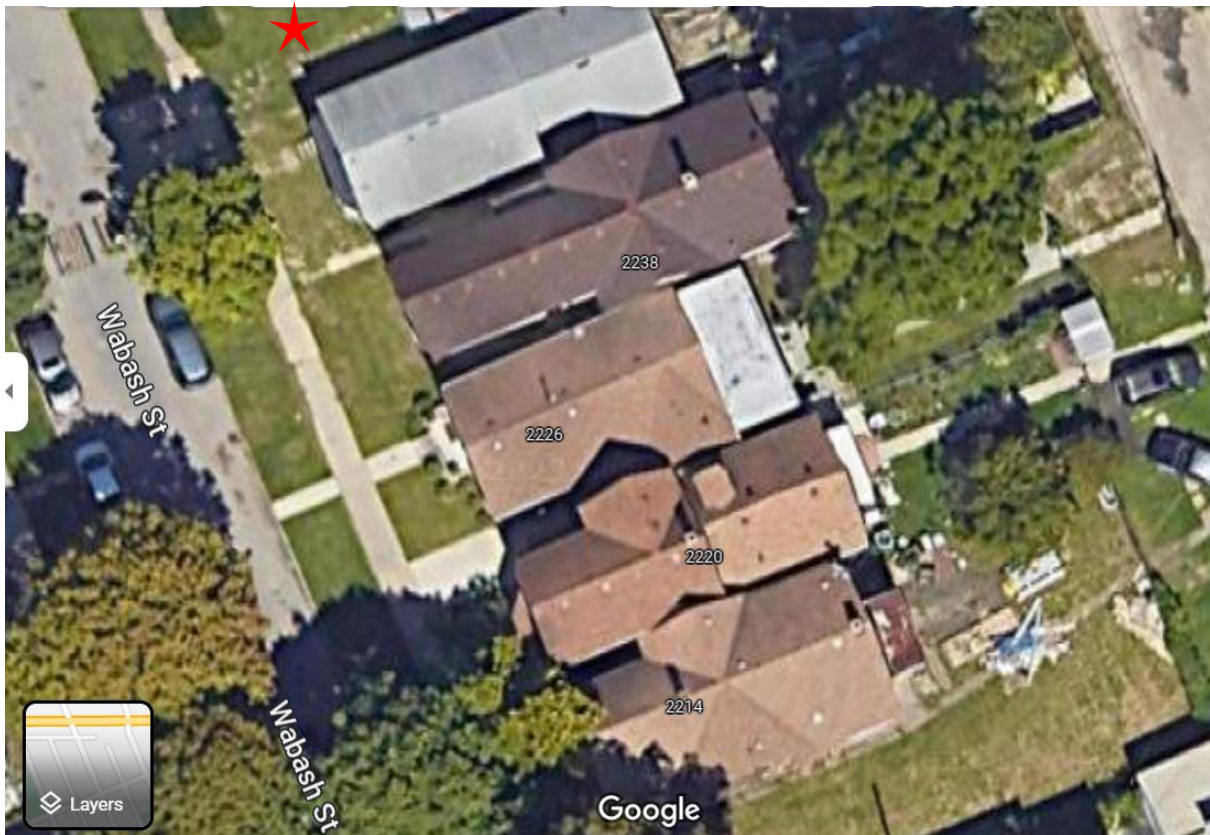
Google aerial image. 2244 Wabash is not visible but is directly above where the star is located. This view shows how four of the five houses have cross gable roofs, many of which cover extending walls (identical to what was in place at 2244 Wabash). The photos on the following page offer streetscape views of the above dwellings.

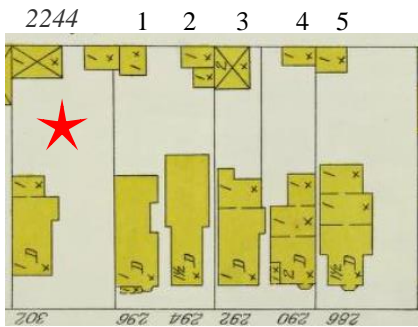
On the following page is an expanded view of the 1897 Sanborn map which shows that neighboring five dwellings had inset or extending walls and all but one had (and still have) cross gabled roofs.

1897 Sanborn map.
 2244 Wabash is highlighted.
 Photos on this page were taken by staff,
 standing at Wabash sidewalk.

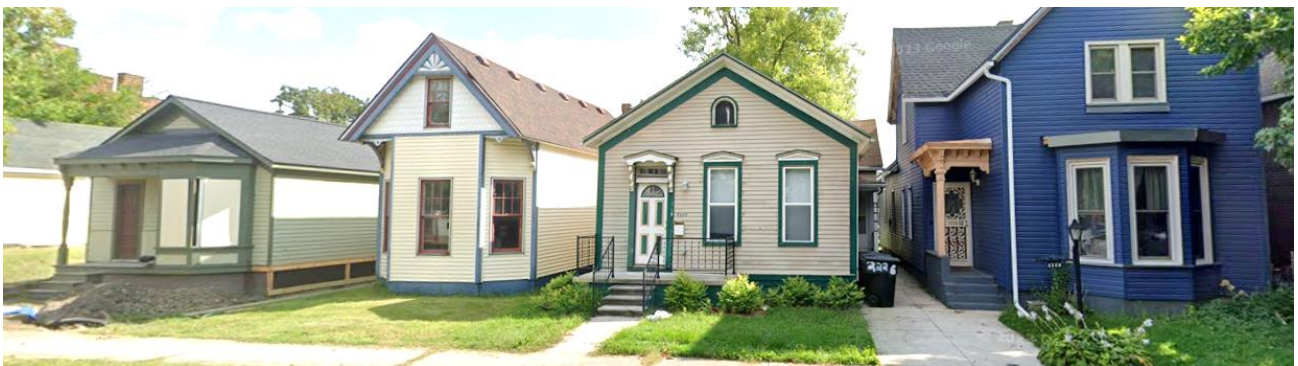
- In addition to the new construction, the applicant is proposing a new foundation/basement for the remaining existing portion of the house, and the re-grading/lowering of the front and side lawn to match the tree lawn and adjacent yards. 19th century houses in Corktown were typically built on piers and many houses have had full foundations added to the structures. Staff doesn't know if the raised yard is original to the site, or if it was added in 1954 along with the retaining walls. Staff doesn't dispute the idea of lowering the grade so that the lawn is similar to the other houses on the street. However, staff doesn't know if the applicant proposes to cover the area between the wood siding and grade with some type of skirting, which is a typical detail for houses in the district which are of similar age.

Google street view. 2244 Wabash is partially seen on the far-left side of the photo. This view shows the flat yards of the neighboring houses.
