**STAFF REPORT:** OCTOBER 11, 2023, REGULAR MEETING

**APPLICATION NUMBER:** HDC2023-00056

**ADDRESS:** 226 MACK

**SCOPE:** REPLACE WOOD AND VINYL WINDOWS WITH ALUMINUM-CLAD WOOD WINDOWS

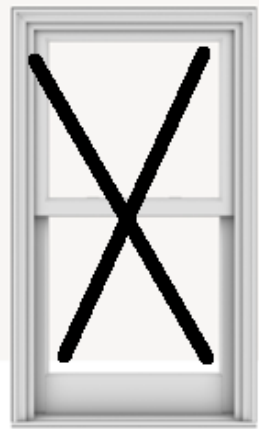
~~Andersen E-Series aluminum-clad wood window in white. Image from product website.~~

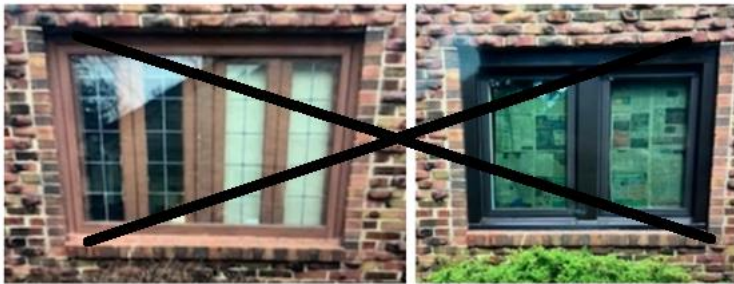
~~Before (left) and after (right) examples of aluminum cladding provided by the applicant. Note that the proposed color is white rather than the black shown.~~

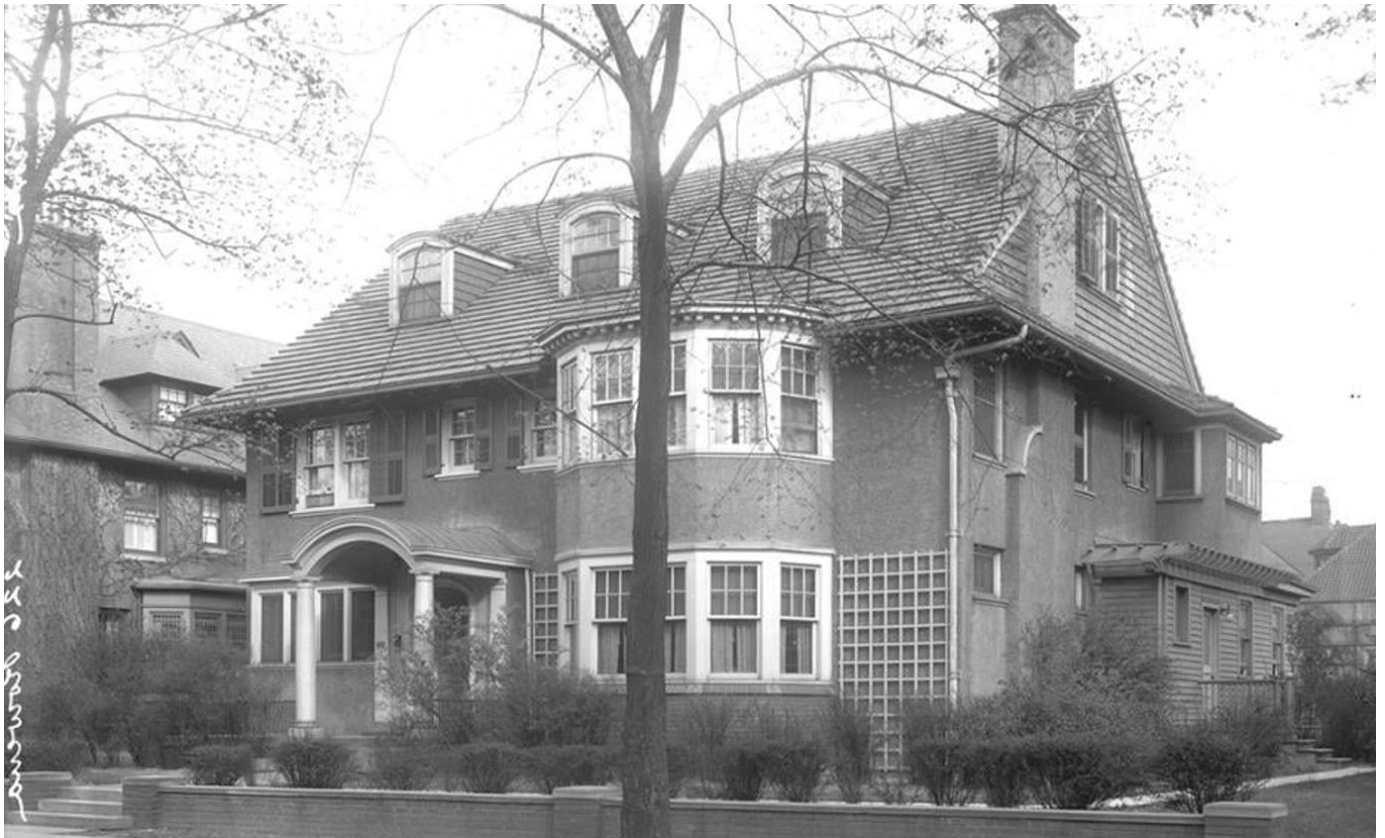
Undated photo from the Burton Historical Collection.

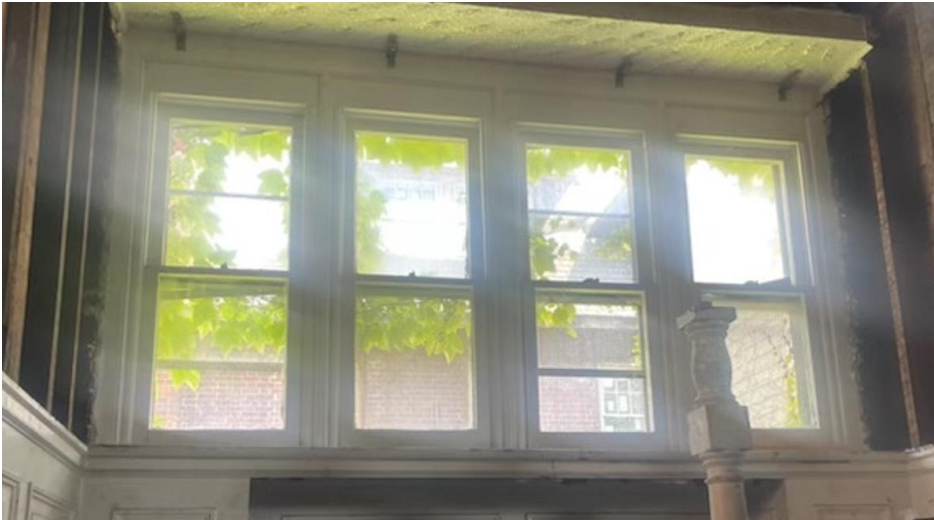
- Though the exact appearance of the missing windows on the property is not documented (other than the dormer windows, discussed under “Issues,” below), the proposed Pella Lifestyle window closely approximates the appearance of a typical historic wood window and is a compatible replacement for the missing windows and vinyl windows. The photo above also demonstrates that one-over-one windows are appropriate for the property. (See National Park Service, *Replacement Windows that Meet the Standards*, 2022)<sup>1</sup>

Staff recommends that the Commission issue a Certificate of Appropriateness for the proposed replacement of missing windows and vinyl windows as these work items meet the Secretary of the Interior’s Standards for Rehabilitation, with the following conditions:

- Existing historic window casing will be retained (it may be replaced with matching wood casing if missing or deteriorated beyond repair) and will not be obscured by aluminum cladding.
- ~~The color of the windows will be a color selected from Color System C or D, or another color approved by staff.~~
