**ADDRESS: 3964 W. LAFAYETTE**

**APPLICATION NO: HDC2023-00141**

**HISTORIC DISTRICT: HUBBARD FARMS**

**SCOPE: REBUILD WING**

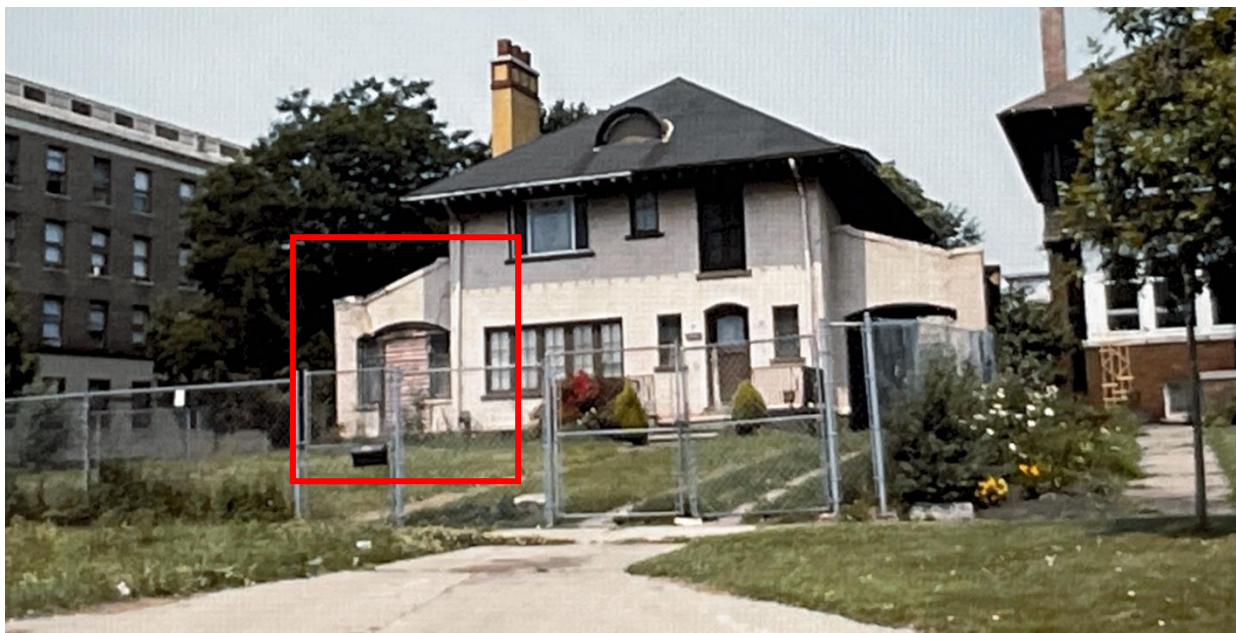
- Per the previous point, the wing proposed for rehabilitation was extant an enclosed space since its initial construction. See the photos which demonstrates that the wing mirrors the appearance of the porte cohere and provides a distinct sense of symmetry when viewing the home’s primary elevation from Lafayette Street. The wing also includes a number of distinctive architectural details which are associated with the Spanish Colonial Revival style to include arched window openings, stucco cladding, and deep overhanging eaves with decorative jigsawn wood rafter tails at its roof. The wing also retains its original wood windows and trim (see below photos) and is highly visible as the home is located as an intersection. For these reasons, the wing, to include its remaining fenestration, is a distinctive character-defining element of the building, in staff’s opinion.

**3964 W. Lafayette, designation slide, wing proposed for rehabilitation**

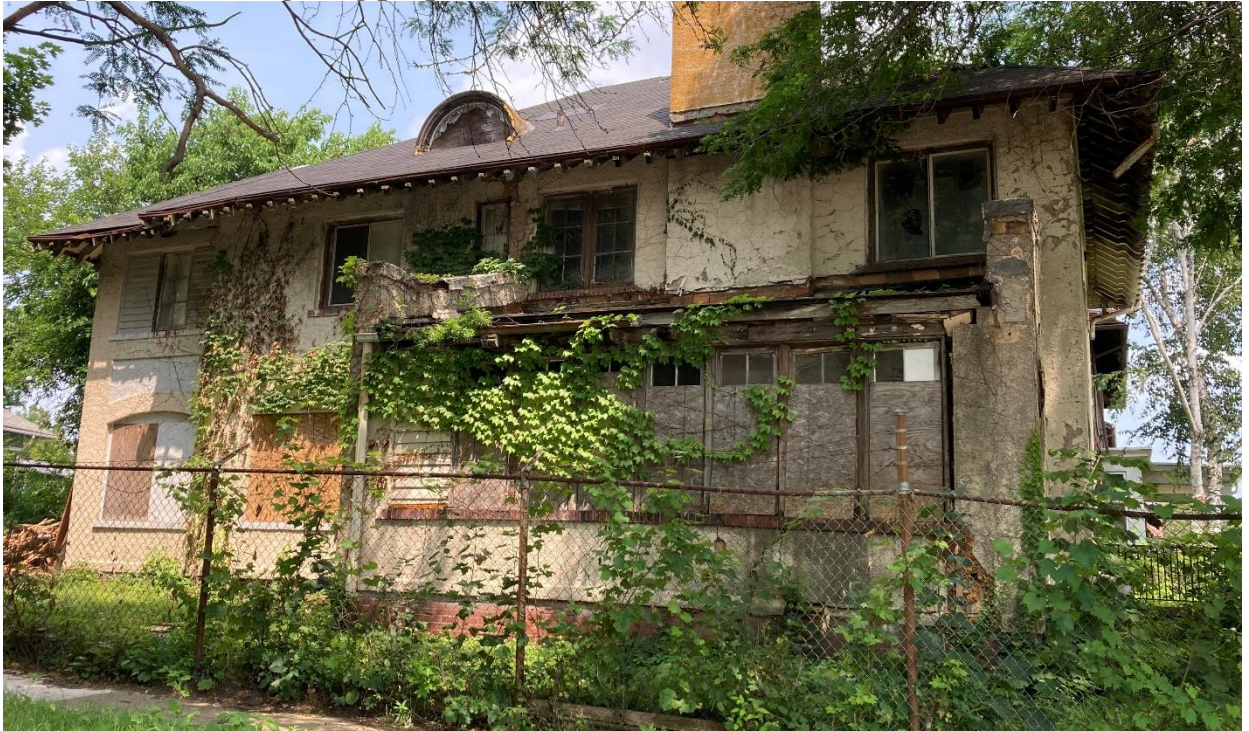
**Facing east**

**Staff photos, showing wing proposed for rehabilitation, taken 7/30/2023**
