STAFF REPORT: 02/07/2024 REGULAR MEETING

APPLICATION NUMBER: HDC2024-00010

ADDRESS: 13134 BROADSTREET

SCOPE: REPLACE WINDOWS, ROOF, GUTTERS (WORK COMPLETED WITHOUT APPROVAL), DEMOLISH GARAGE

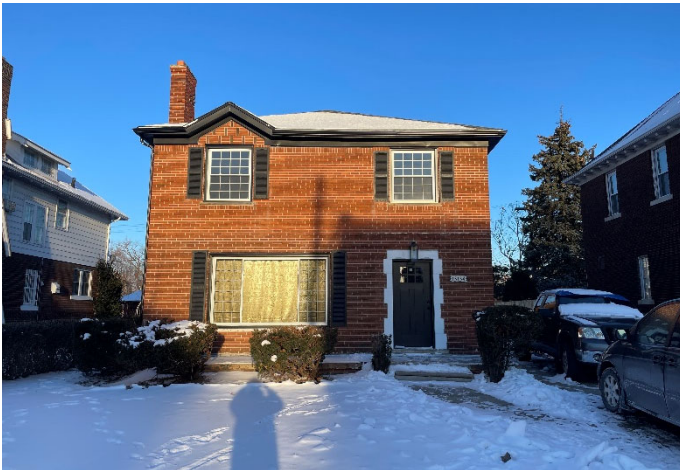
Site Photo 1, by Staff January 17, 2024: (West) front elevation.

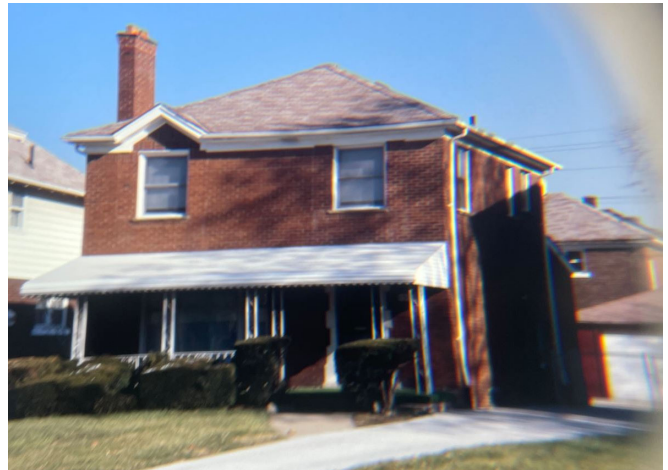
Designation photo 1999: (west) front elevation, showing existing garage in the backyard, porch railing and awning, original 1/1 windows without shutters, and wood fascia and soffits and wood door.

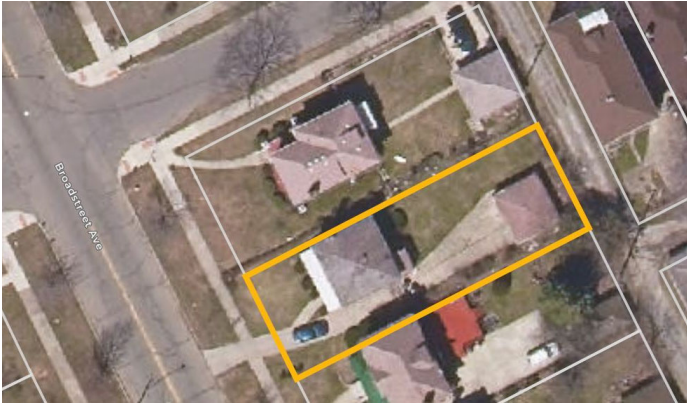
Aerial#1 of Parcel # 14012165., showing original garage and alley behind the garage.

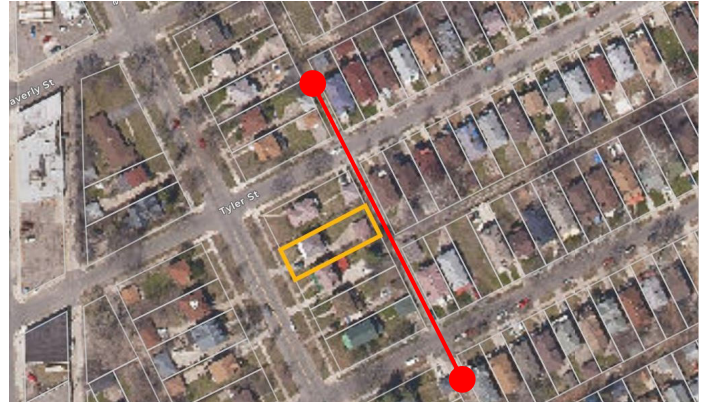
Aerial #2 of Russell Woods-Sullivan HD, showing applicant’s location in the context of other resident’s garages along alley and Photo Study by staff on January 30, 2024 (see extent of photos in red line above).

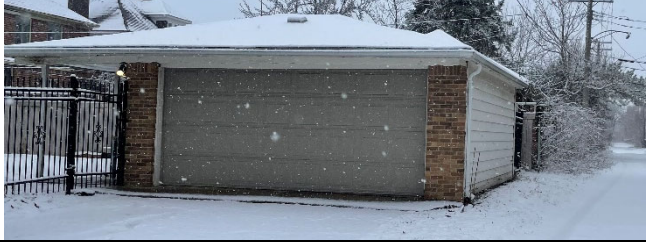
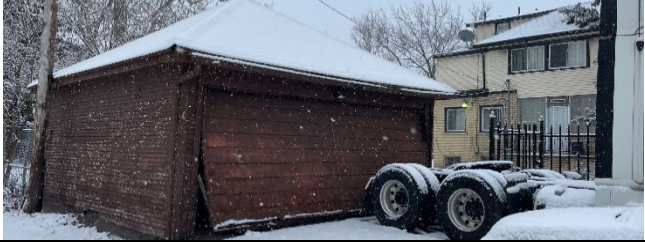
4372 Buena Vista (1925 Dwelling, Frame Garage date unknown)	13114 Broadstreet (1936 Dwelling, Frame Garage with brick cladding date unknown)
