STAFF REPORT: 02/08/2024 REGULAR MEETING

APPLICATION NUMBER: HDC2024-00184

ADDRESS: 2491 LONGFELLOW

SCOPE: ALTER DWELLING (WORK COMPLETED WITHOUT APPROVAL), REMOVE TREE, INSTALL PARKING PAD AND FENCE

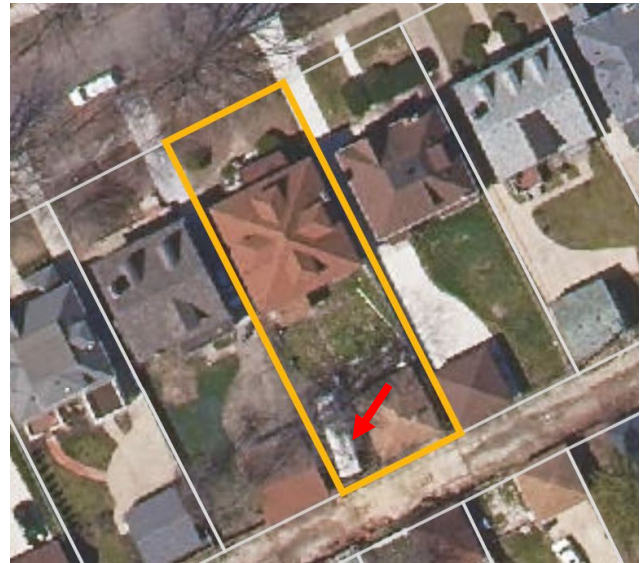
Aerial 1 of Parcel # 10002637, by Detroit Parcel Viewer, showing the proposed pad location (arrow).

- Remove front foundation shrubs and replace with lawn (Work completed by previous owner without approval).
- Remove rear tree.
- Install rear gravel parking area and walking path per attached site plan.
- Install 6' wood privacy fence to match existing privacy fence per attached site plan. Stain fence after one year of installation.
