REVISED STAFF REPORT: 06/12/2024 MEETING
APPLICATION NUMBER: HDC20204-00318
ADDRESS: 1475 LONGFELLOW
HISTORIC DISTRICT: BOSTON-EDISON
APPLICANT: TIM FLINTOFF (4545 ARCHITECTURE)
OWNER: SHARIF AFFAS
DATE OF PROVISIONALLY COMPLETE APPLICATION: 5/20/2024
DATE OF STAFF VISIT: 5/29/2024

SCOPE OF WORK: ERECT REAR ADDITION

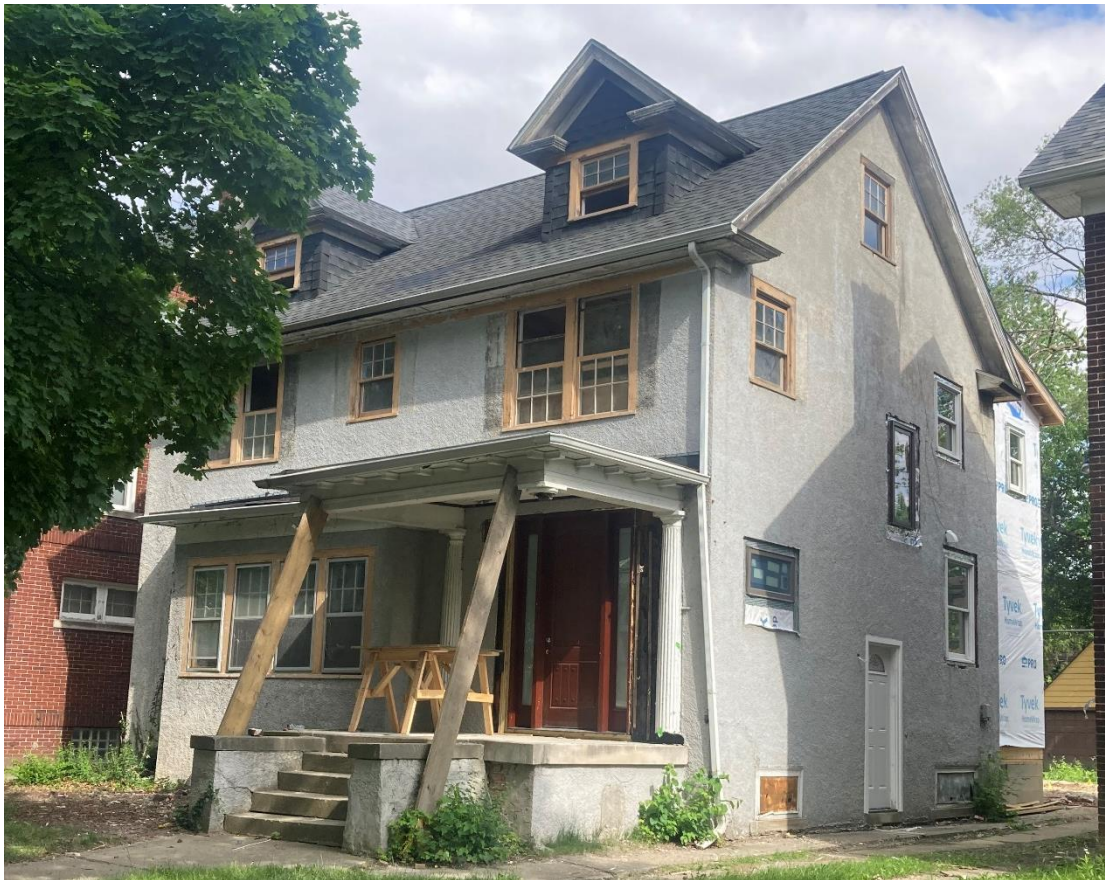
1475 Longfellow, staff photo taken on 5/29/2024. Facing southeast.

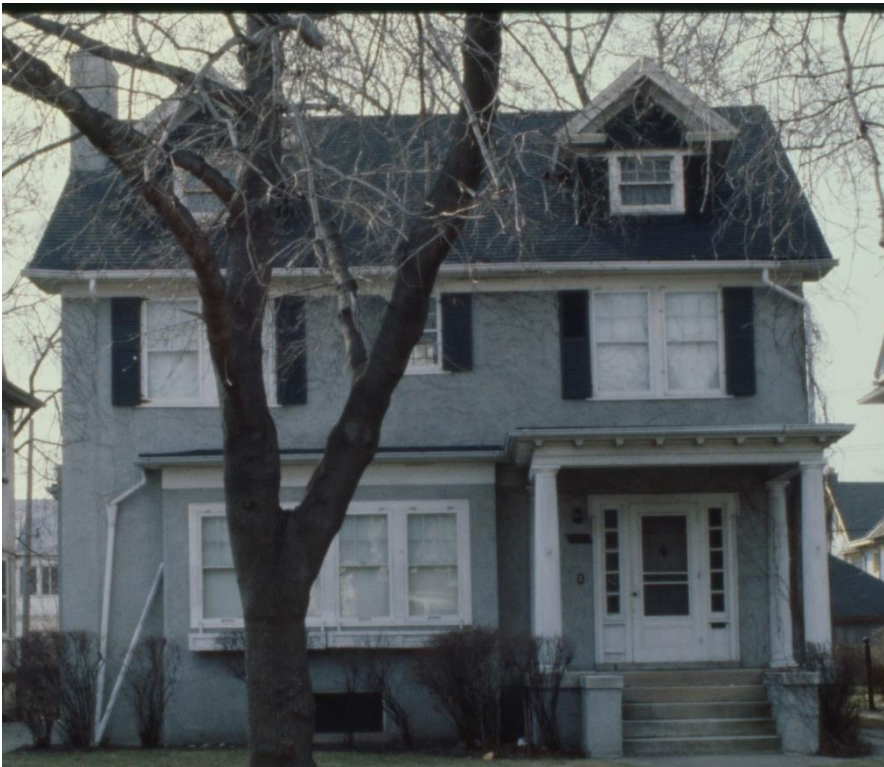
Designation slide, appearance in 1980

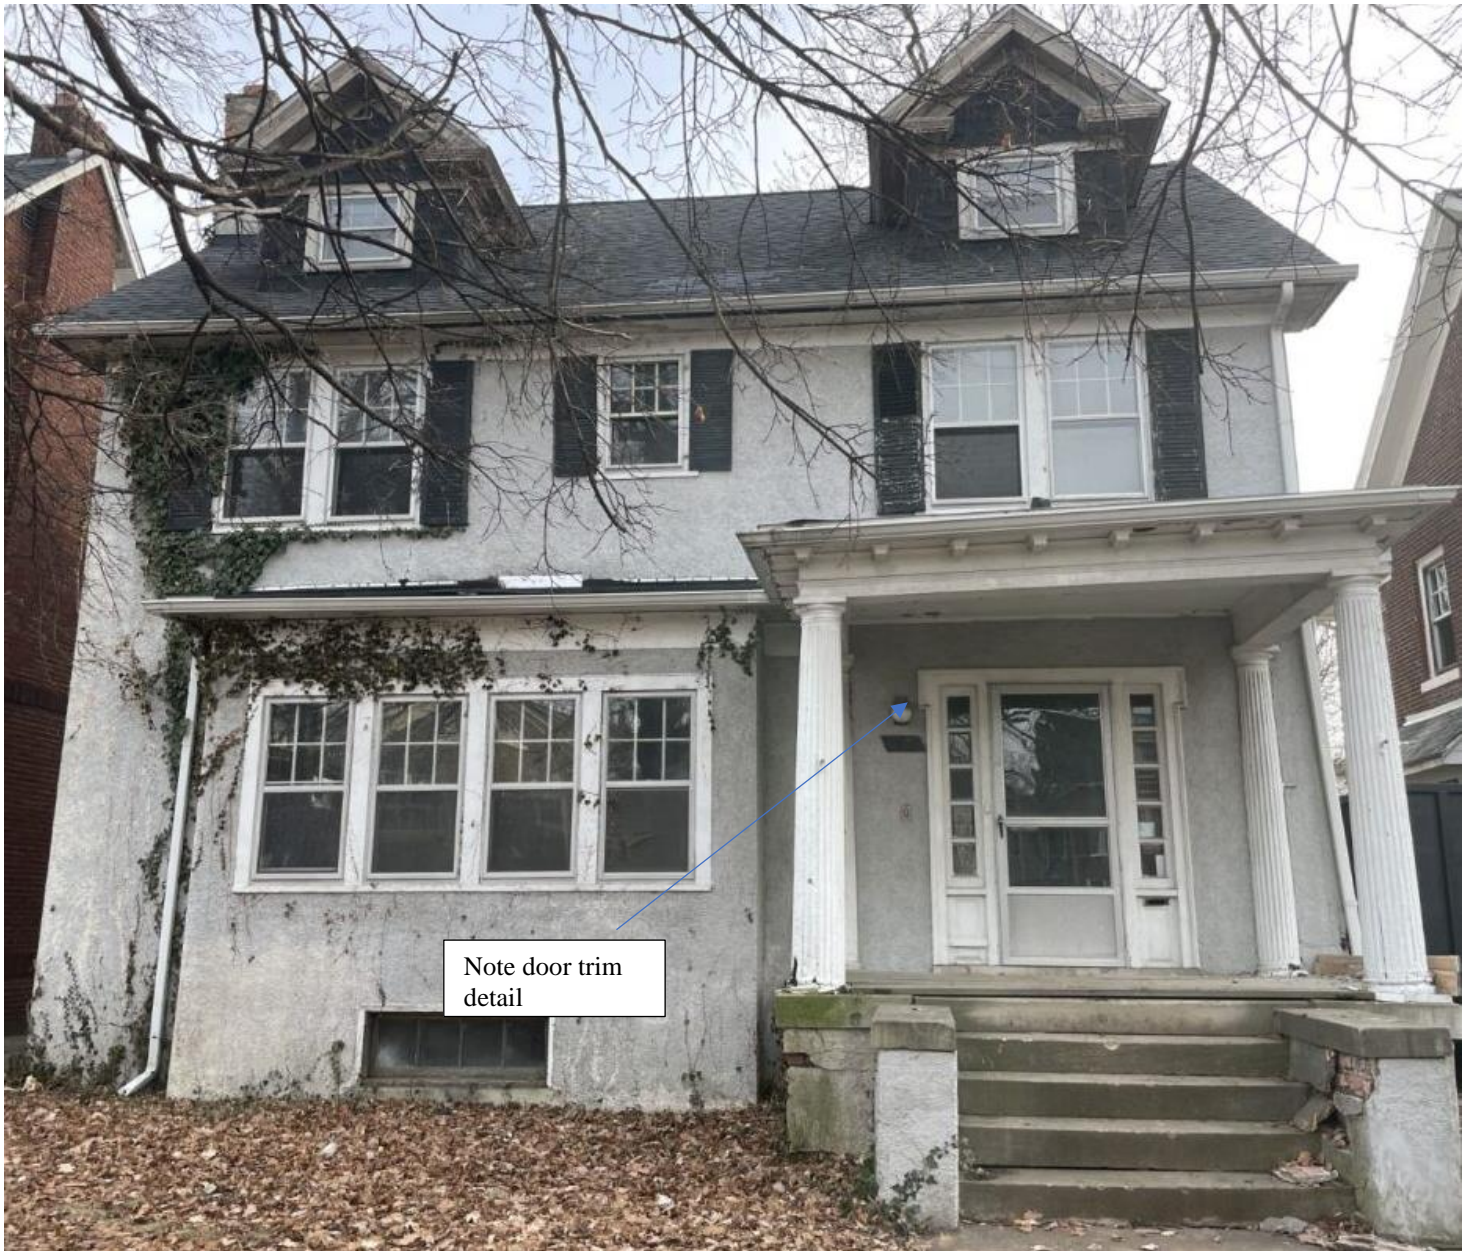
Photo of 1475 Longfellow taken by staff in 12/2023. Appearance prior to unapproved work. Note that the original character-defining porch posts, front door/sidelites and shutters remained at this time.

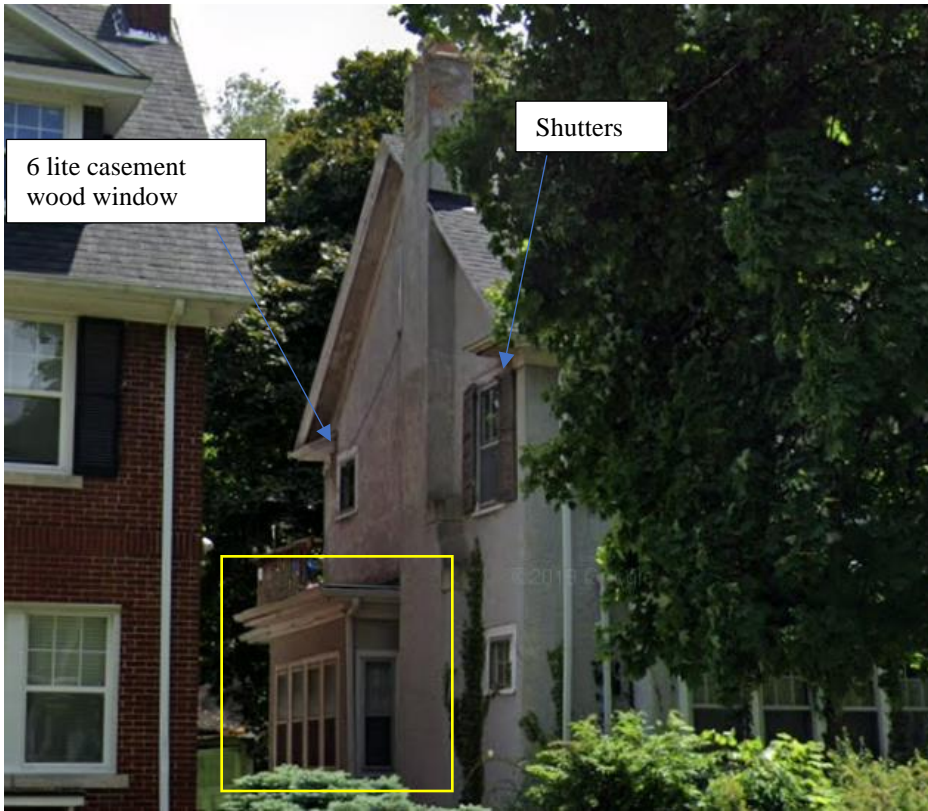
East elevation, Google Streetview, 2022. Note original windows, shutters at second story, and projecting sunroof bay at first story (outlined in yellow). This bay also extended to the building's rear elevation

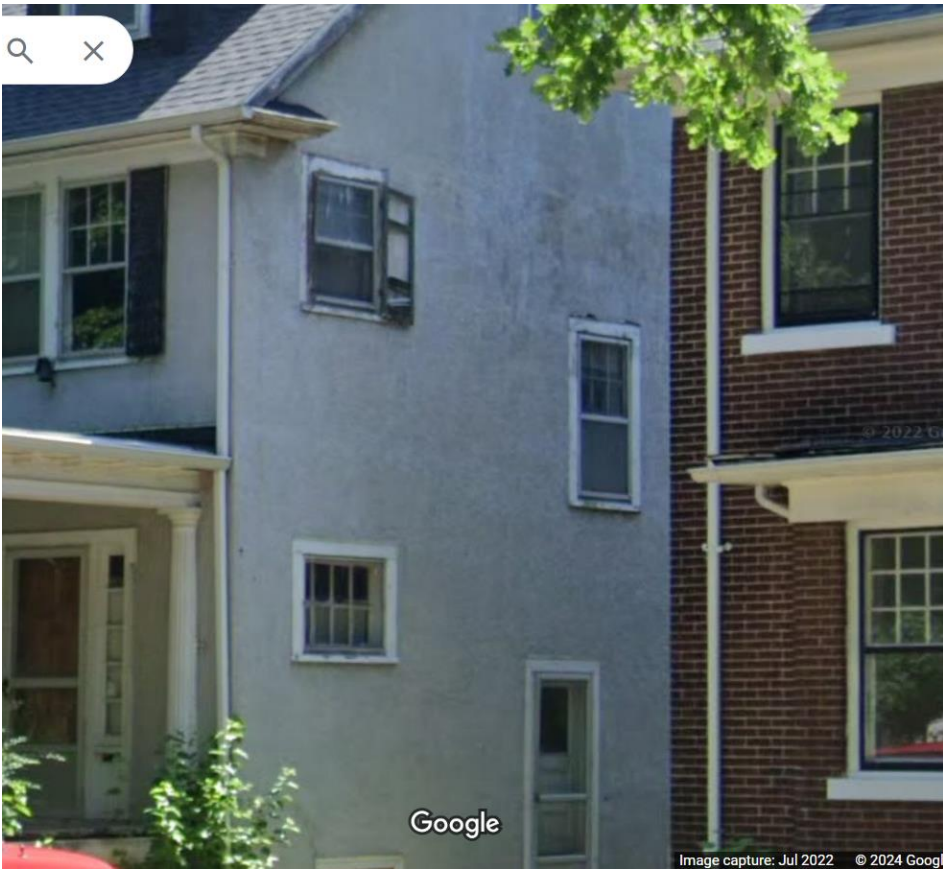
West elevation, Google Streetview, 2022. Note that original windows, shutter remnant, and wood door at first story remain

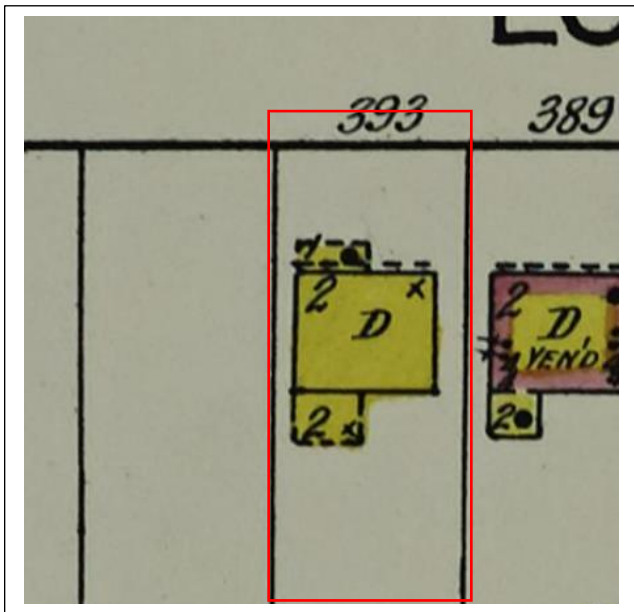
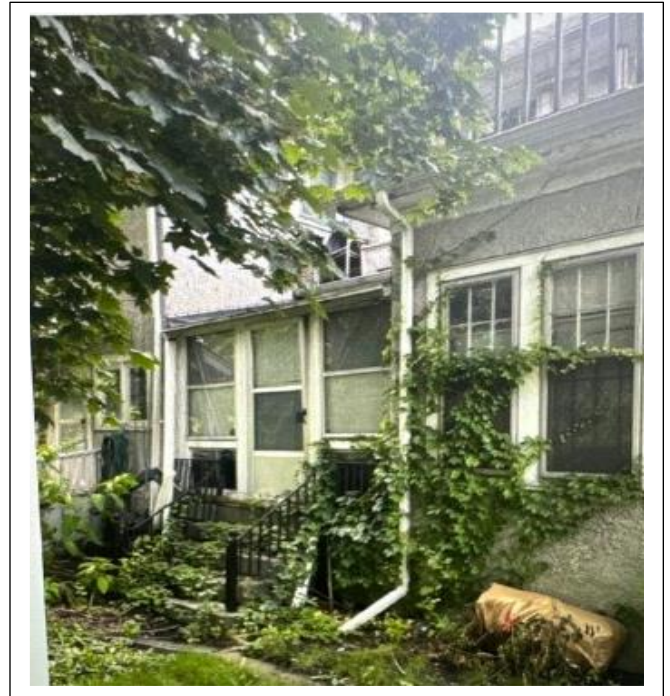
Left, 1915 Sanborn Map (1475 Longfellow outlined in red). Prior to 1920, the property was addresses as 393 Longfellow. Right, photo of rear elevation, prior to unapproved new two-story addition. Provided by applicant
