**STAFF REPORT: JUNE 12, 2024 MEETING**  
**APPLICATION NUMBER: HDC2024-00273**  
**ADDRESS: 3417 SEMINOLE**

**HISTORIC DISTRICT: INDIAN VILLAGE**  
**APPLICANT: NICOLE RODRIGUEZ**  
**PROPERTY OWNER: NICOLE RODRIGUEZ**  
**DATE OF PROVISIONALLY COMPLETE APPLICATION: MAY 20, 2024**  
**DATE OF STAFF SITE VISIT: MAY 22, 2024**

**SCOPE: DEMOLISH GARAGE, ERECT GARAGE**

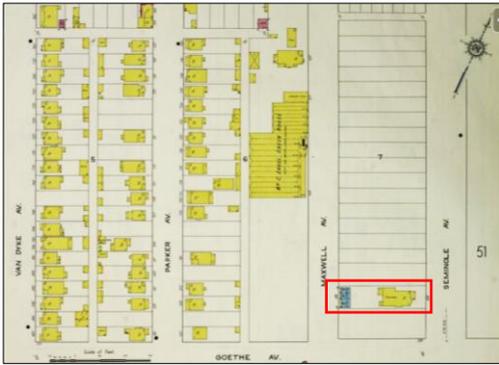
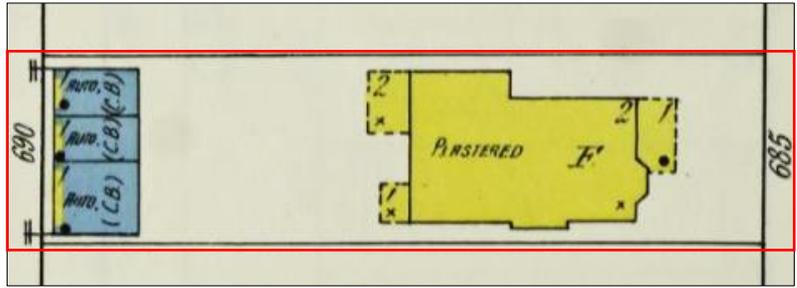
Sanborn map, Vol. 8, 1915, Image 51. The full view of this map, at left, confirms 3417 Seminole, 1915 address - 685 Seminole, was the only house erected on the west side of Seminole between Goethe and Mack (only three houses were erected on the east side of the same block). The garage is not visible in the photo on the previous page; therefore, it was erected after the house but in time to be included on the 1915 map. The blue color and "CB" identify the walls as concrete block. The dark circle identifies composite roofing, and yellow identifies wood doors. The yellow house identifies wood frame construction and stucco/plastered exterior finish, with a wood shingle roof ("x").

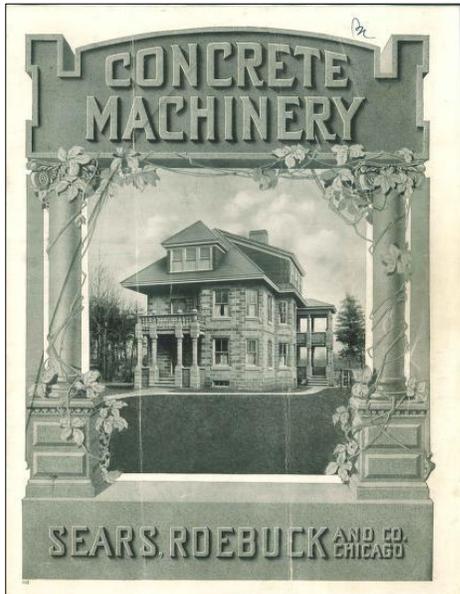
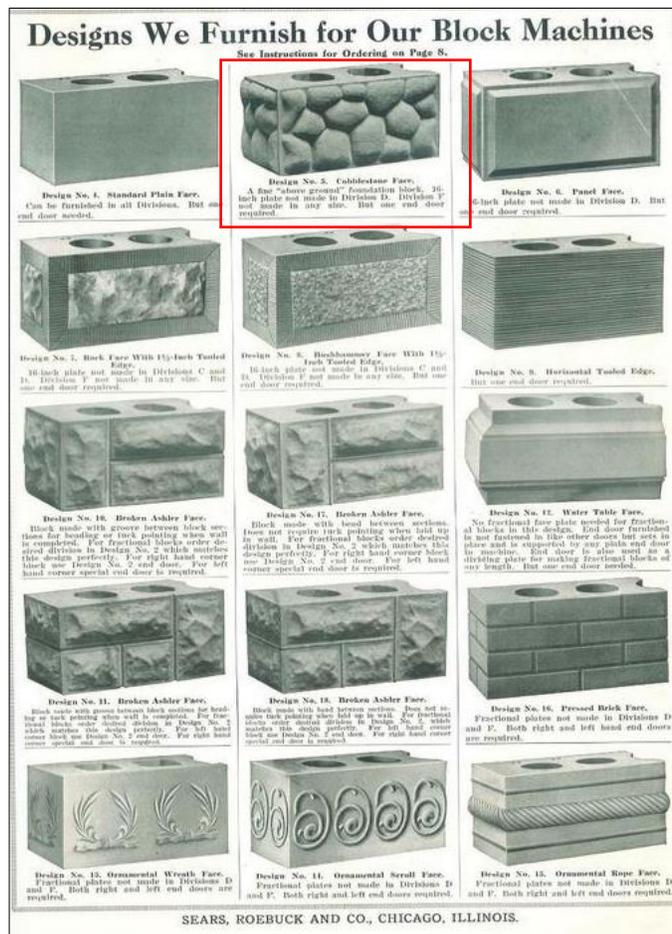
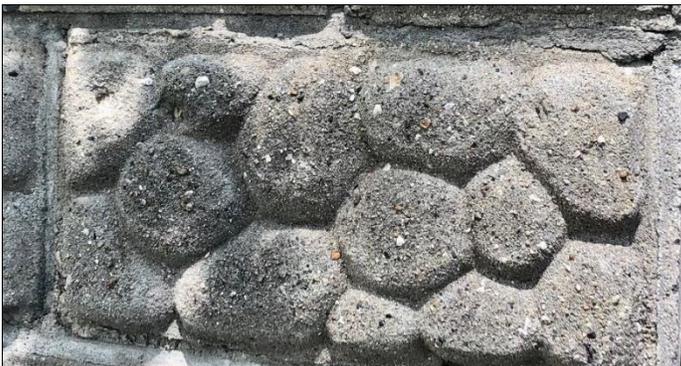
Cover and inside page of a 1915 Sears, Roebuck & Co. catalog. The cobblestone pattern offer by Sears is very similar to the patterned blocks used to erect the garage at 3417 Seminole.

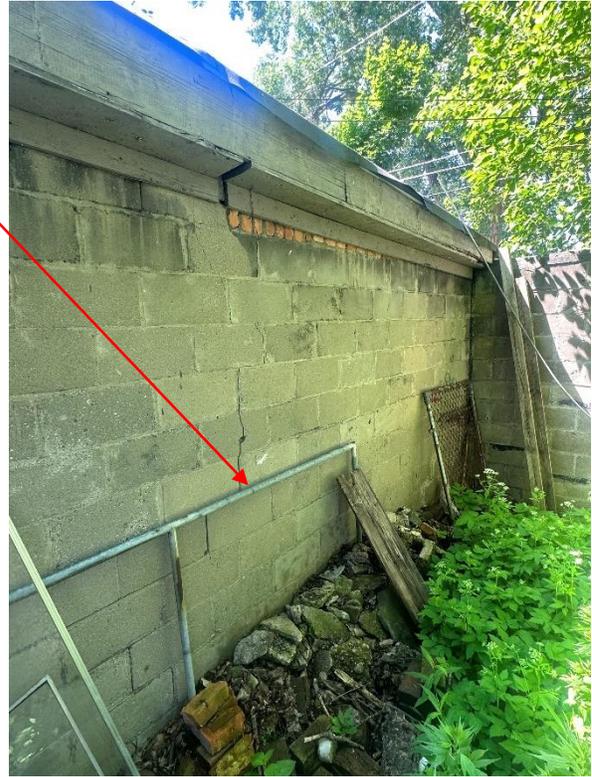
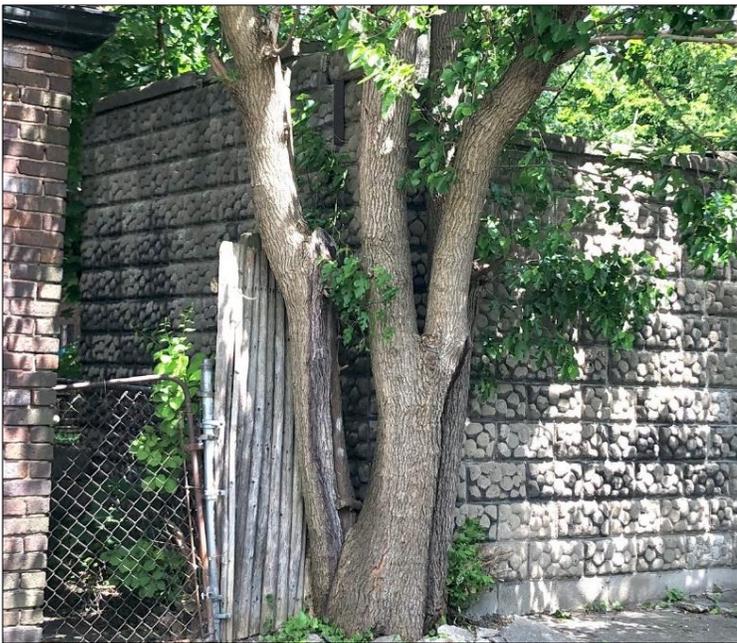
NW corner of garage.

Staff is concerned about the tree growing at the northwest corner of the garage. Its removal is not mentioned in the application. Due to its location and impact on the structure, staff recommends, and has authority to approve, its removal.

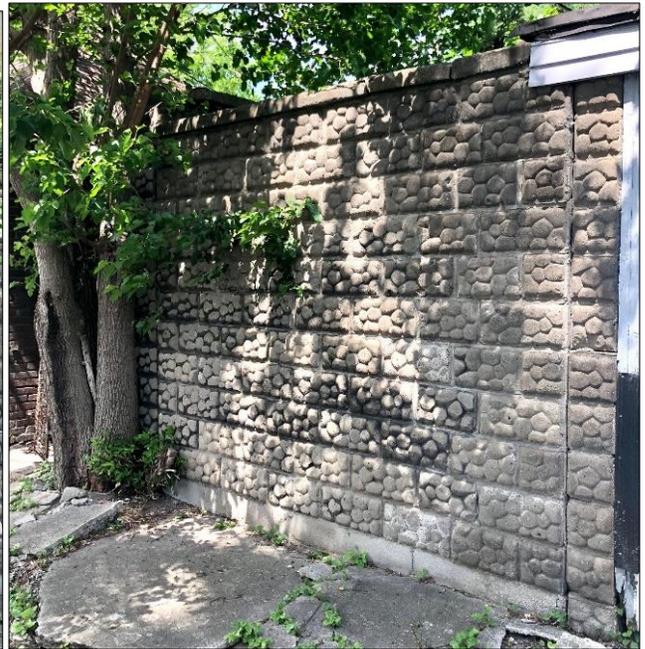
At an unknown time, the roof and east wall of the northern bay were removed, and the overhead door on the west wall was filled in with matching concrete block (likely reused from the now-demolished east wall). Staff didn't find Commission approval for this alteration.

Views from Maxwell Street.

View of infilled wall.

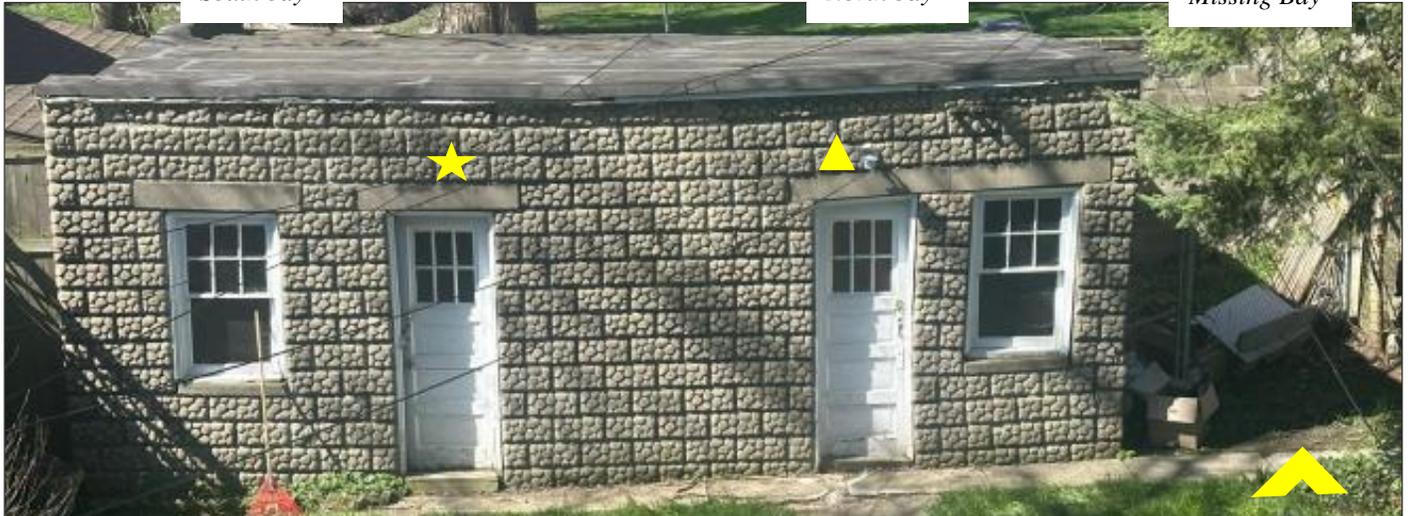
East elevation – facing house.

*These photos show there may be a long-standing issue with settlement, causing the frames and lintels to become unlevel. There is one area where a crack occurred in the middle of a block (circled). The doors and window openings contain historic-age wood components that are in repairable condition.*
