STAFF REPORT: JULY 10, 2024 MEETING
APPLICATION NUMBER: HDC2024-00266
ADDRESS: 1651 EDISON
HISTORIC DISTRICT: BOSTON-EDISON
APPLICANT: MERISA LEWIS
PROPERTY OWNER: MERISA LEWIS
DATE OF PROVISIONALLY COMPLETE APPLICATION: JUNE 18, 2024
DATE OF STAFF SITE VISIT: JUNE 21, 2024

SCOPE: REPLACE WINDOWS, ALTER EXTERIOR (WORK DONE WITHOUT APPROVAL)
7/10 – Revised report in red; in response to recent submittal of additional information by applicant.

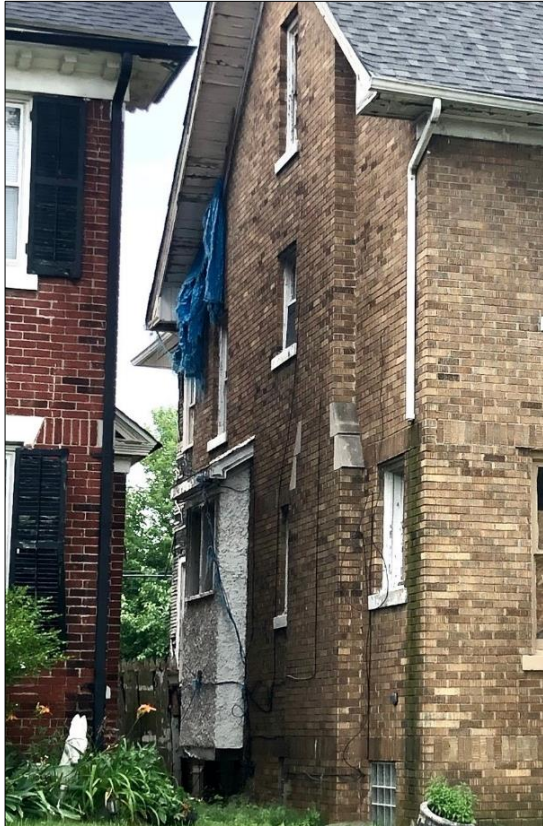
East-side wall. Staff photo, June 21, 2024.

The east and west side walls feature a small extension, each of which includes two mullied double-hung windows, sloping roofs and stucco wall finish.

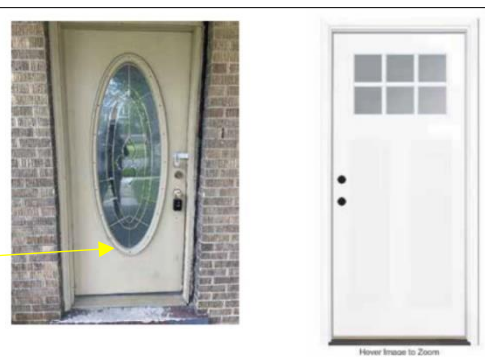
Applicant photos-existing and proposed door.

Proposed: Replace a non-historic front door with a 2-panel, 6-light fiberglass door; install full glass storm door. Color: TBD.

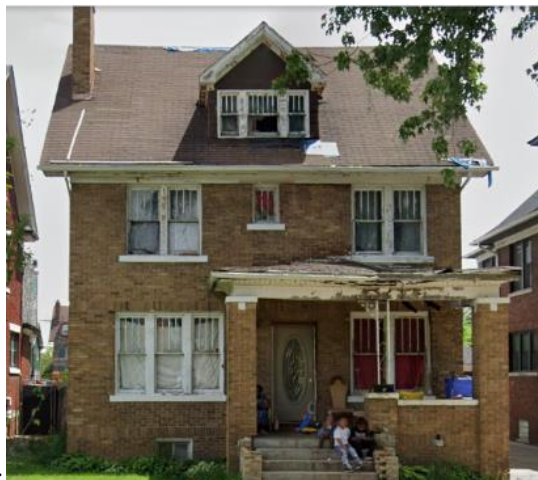
Google street view image, June 2019.

The existing roof was installed by a previous owner without HDC approval. It replaced an existing asphalt shingle roof.

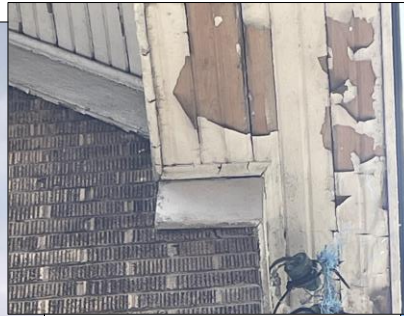
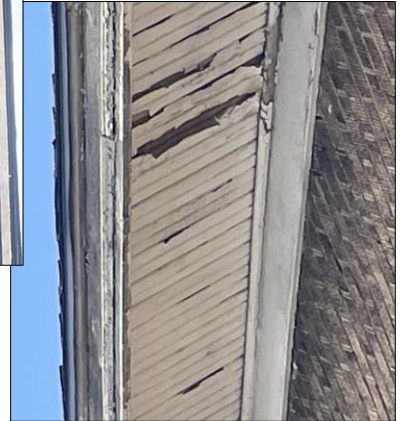
Close-up views are applicant photos.

The existing eaves and soffits are character-defining features of the dwelling. Their condition consists of peeling paint and the occasional deteriorated or missing wood board, and therefore are in repairable condition. The installation of a manufactured product would remove the profile and surface texture of the wood soffits, altering the appearance and architectural proportions of the house. Wood is commonly available, reasonable, and a typical repair treatment for these locations.

The existing eaves and soffits are character-defining features and in repairable condition, with peeling paint and the occasional deteriorated/missing board. The installation of a manufactured product such as the proposed Hardie Soffit, would alter the profile and surface texture/beadboard expression of the soffits, altering the appearance and architectural design of the house.

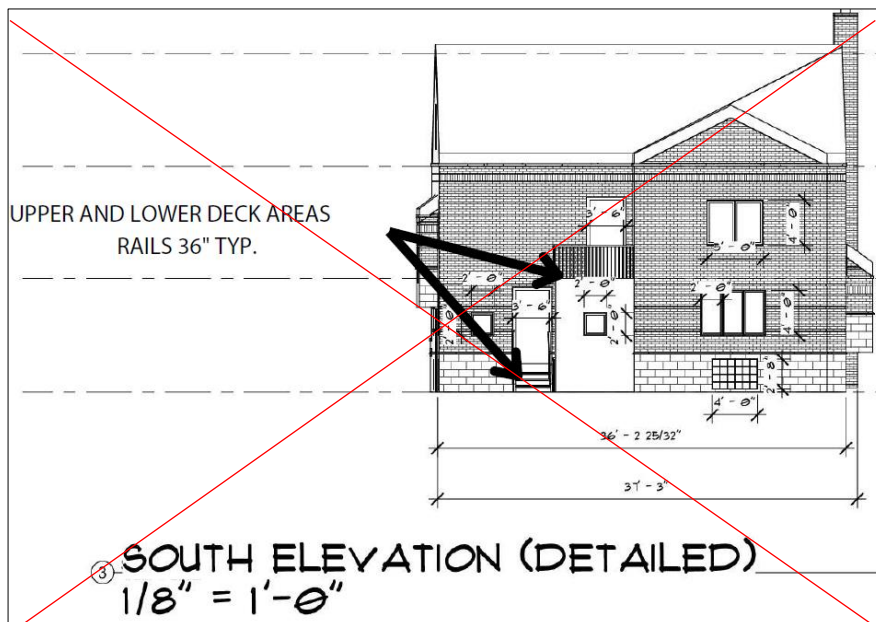
Applicant drawing.

~~The window opening at the second floor is to be resized and operation changed from double hung to slider. The windows at the first floor are proposed to be replacement double hung but are not drawn that way. The lack of details to the elevation drawings and renderings suggest brick on all surfaces with concrete block at grade, a change from a hip to gable roof, and the windows are not detailed according to operation (double hung units are proposed at the first floor) and suggested grid patterns. Staff requested that the drawings be revised to clearly show the proposed work items. However, the revised drawing set only had a note added to identify the rear porch railings.~~

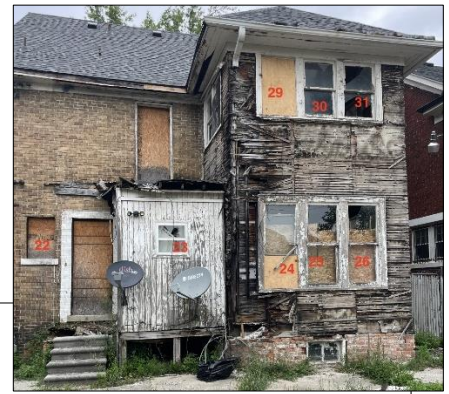
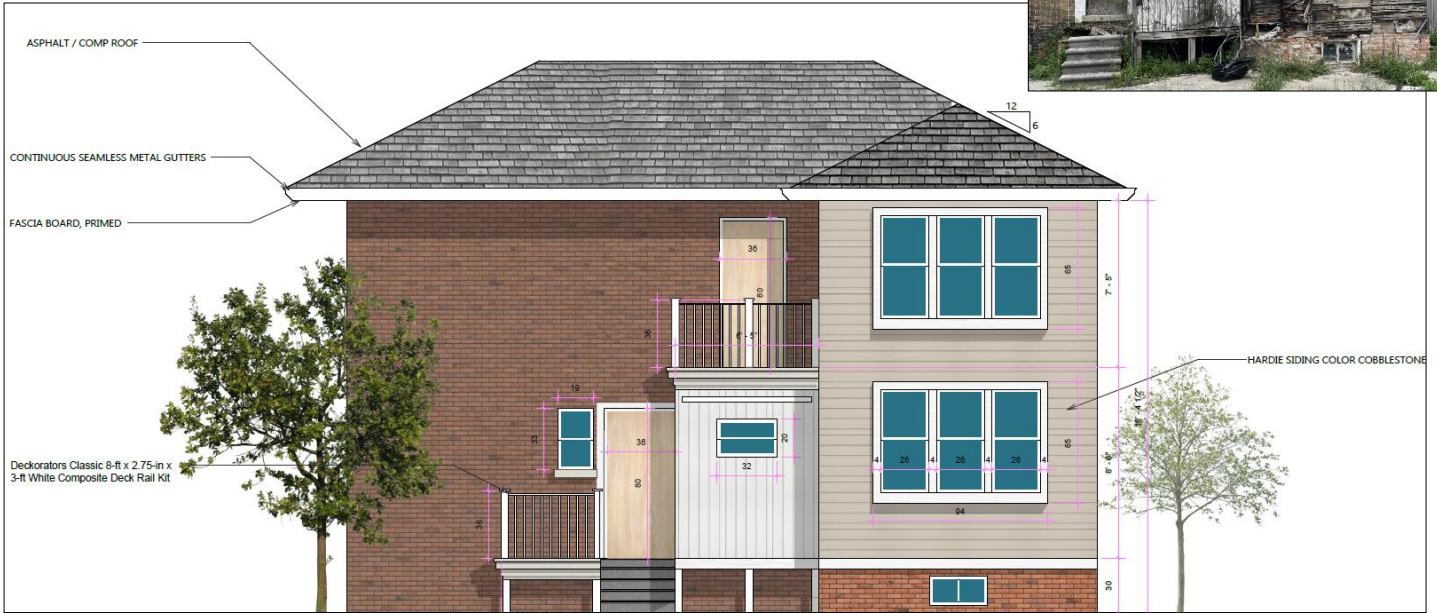
Applicant drawing, option one. Hardie siding.

The applicant submitted revised rear wall drawings to correctly reflect the house's massing/roof lines, cladding materials (existing and proposed), retention of existing window openings on the extension, delineation of Hardie siding and stucco cladding options, as well new porch landing at first floor and porch railings (both floors). However the trim band at the top of the second floor, directly below the roof isn't shown.

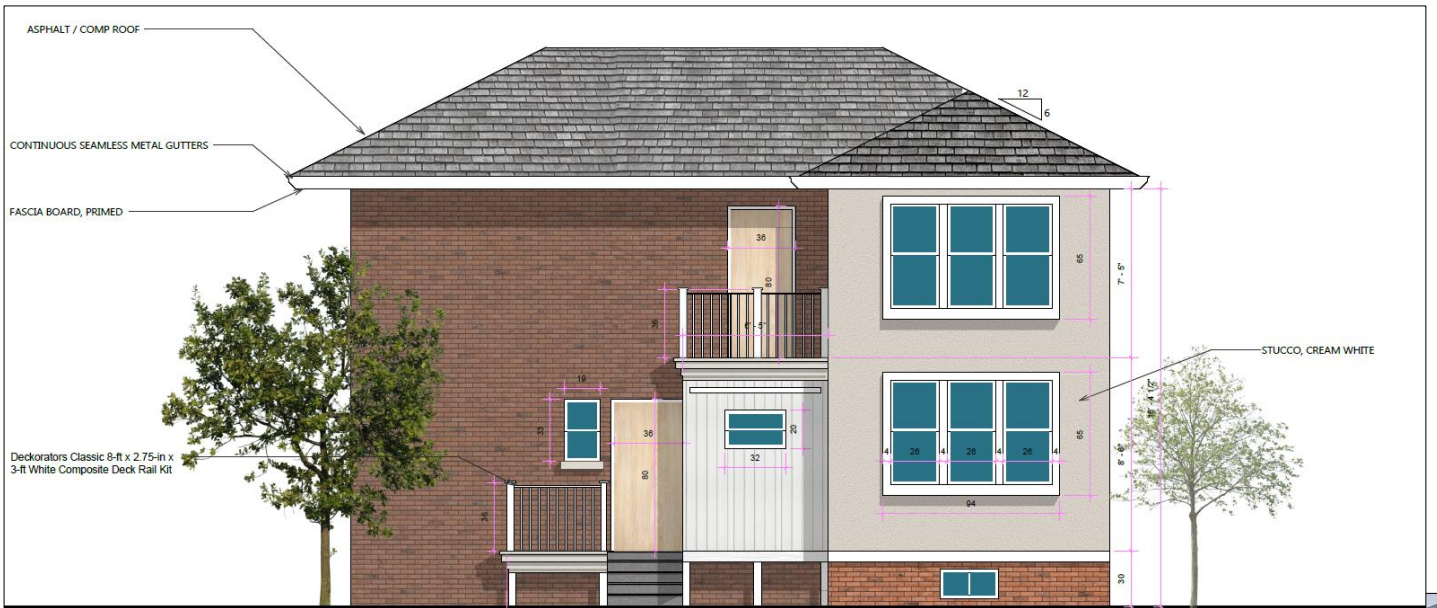
Applicant drawing, option two. Stucco siding.

The stucco finish would visually connect the two-story extension to the side elevation extensions that retain their historic stucco finish.

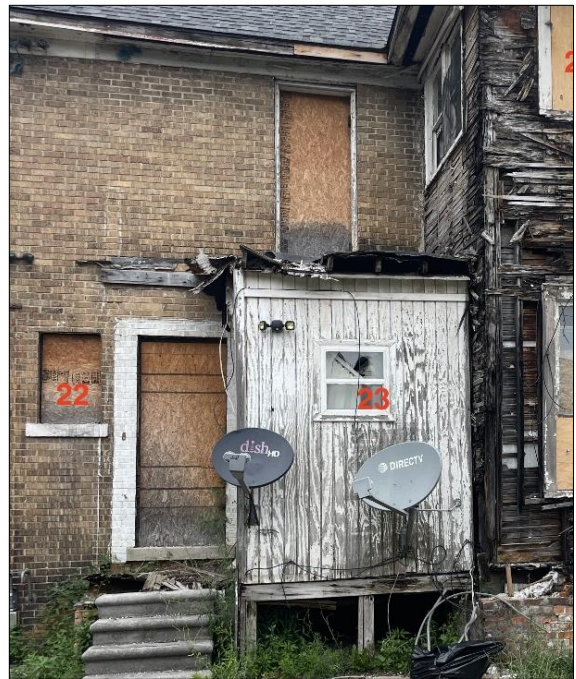
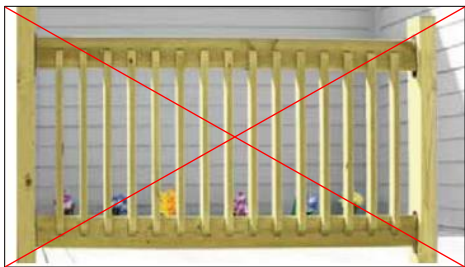
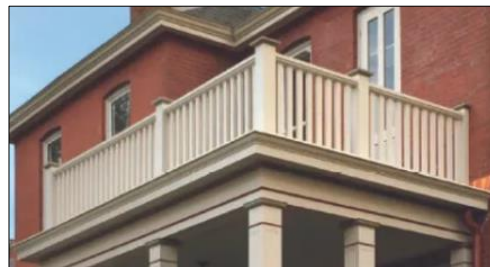
Due to its rear location, staff doesn't know when this section of the porch was enclosed, and it is possible that this enclosure was present at the time of designation. The way staff reads the narrative and drawings, this enclosed space is to retain the existing T1-11 siding, as well as the non-historic window (the narrative states glass will be installed in the sashes).

Due to the stabilization and repair of the enclosure, the applicant proposes to install a perimeter railing at the upper porch and submitted a photo of a suggested railing design. ~~This design is used on contemporary decks and is not compatible for use as a porch railing on an early 20th-century dwelling.~~ A perimeter railing with end posts, top and bottom rails and balusters would be similar in construction details to the original railing and a compatible design.

Above right: Google image of a compatible railing design for an early 20th century house, as typically approved by the Commission.

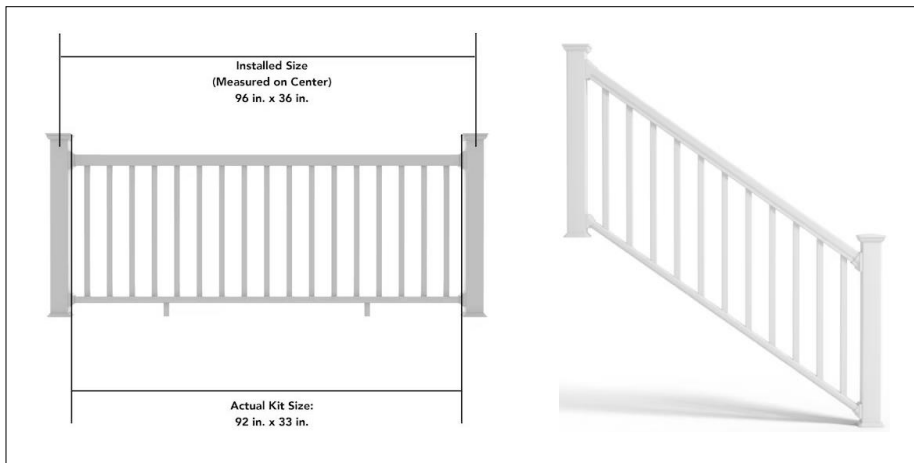
Applicant photos.

The applicant submitted photos of a different railing design, which includes the defined components discussed above, and is similar to the Google image. However, the railing material appears to be vinyl, rather than wood.

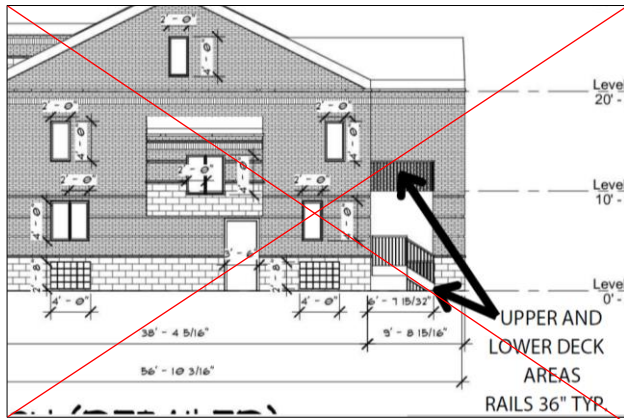
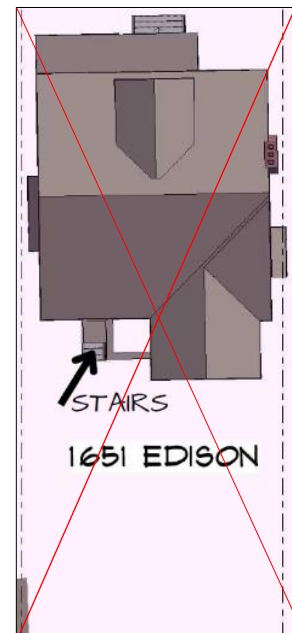
These revised drawings remain not adequately detailed to confirm the dimensions and design of this construction.

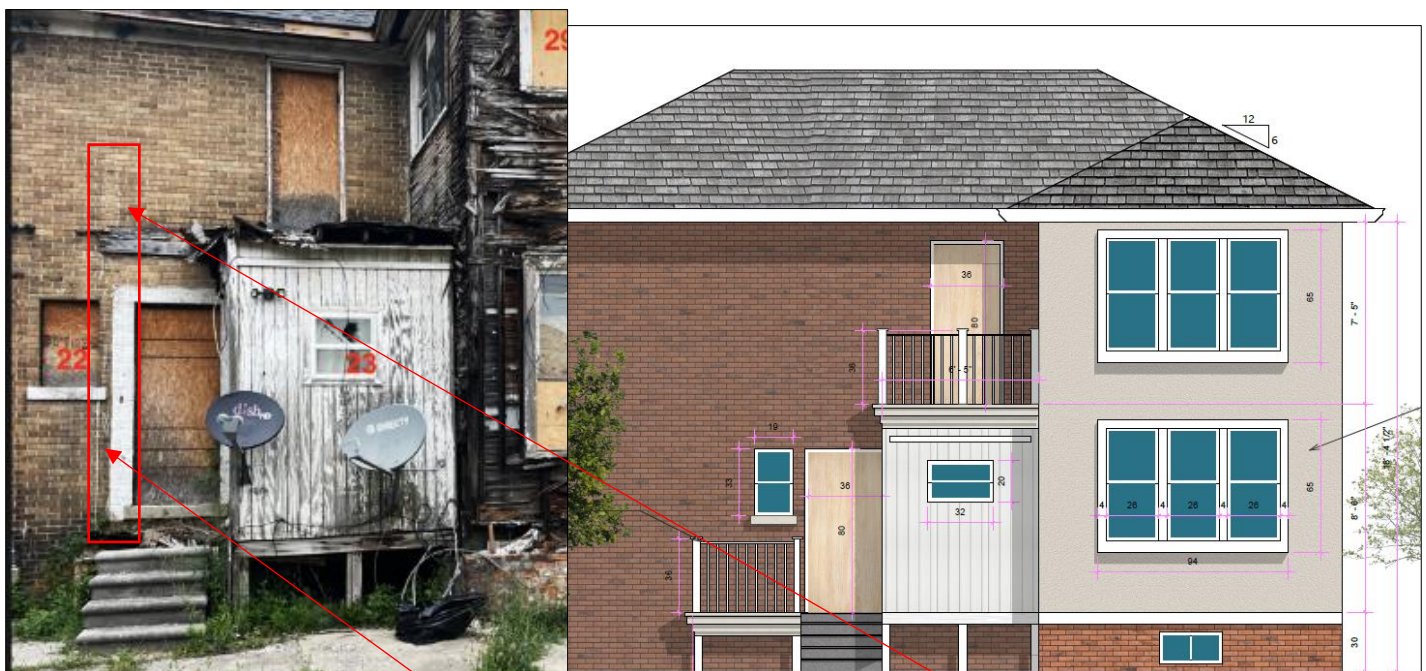
The revised drawing submitted by the applicant on July 9, shows a clear representation of the proposed upper porch and railing, as well as the lower porch platform, railing and stairs. The proposed design does not replicate the original footprint (as shown by the ghost image of the railing and support post). It is staff's opinion, that due to the later partial porch enclosure (which the applicant proposed to retain), the proposed footprint/design is compatible with the current rear wall design and its massing.

Applicant drawing. Remaining paint line adjacent first floor door opening and ghost image of upper porch railing offer evidence of the original two-story porch footprint (enclosure covered with T1-11 siding was originally part of the open porch).

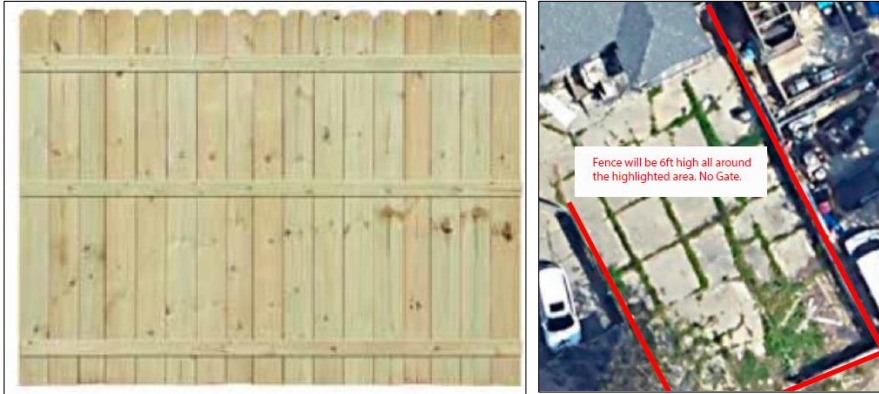
Applicant Photos.

The design and location of the wood fence complies with the Commission’s *Fence and Hedge Guidelines*.

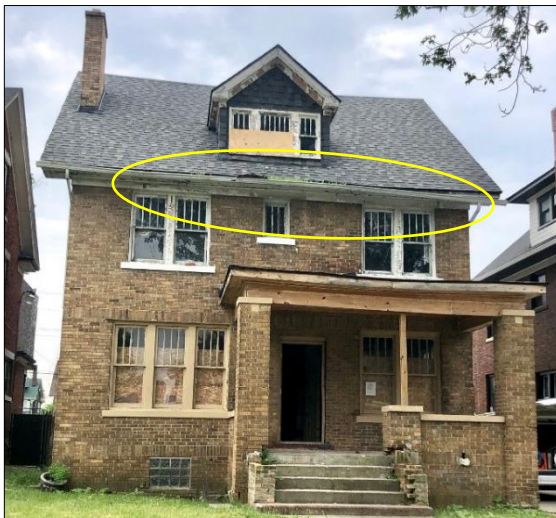
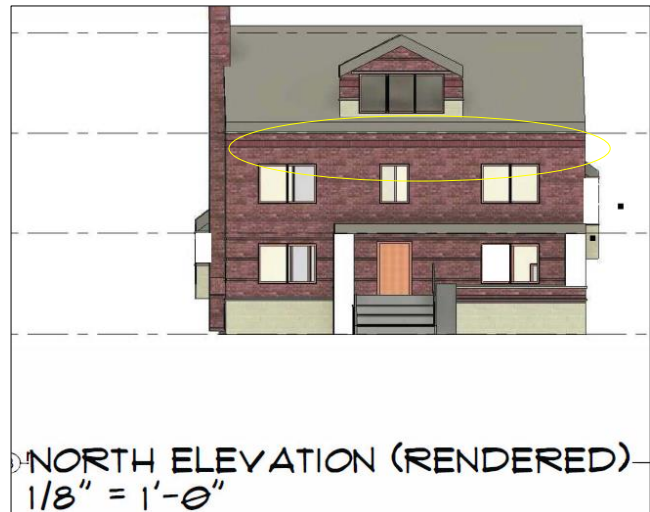
North wall

The scale/massing of the house in the rendering makes it appear wider than tall, the dimensions of the dormer are off, and the locations and sizes of the windows openings are not accurate (which includes operation and no muntin/grid patterns shown).

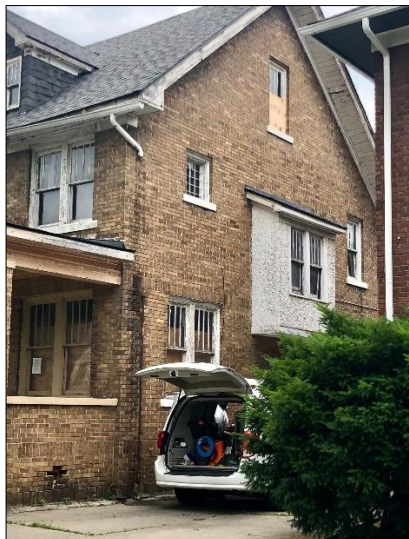
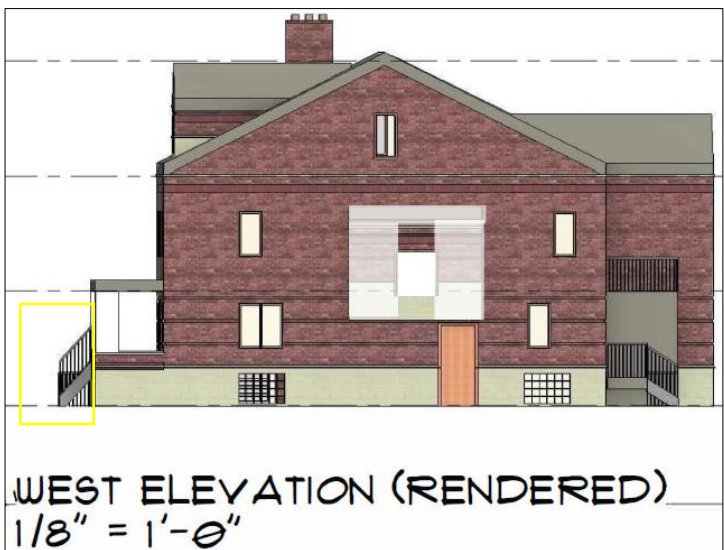
West wall

Similar to the front wall, the dimensions are out of scale (such as roof pitch) and building components are not drawn nor placed correctly on the wall. This elevation also suggests inappropriate replacement of the front step wing walls with narrow railings.

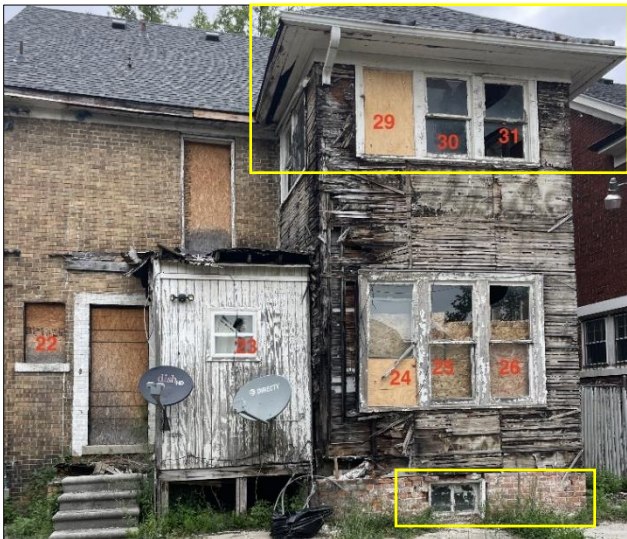
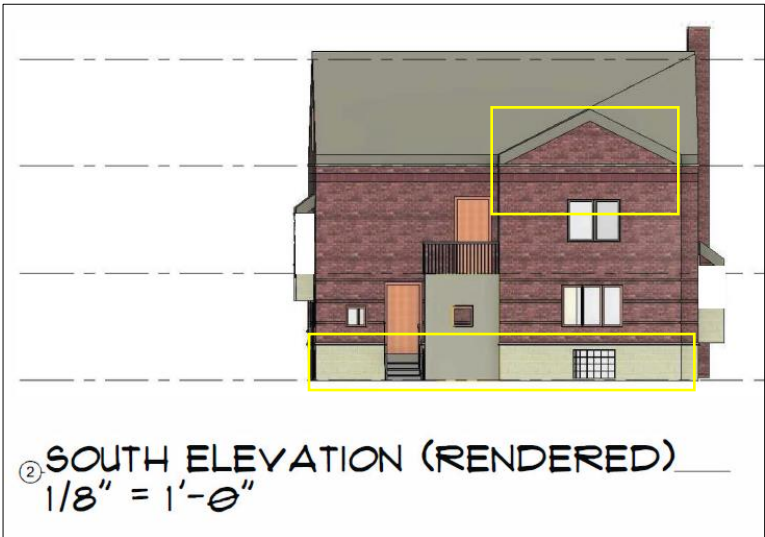
South Wall

A quick comparison shows that the overhanging eaves are gone, the head height of the windows at the second floor are much lower, and the pattern and coloring of the wall material depicts masonry on all walls, with concrete block (rather than the existing brick) at grade (colored beige). The hip roof is not delineated and appears as though a gable roof will be erected.

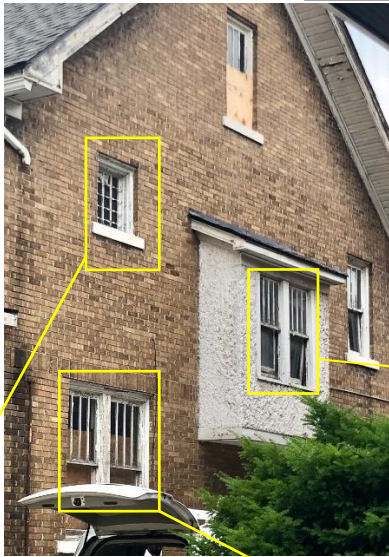
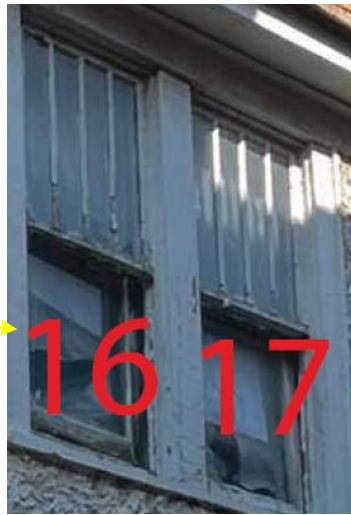
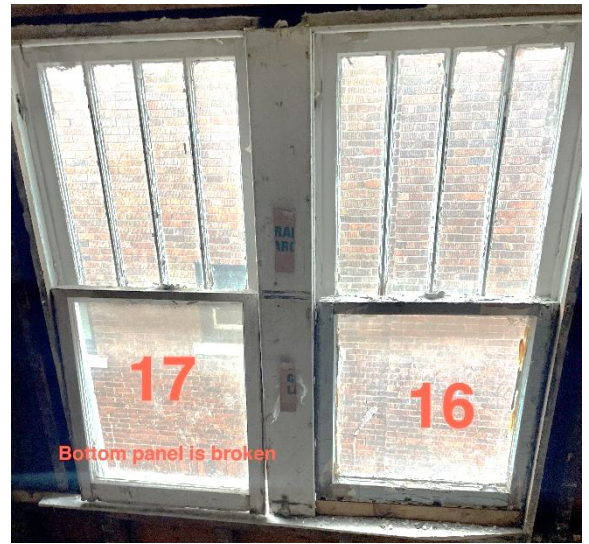
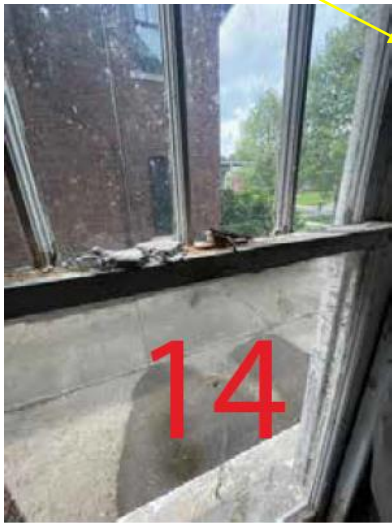
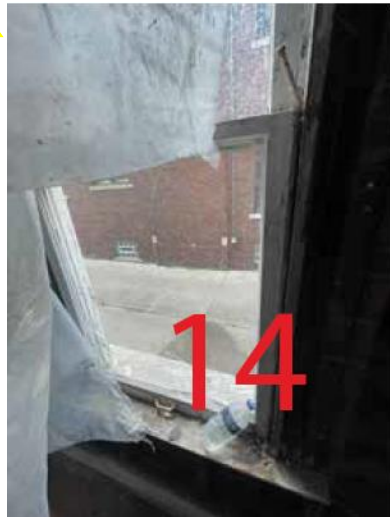
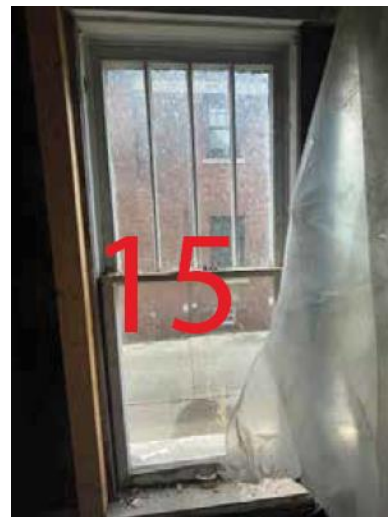
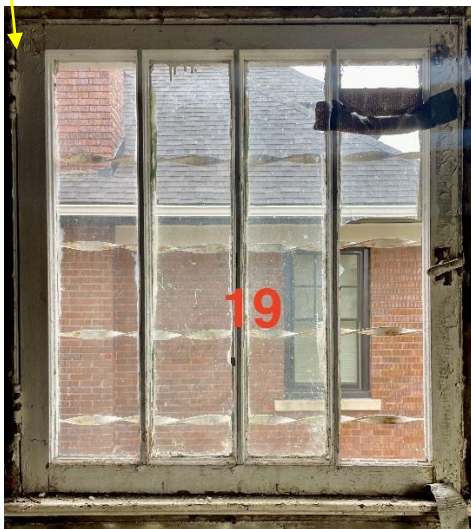
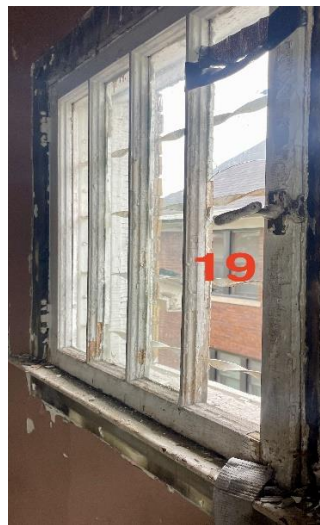
West-side Wall

The applicant didn't submit a numbered exterior photo for the west wall. The exterior photo was taken by staff, and staff is identifying the interior photos for this wall location.

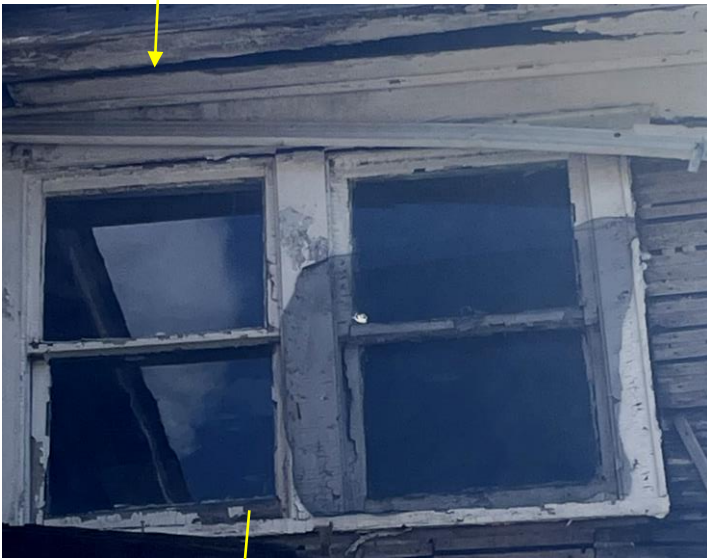
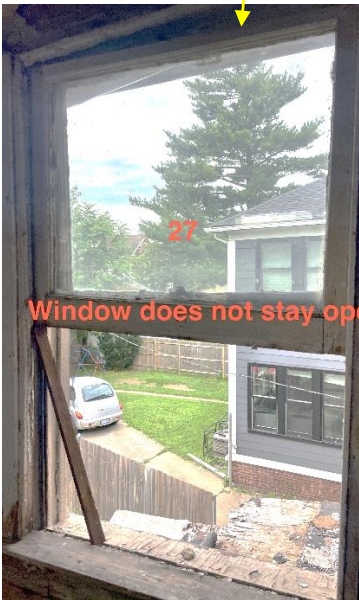
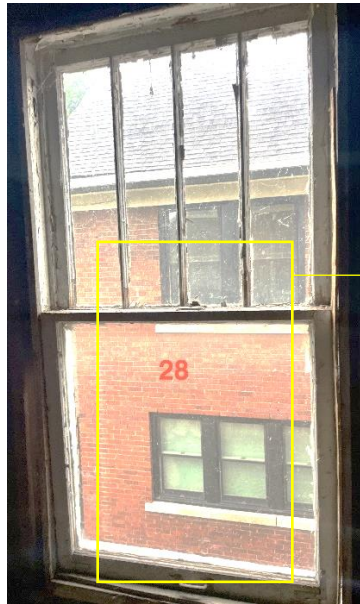
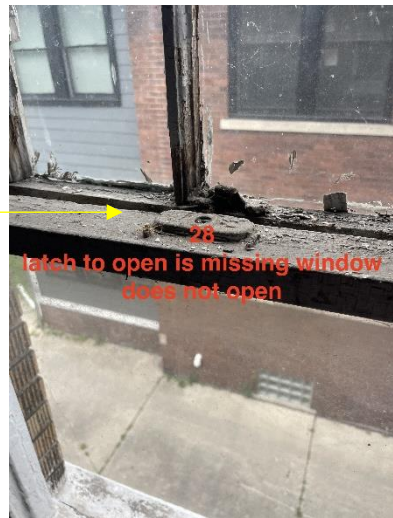
Rear-south Wall

#23 is a non-historic window in a non-historic wall.

#28 is numbered wrong, as all the windows in the rear extension have one-over-one windows, and it appears this window looks towards 1659 Edison (to the west).
