STAFF REPORT: JULY 10, 2024 MEETING

APPLICATION NUMBER: HDC2024-00326

ADDRESS: 19511 SHREWSBURY

SCOPE: REPLACE PORCH TILES

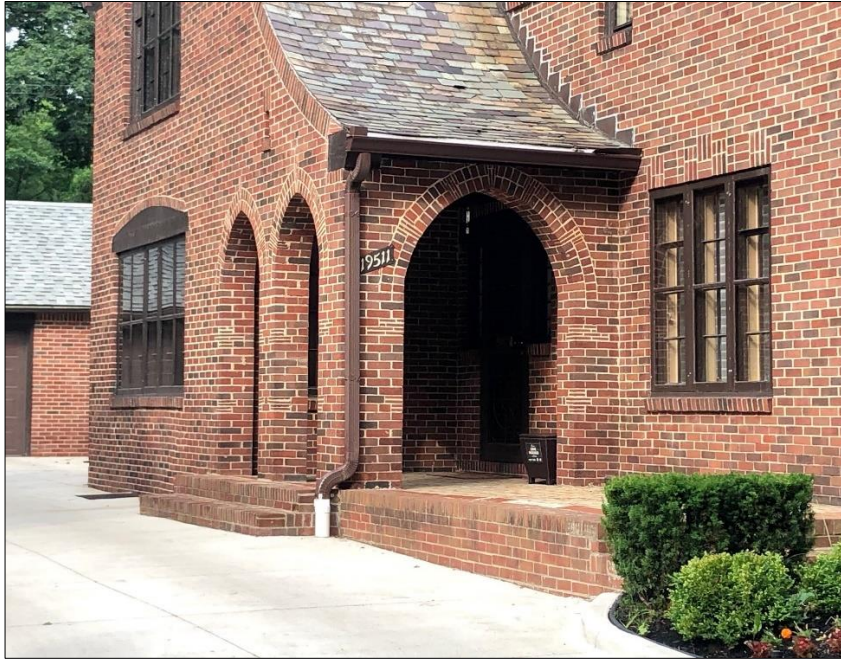
Staff photos, May 2024.

As seen in the below photos, the porch floor is a visible element as seen from the public right-of-way, but the specific pattern is not a dominant feature due to its horizontal placement.

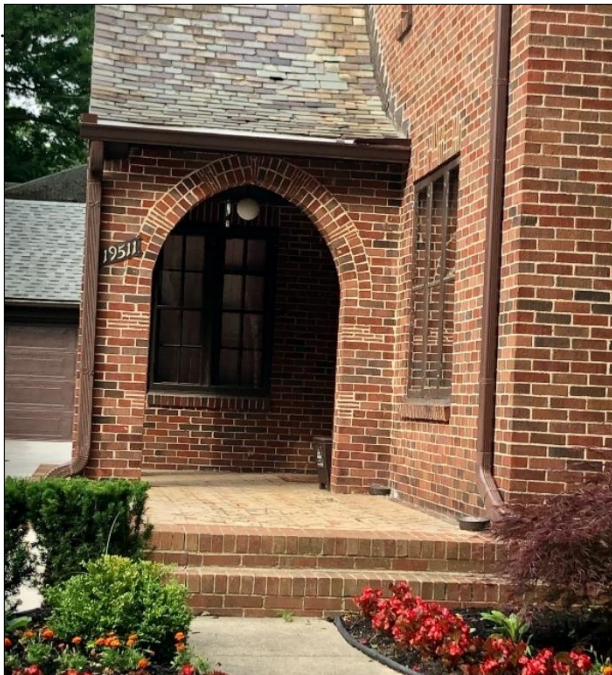
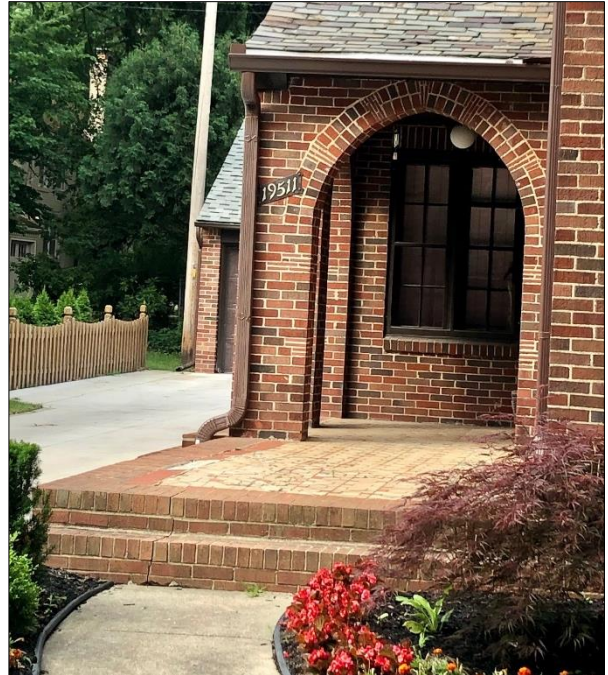
As a large number of the tiles on the open porch are broken, and is more than half the surface area of the porch, staff agrees that the existing porch floor is deteriorated beyond repair.

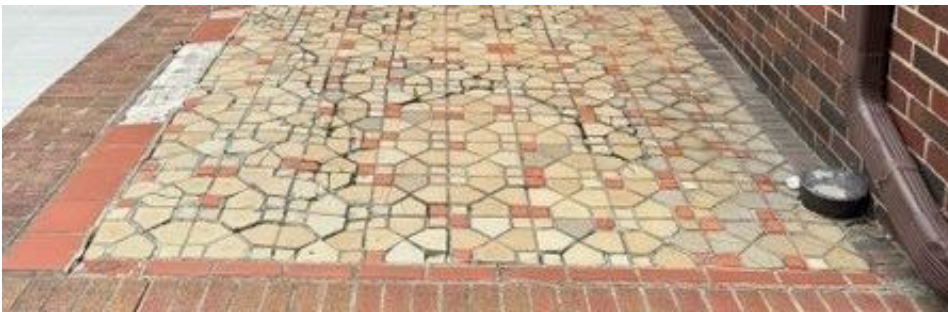
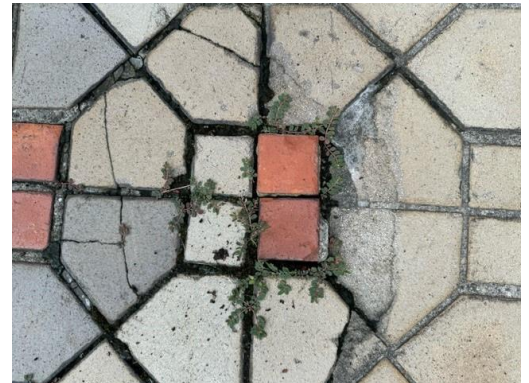
Applicant photos

- The proposed product is twice the size (24-inch octagon, compared to existing 12-inch).
 - This will drastically change the proportion of the pattern and increase the visual dominance of the porch floor. The proposed paving pattern may work well with a large expanse, such as a driveway and patio, but will likely overpower the small dimensions of this porch and its proportional relationship with the other building materials (slate tiles and brick) used on the house.

- A consistently designed border (emulating the formality of the Tudor Revival design) are the features to be matched.
 - The applicant must submit a floor plan that identifies the material, dimension, pattern and color of the bordering material.
