STAFF REPORT: JULY 10, 2024 MEETING
APPLICATION NUMBER: HDC2024-00329
ADDRESS: 1450 SEYBURN
HISTORIC DISTRICT: WEST VILLAGE
APPLICANT: VOYTEK MARDULA
PROPERTY OWNER: VADELLA LLC
DATE OF PROVISIONALLY COMPLETE APPLICATION: JUNE 18, 2024
DATE OF STAFF SITE VISIT: JUNE 21, 2024

SCOPE: ALTER PORCH (WORK COMPLETED WITHOUT APPROVAL), PAINT TRIM AND PORCH POSTS, RETAIN FRONT DOOR SURROUND

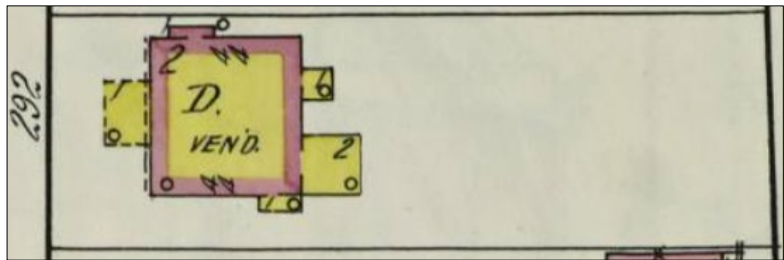
Sanborn Map, Vol. 8, 1915

The Sanborn Map identifies the entire dwelling as frame construction (yellow). The red/pink border running the perimeter of the house and northern box bay identifies that these walls (all levels) are covered with brick veneer. The "ven'd" confirms the remaining extensions of the house have brick veneer at the first floor walls; the second story of the rear extension would be covered with wood siding.

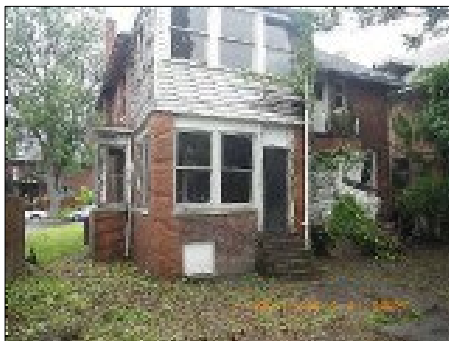
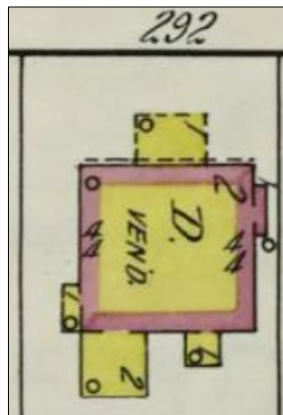
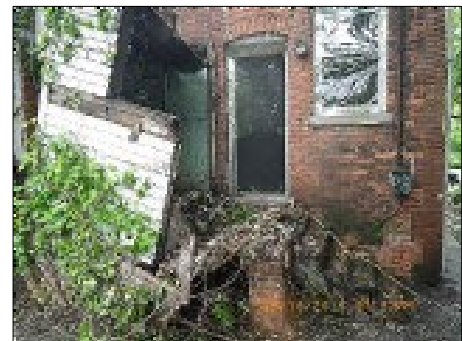
Photos from 2013 HDC application.

The circa 2013 photos below offer a visual confirmation of the materiality of the rear two-story extension and single story porch at the north end of the wall (which was in a severe state of disrepair).

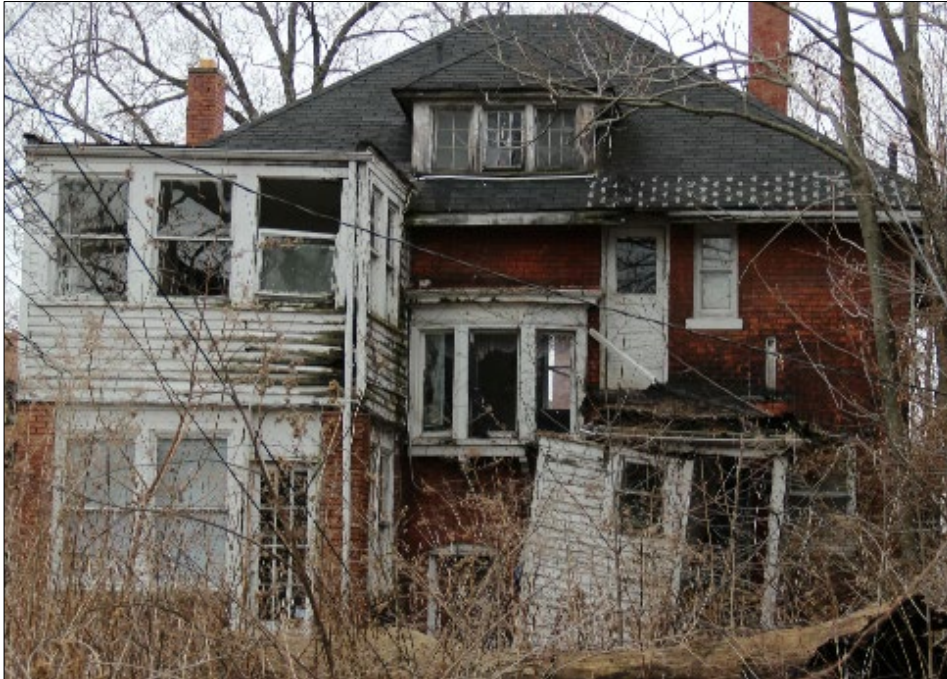
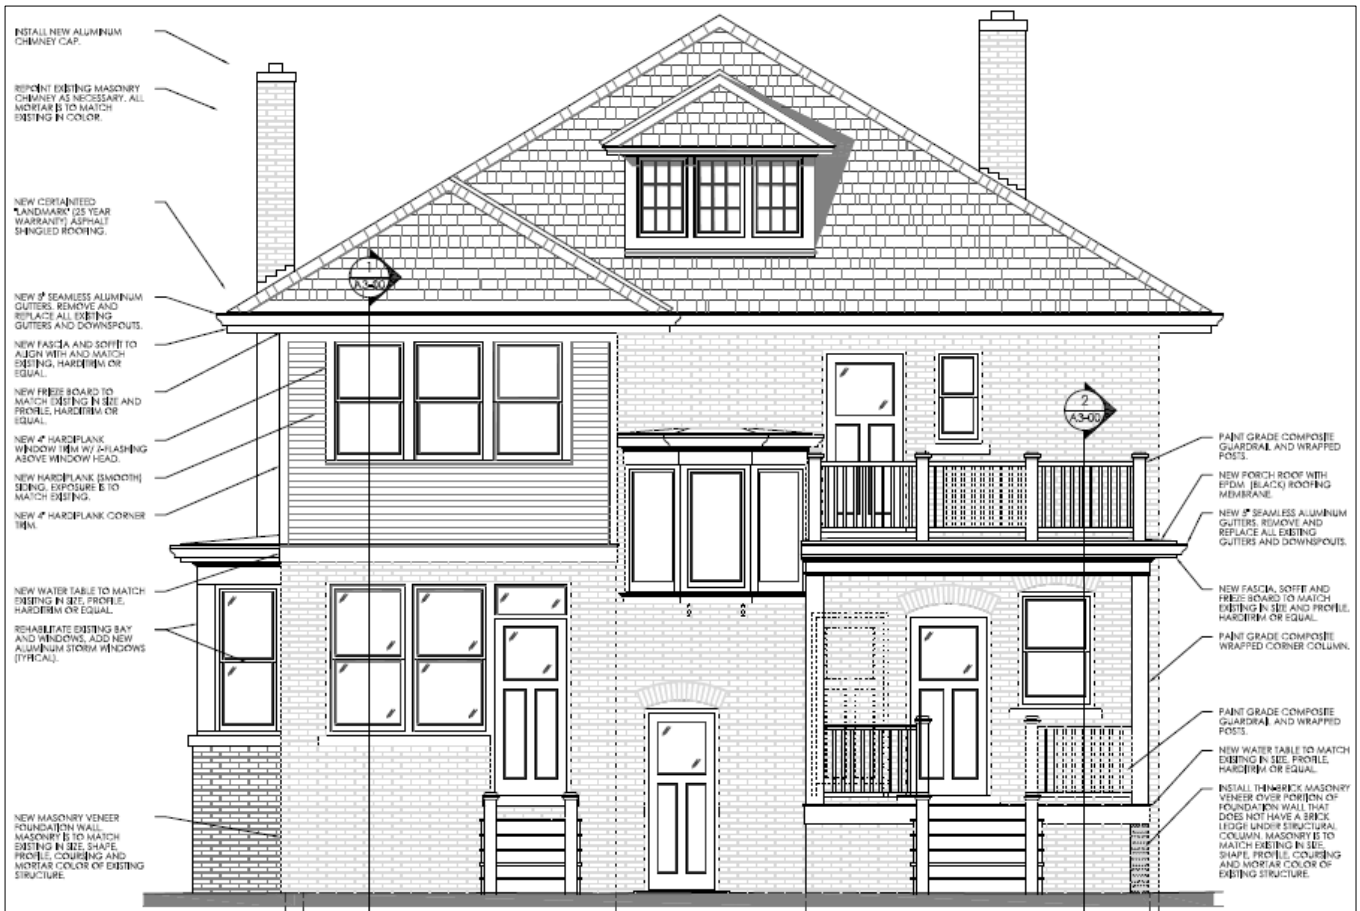
Above: 2013 photo submitted by applicant.

Alterations made to the rear elevation, not reviewed/approved by the Commission or staff, include:

- Removal of the central (one of three) windows in the dormer; and window operation changed from multi-light casements to one-over-one double-hung.
- Door leading to the upper porch was removed and bricked in; and the narrow double-hung window was changed to fixed/casement. Upper porch railing was removed (ghost image is present).

- Two doors at the first floor that led to the raised porch were removed and bricked in, but the historic opening's stone threshold remains. It appears as though there are not any stairs that lead from the yard to the raised open porch. Unadorned, thin posts support the roof.
- The two-story extension was not built as approved.
 - Window openings at the rear wall changed in size and operation; mullied one-over-one double-hung openings are now smaller single fixed openings with clear glass.
 - Vinyl siding was installed on all walls, rather than brick at the first floor and wood clapboard siding at second floor.
 - The door, wood platform and stairs at the rear wall were not installed.

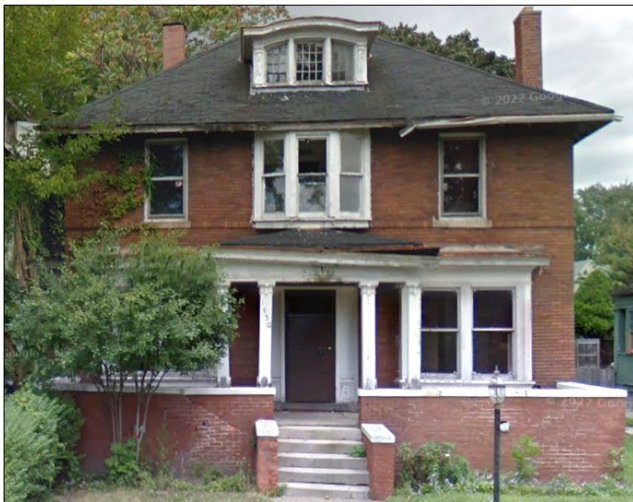
2013 Google street view.

- Installed temporary particle board painted black around front door trim. *The contemporary door and particle board surround (replacing the dimensional side panels) destroyed the historic dimensional opening and is not an appropriate design for an early 20th century Neo-Georgian/Four-Square house. The applicant states the particle board is temporary but didn't include a permanent design solution in this application. According to the Standards, new side panels must match those that were removed without approval. The flat panel/5-light door should be replaced with a minimally adorned traditional design, compatible with the vernacular style of the house.*

- Paint front and rear porch pillars. Paint all existing window trim and pillars in black (Color System E) for 20th Century composite. *The applicant doesn't propose to wrap the posts to create columns. The retention of the supporting posts as a finished detail is not appropriate for this house's design and era of construction, as well as their prominent locations. One of the hallmark features of Neo-Georgian houses is contrasting trim. As this house has dark brown brick, the appropriate colors for the trim (windows, posts, etc.) are various shades of white to yellowish white, not black..*
