**STAFF REPORT: AUGUST 14, 2024 MEETING**

**APPLICATION NUMBER: HDC2024-00381**

**ADDRESS: 3747 TYLER**

**SCOPE: INSTALL VINYL WINDOWS\* (WORK COMPLETED WITHOUT APPROVAL), ALTER PORCHES**

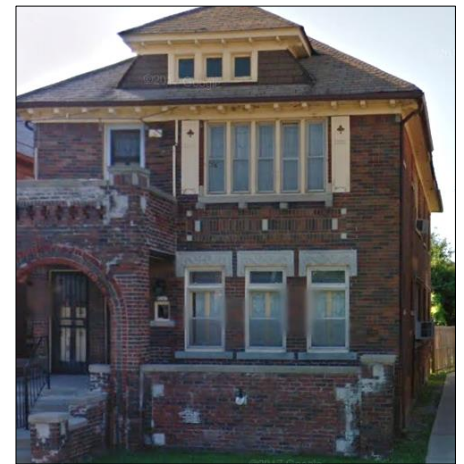
August 2011 Google street view photo.

- Aluminum-clad wood single-hung windows, suggested at the second floor to replace the vinyl slider/fix window, do not match the operation (nor the glass details) of the historic leaded glass mulled casement windows. Additionally single-hung windows are not adequate replacement of double-hung windows due to the stationary upper sash being welded to the window frame.
