STAFF REPORT: 8/14/2024 REGULAR MEETING
APPLICATION NUMBER: HDC2024-00404
VIOLATION NUMBER: 912
ADDRESS: 677 W. CANFIELD
HISTORIC DISTRICT: WEST CANFIELD
APPLICANTS/ PROPERTY OWNER: MATTHEW ALLEN FLESZAR
DATE OF PROVISIONALLY COMPLETE APPLICATION: 07/22/2024
DATES OF STAFF SITE VISITS: 06/26/2024, 7/25/24

SCOPE: ALTER REAR DOOR AND WINDOW OPENINGS AND REAR PORCHES (WORK COMPLETED WITHOUT APPROVAL)

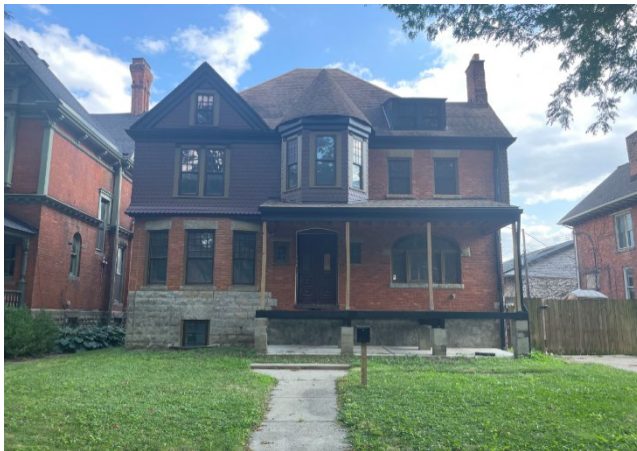
Site Photo 1, by Staff July 25, 2024: (North) front elevation showing current conditions.

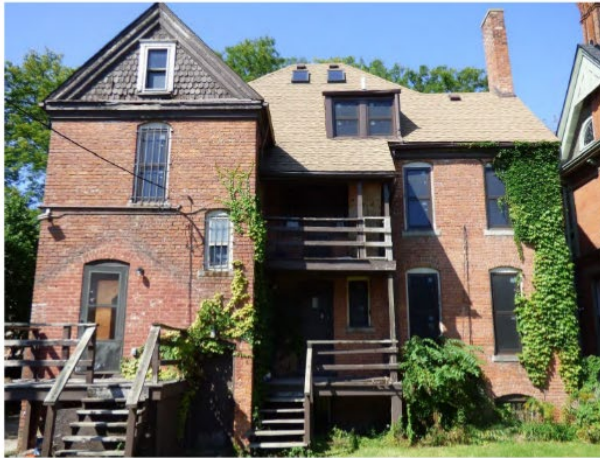
Date Unknown used in 2020 COA

Violations & COA Proposals

- 1) Replace filled-in gable window
- 2) Modify 2nd floor apartment window & door layout
- 3) Modify 1st floor apartment window & door layout
- 4) Extend deck/balcony footprint
- 5) Modify porch steps

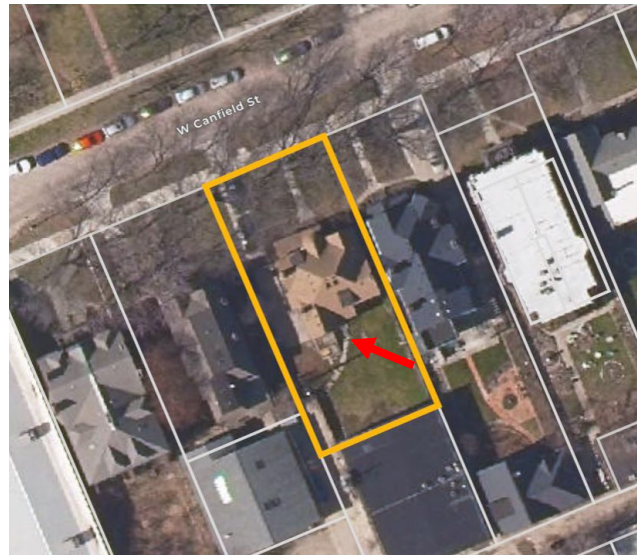
Aerial 1 of Parcel # 04000899, by Detroit Parcel Viewer, showing the location of proposed basement entrance structure (arrow).

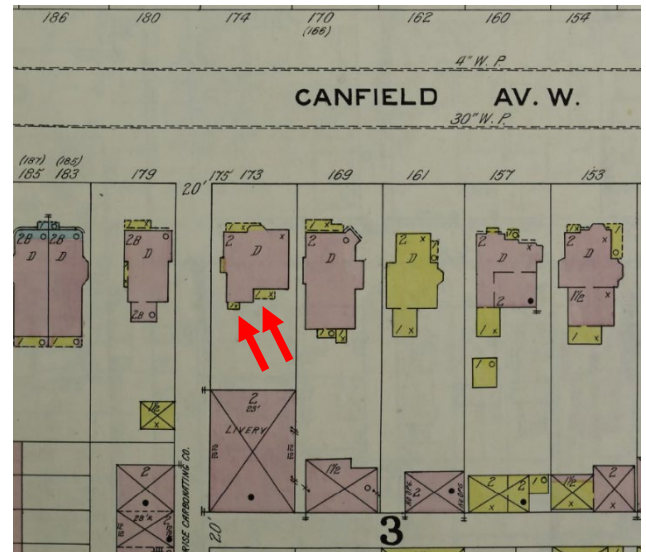
Fig. 5, Sanborn 1897 Vol 2, Image 90: rear single story rear porches (arrows).
