STAFF REPORT: 09/11/2024 REGULAR MEETING

APPLICATION NUMBER: HDC2024-00435

ADDRESS: 4031 FULLERTON

SCOPE: REPLACE STEEL SASH WINDOWS WITH COMPOSITE WINDOWS

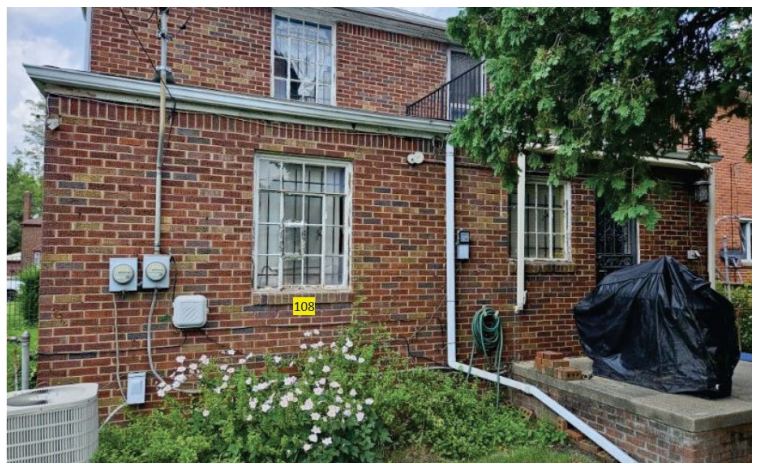
Fig 2, by Applicant, 2024: Rear (South) showing proposed window replacement location.

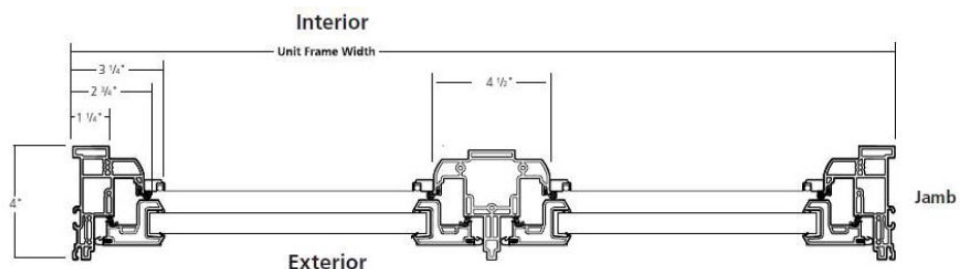
- Staff requested dimensions for the proposed casements and received the comparison of the existing and proposed mullion dimensions (see fig. 7) and the section dimensions of the proposed casements (See fig 8). Staff observed how these dimensions increase in width, ignore the existing transoms and sidelights, and provide a bulkier appearance in the head and jamb.

- Staff received confirmation that the brick mould would be removed and an aluminum or fibrex "L trim" (see fig.9) be installed between the window opening and the new casements. This L trim does not meet NPS guidelines, which necessitates that any replacement of steel sash windows with a new frame should be of minimal dimension.
