STAFF REPORT: SEPTEMBER 11, 2024 MEETING

APPLICATION NUMBER: HDC2024-00436

ADDRESS: 1321 LABROSSE

SCOPE: DEMOLISH GARAGE, ERECT GARAGE (WORK COMPLETED WITHOUT APPROVAL)

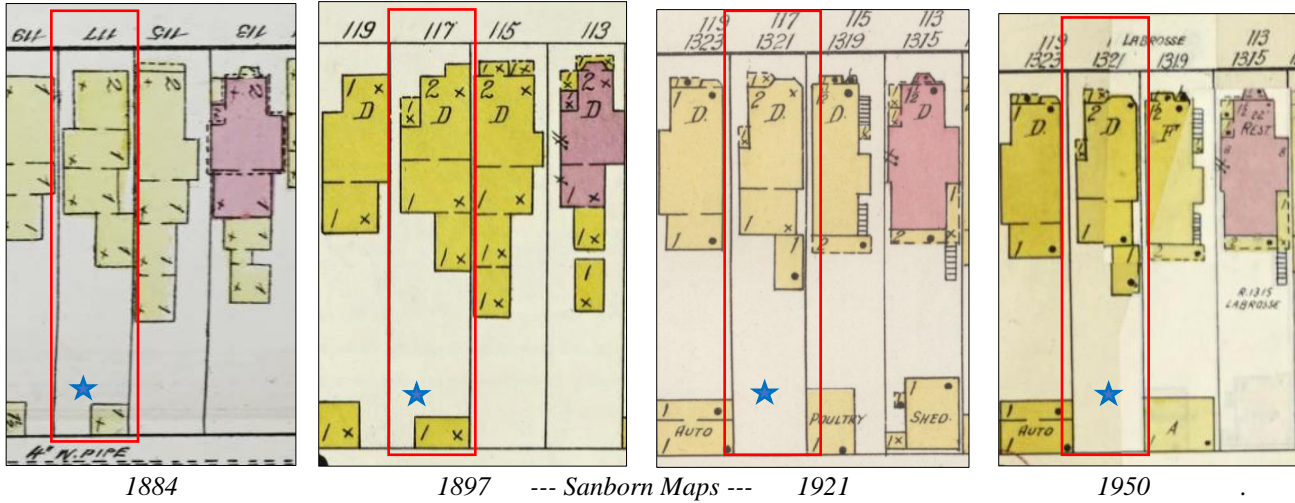
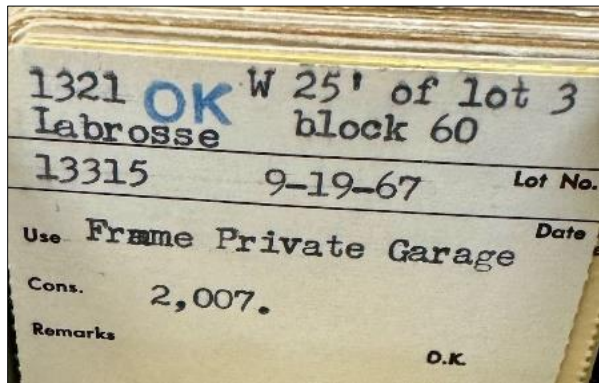
BSEED permit card

- The Corktown Historic District was enacted in 1984 and expanded in 1998.
- The Sanborn maps document a single story, wood-framed structure (★)at the alley in the 1884 and 1897 maps, but this structure was gone by 1921. A wood-frame garage was erected in 1967 and was likely the structure demolished in 2020.

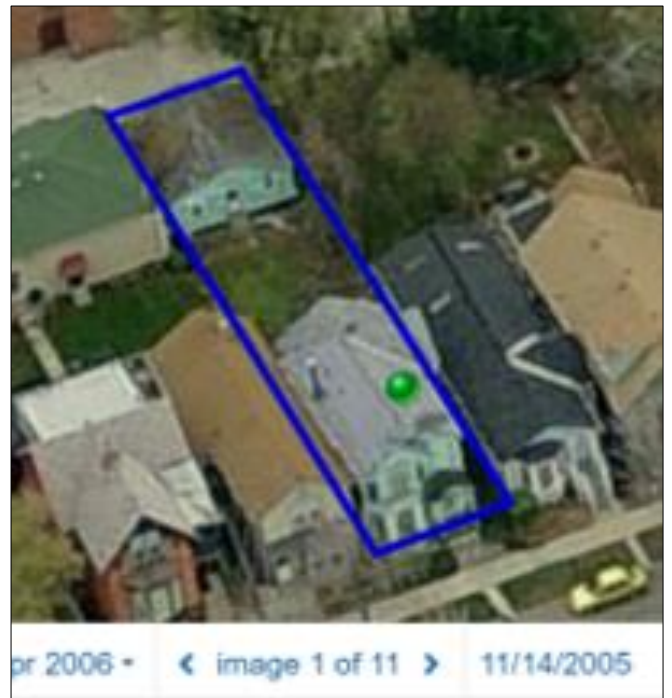
November 2005 image, EagleView. This is the earliest photo staff found of the former garage.

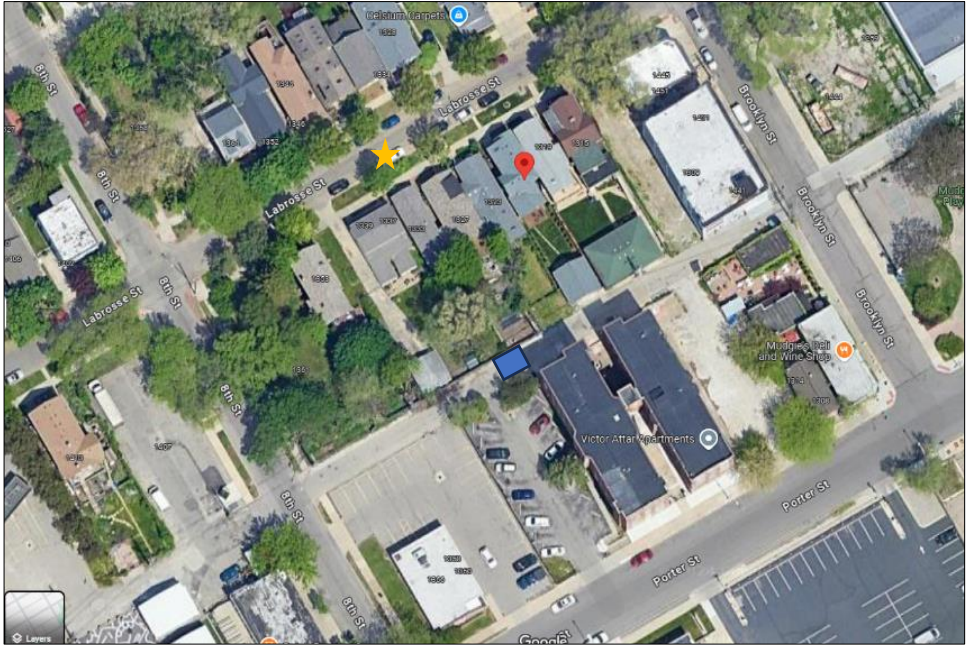
This Google aerial view shows a mostly intact residential streetscape at Labrosse (★), but an inconsistent garage/alley street wall (■). Also, the environment at the alley expands beyond residential to include industrial and apartment buildings as well as open lots (due to demolitions along Porter Street).

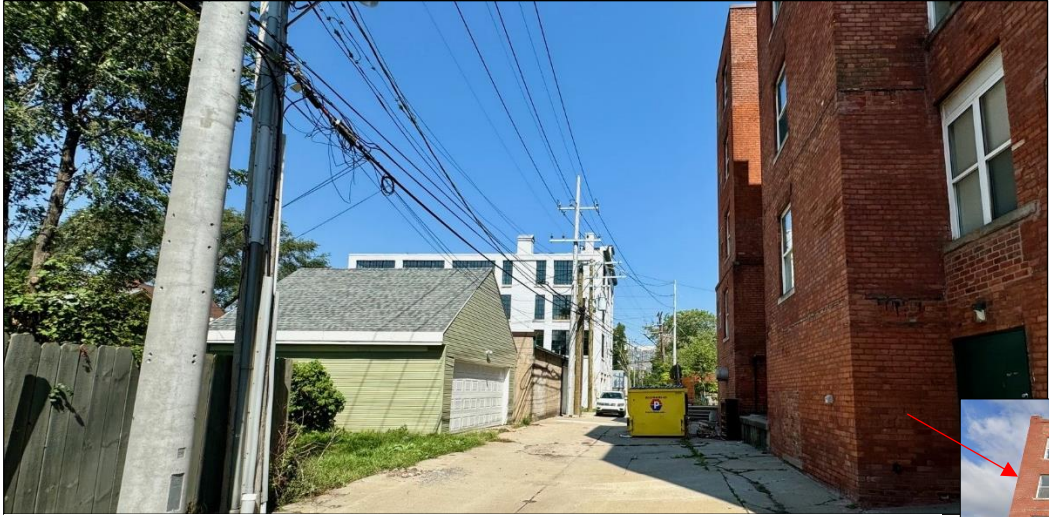
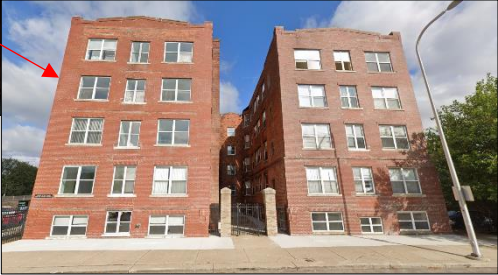
Alley looking east towards Brooklyn Street. Staff photo, August 2024. The garage for 1321 Labrosse faces the rear wall of a historic-age, 4-1/2 story apartment building at 1324-1336 Porter Street.

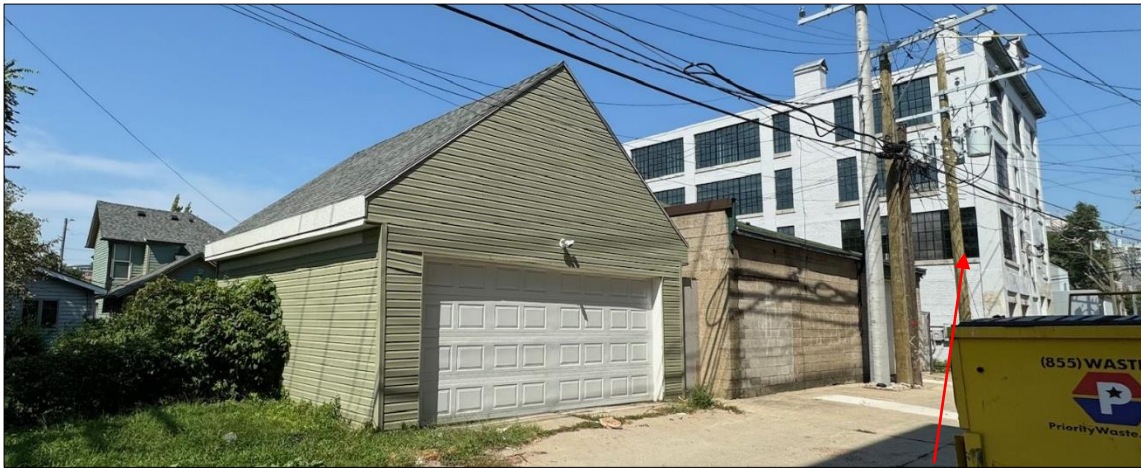
This photo, looking northeast from the alley, shows the close proximity of the Kaul Glove Company building. Erected in 1917 for the Robert Keller Ink Company, the HDC reviewed an application for the building's rehabilitation in 2021. It is now used as office space for multiple companies.
