**STAFF REPORT: SEPTEMBER 11, 2024 MEETING**

**APPLICATION NUMBER: HDC2024-00454**

**ADDRESS: 1710 BAGLEY**

**SCOPE: REPLACE EXISTING SIDING WITH ENGINEERED SIDING**

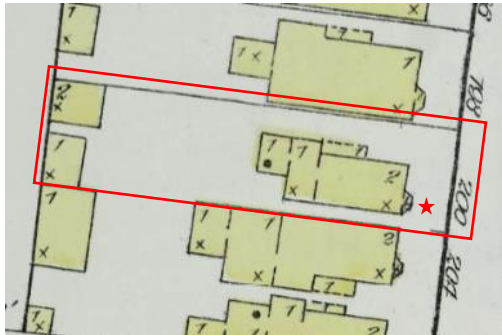
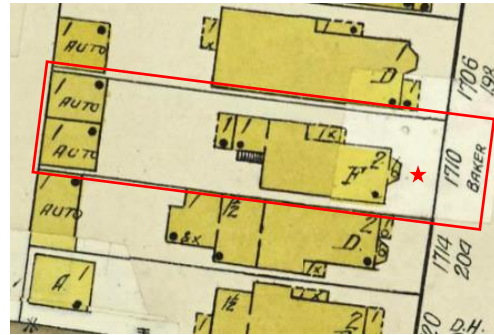
Sanborn Maps

- The Corktown Historic District was enacted in 1984 and expanded in 1998.
- The dwelling’s current massing appears to match the footprint shown in the 1884 Sanborn map.

The 1921 and 1950 maps (1950 is shown here) indicate the front bay window was moved, but current conditions/location matches that of the 1884 map.

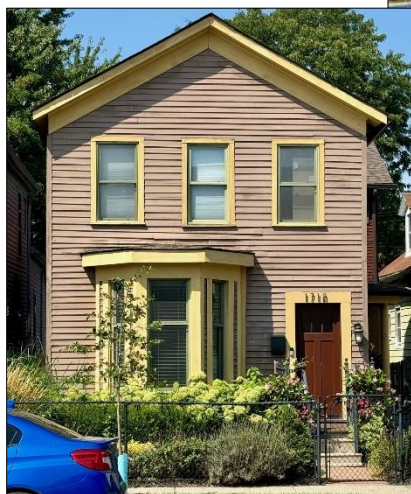
- The 1984 designation photo shows the front wall had also been covered in asphalt siding that remains in place on the side walls. The neighboring property was also covered in asphalt siding (aka Insulbrick).

- As the Final Report states, many houses were “modernized” toward the end of the 19<sup>th</sup> century through the installation of brackets, window hoods and stylistic porches. Some houses however, such as 1334 Labrosse (which is similar to 1710 Bagley) remained “unpretentious” and didn’t received additional applied architectural detail.

Above: 1984 designation photo, HDAB.

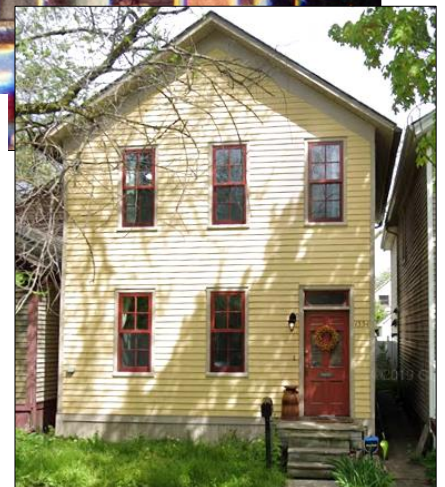
Left: 1710 Bagley. Staff photo, August 2024.

Right: 1334 Labrosse, Google Streetview.

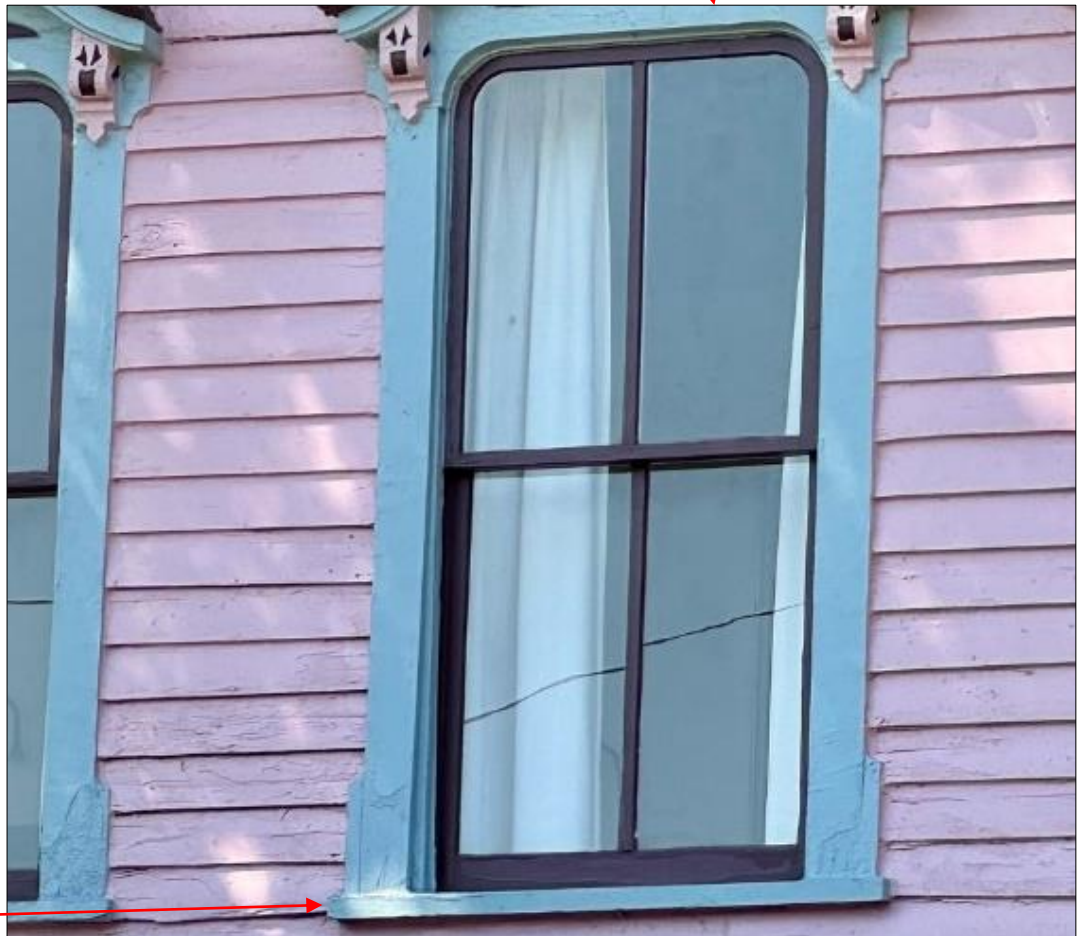
The wood siding originally had, and generally retains, a smooth finish. The “embossed grain” surface on some areas of the lap siding is due to the uneven finish of not fully removed multiple coats of paint that was applied over the course of 100 + years, and is an expected and authentic expression for century-old siding.

Note the generally smooth surface of the wood trim around the windows, as well as the window casing proportions. Typical window trim detail for late 19<sup>th</sup> century wood-sided houses has narrow and projecting wood sills, as shown at right.

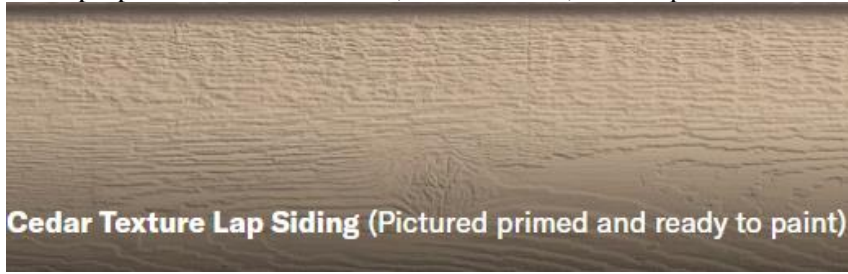
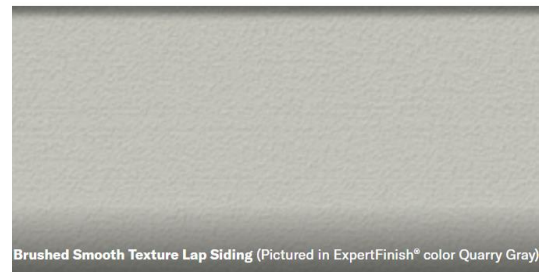
- Staff emailed the applicant and asked if an investigation at the side walls has occurred to determine if wood siding is present under the asphalt siding.
- The application proposes to remove all existing siding and install LP Smartside siding and trim. The applicant proposes the “cedar” finish, shown below, but the product does offer a “smooth” finish.

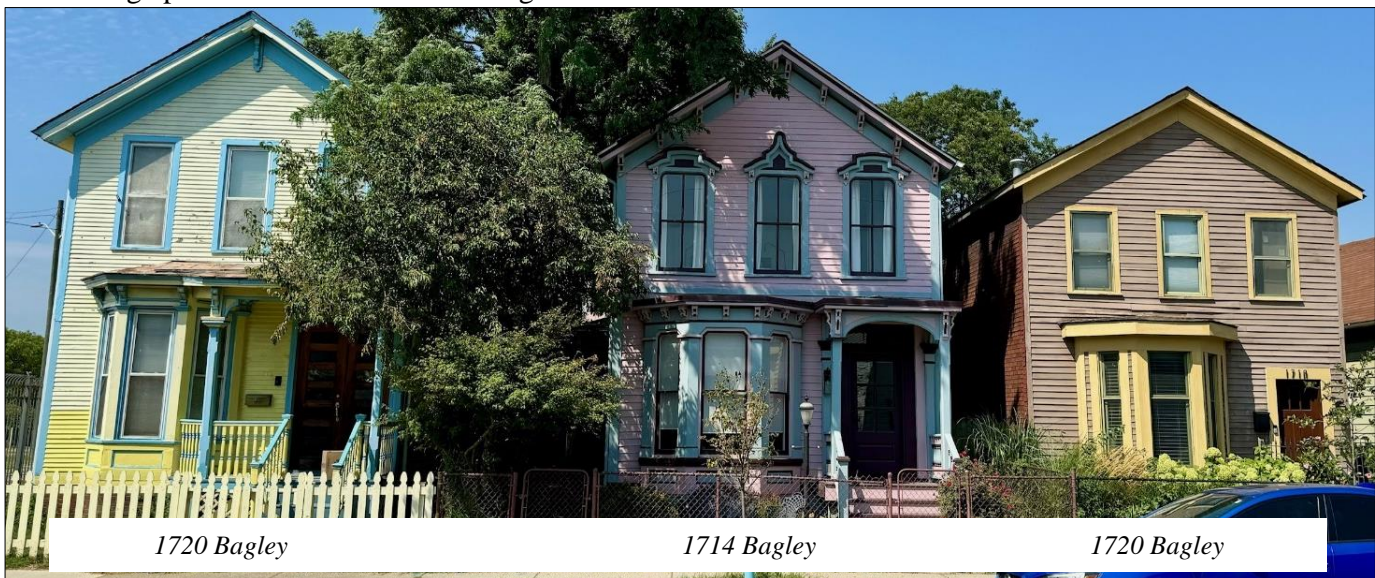
*Streetscape view of 1710 Bagley (far right) and adjacent circa 1880’s wood-sided houses.*

- The Certificate of Appropriateness issued in 2002 was for the installation of wood lap siding at the front elevation. It is staff’s opinion the replacement of the 20+ year old wood siding should be completed with the installation of new wood siding, as Standard Six states *“Deteriorated historic features shall be repaired rather than replaced. Where the severity of deterioration requires replacement of a distinctive feature, the new feature shall match the old in design, color, texture, and other visual qualities and, where possible, materials.”* Wood lap siding is readily available and can offer a matching texture, exposure and edge profile to historic wood siding.
