STAFF REPORT: SEPTEMBER 11, 2024 MEETING

APPLICATION NUMBER: HDC2024-00495

ADDRESS: 3747 TYLER

SCOPE: INSTALL WOOD WINDOWS, DOORS AND ERECT REAR PORCH

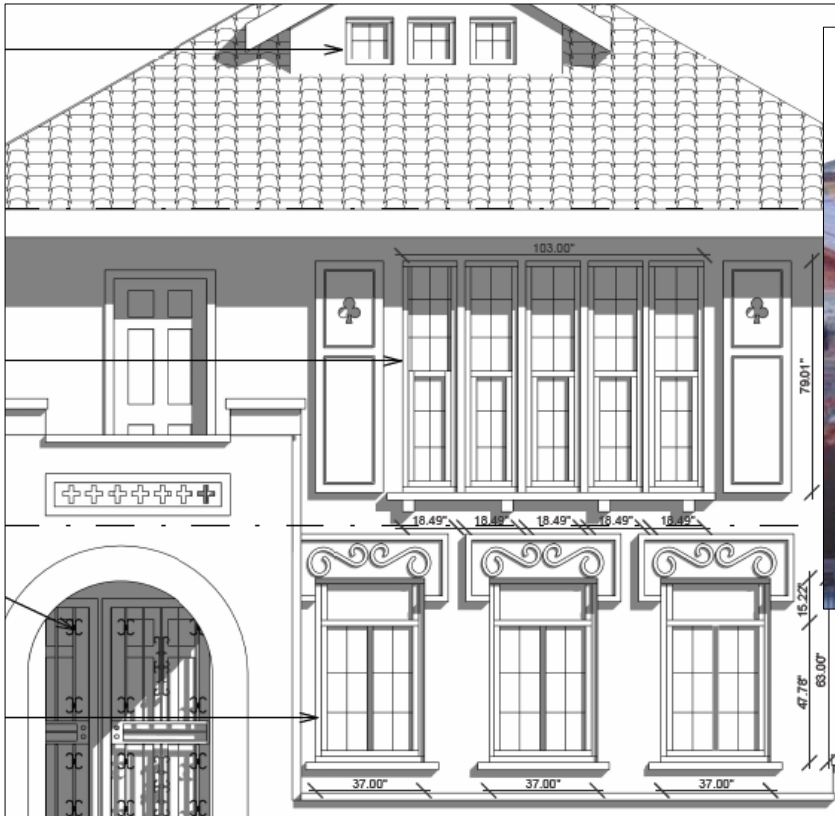
Front Wall - Proposal

- The leaded glass windows were removed without HDC approval, therefore, the only replacement windows that would meet the requirements of the historic ordinance (Section 21-2-59(e)), are new leaded glass windows, with an identical pattern, within every window opening.

- If the Commission considers not requiring leaded glass windows to be fabricated for the front elevation openings, it is staff's opinion that the window operations must be matched to retain the verticality and rhythm of the original window arrangement. It is also staff's opinion that a muntin pattern should not be specified for these windows. The muntins/grilles would be substantially thicker (in width and depth) than the lead caming and would only be available in a horizontal/vertical pattern as shown on the elevation. This would establish new geometric patterns for the windows and significantly reduce the glass area; all of which, in staff's opinion, would conflict with, and detract from, the highly ornamented wall surfaces and window hoods.

Recommendation One – Denial – Replacement of leaded glass windows and wood doors with leaded glass panels at façade

- The historic windows and upper porch door were distinctive, character-defining features of the house, and their removal substantially altered the appearance of the building. The only replacement windows that will meet the Standards are new leaded glass windows, with an identical pattern, within every opening, as well as glass door panel.
- The proposal to install a solid panel door and wood windows that have a traditional muntin pattern rather than the leaded glass pattern will not restore nor improve the historic and architectural design of this property.
- The uniformity and relationship between the window openings on each floor and each elevation is an important architectural component of the dwelling. The casement units on the front elevation offered a verticality to each window opening that will not be duplicated by the installation of double-hung windows at the second floor.

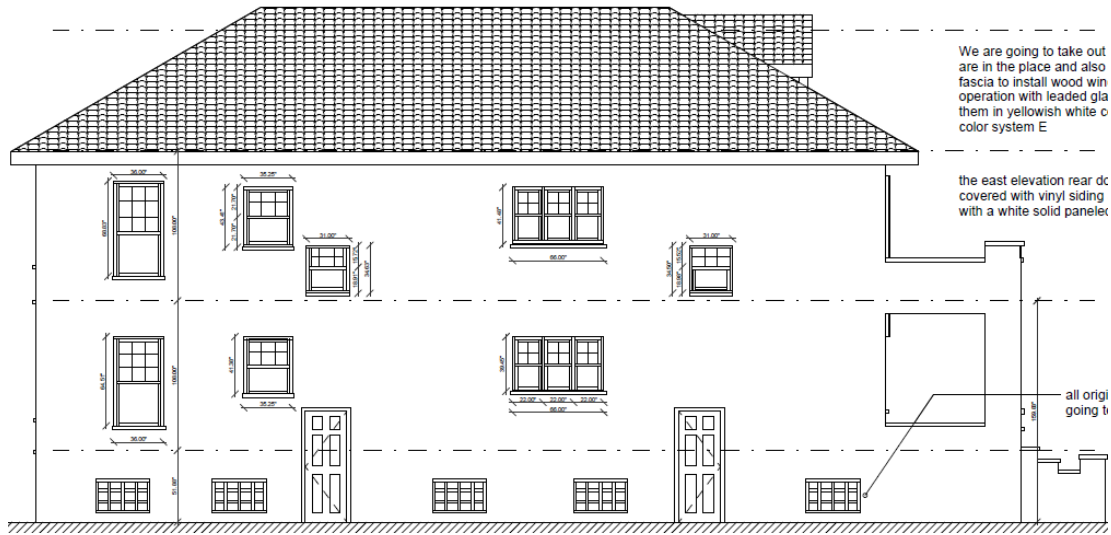
Left- East Side Wall

- The current application reverts to matching the historic window operation of each opening on this wall. However, the historic muntin pattern was a linear 3-over-1, not 4, 6 and 9-over 1.
- This dwelling is a two-family flat, and the application includes the installation of a new doors within each existing door opening. The six-panel offers a minimal design with vertical proportion, and it is staff's opinion they are compatible for this property, however the selected color of white is not compatible with the architectural design of the dwelling.

- For the replacement windows at the side and rear walls, solid wood or aluminum-clad wood windows will be selected. Cut sheets confirming the manufacturer, product line, material, operation, color, and simulated divided light dimension and profile will be submitted for staff review. All double-hung windows will have a 3-over-1 pattern, and the small square windows will not have any glass pattern. A window schedule that confirms the details for each window will be submitted for staff review.

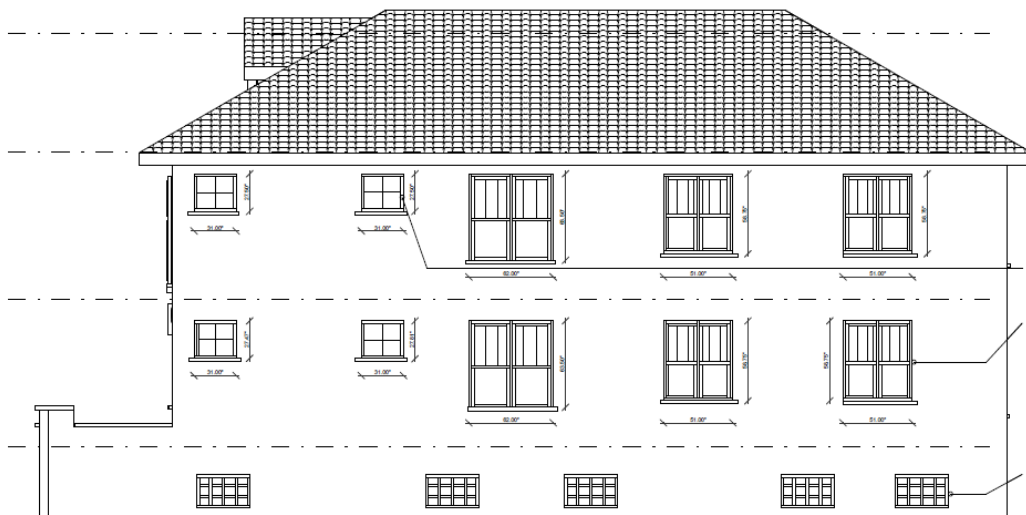
Right- West Side Wall

- Similar to the other side wall, the applicant proposes to remove the vinyl windows and install double-hung units in the taller-than-wide windows and has drawn the historically correct muntin pattern on this side of the house. However, it is staff's opinion the small square windows should not have a muntin pattern as these special windows historically often had a different glass design (possibly leaded glass). Staff did not find a photo to document if a pattern was historically present on these windows, therefore glass with no pattern is a compatible design.

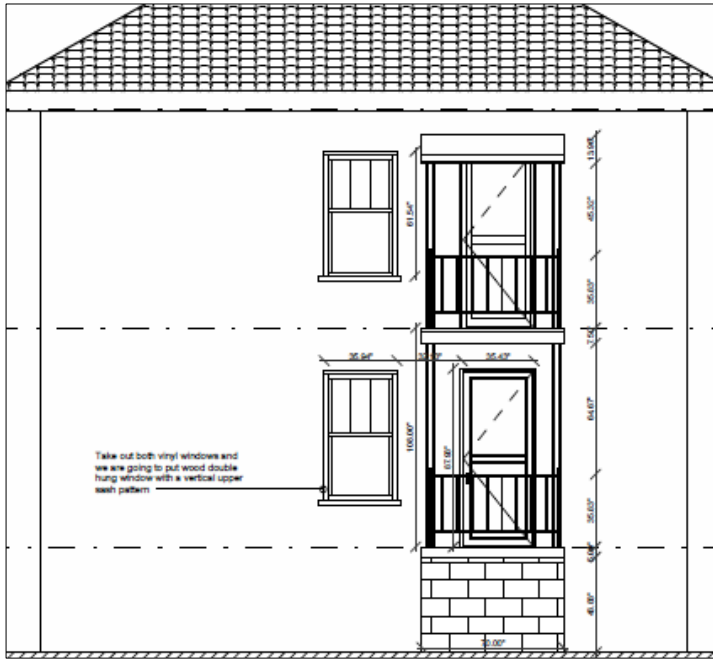
Rear Wall

- The application proposes to remove the vinyl windows and install wood windows with a 3-over-1 pattern to match the documented historic condition. A two-story porch is proposed in a dimension and design that is similar to the ghost images shown in the 2018 photo that documents the placement of the former porch.

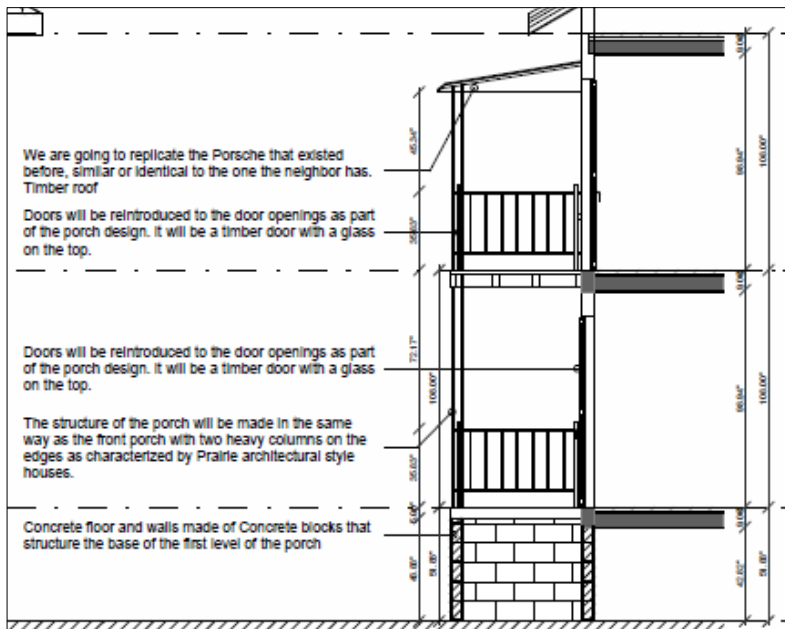
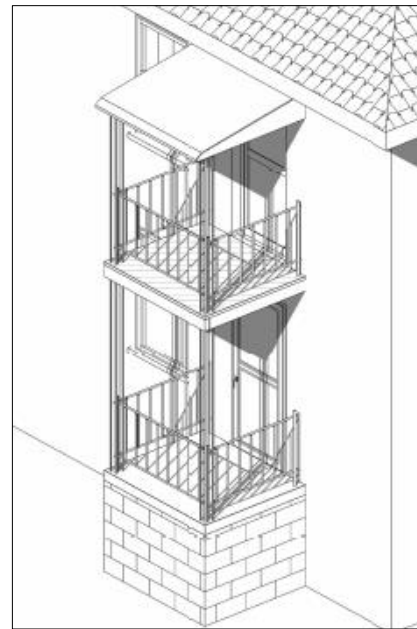
Applicant drawings

- It is staff's opinion that the historic porch was likely wood construction (based on the width of the railing profiles) and that wood construction for the new posts, railings and landings (no concrete block or iron railings/posts) would be compatible at this rear, secondary location. An awning for the upper porch, as drawn, is also a compatible design option at this location.

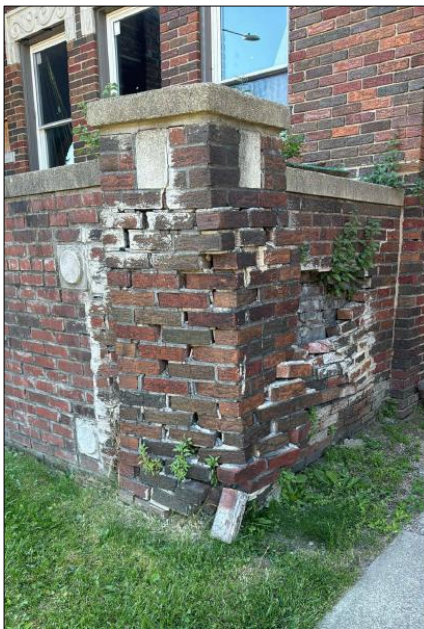
Gently remove loose bricks and clean the surface well to prepare it with cement and re-glue the original bricks and get old bricks of the same brown and red color to put the missing ones and make the walls level again

Scrape off the light gray concrete that is visible on the surface of the bricks to re-establish the original bricks

- The applicant's condition assessment is not fully documented, and the scope of work is not detailed to the level needed, nor described in a way (ex. "prepare it with cement and re-glue the original bricks...") that meets the Secretary of the Interior's Standards.
 - Scopes of work, such as "clean the surface well" need to be fully explained, including method, material and pressure of cleaning.
 - If a section of the existing porch is to be deconstructed and rebuilt (like possibly the outer, east masonry pier which isn't identified in the current scope of work), a dimensioned drawing confirming how it will be reconstructed is required.

- The applicant will create a condition assessment for the masonry front porch that fully documents existing conditions and corresponding repairs that meet the Secretary of the Interior's Standards, as discussed in National Park Service Preservation Briefs #1 and #2.
