STAFF REPORT 10-09-2024 REGULAR MEETING PREPARED BY: G. LANDSBERG

APPLICATION NUMBER: HDC2024-00519

ADDRESS: 3628-3644 LINCOLN

SCOPE: DEMOLISH REAR WINGS, CONSTRUCT NEW REAR ADDITION, REHABILITATE EXTERIOR. DEMOLISH GARAGE, ERECT NEW CARRIAGE HOUSE

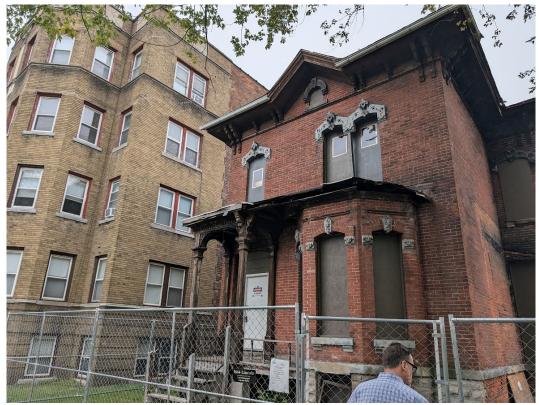
View of existing nineteenth century house at 3644 Lincoln. Note immediately adjacent 5-story apartment building. Staff photo, September 30, 2024.

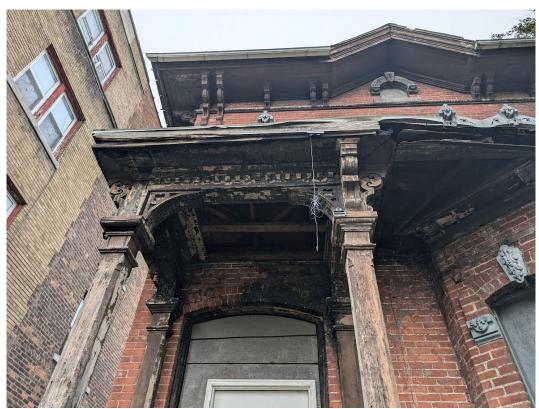
View of front façade/entry porch. Staff photo, September 30, 2024.

- Rehabilitation of the main house/front facade. The applicant proposes a nearly "textbook" rehabilitation of the important street-facing portion of the nineteenth-century house. As described in the proposed project documents, historic features including the highly significant porch, columns, stonework, brickwork, and woodwork will be repaired, and if beyond repair, will be reproduced in exact form, including materials. Per staff's field assessment, much of the surviving decorative woodwork appears salvageable. True wood double-hung windows are specified everywhere. Per the architect's submission, concerning the porch reconstruction:

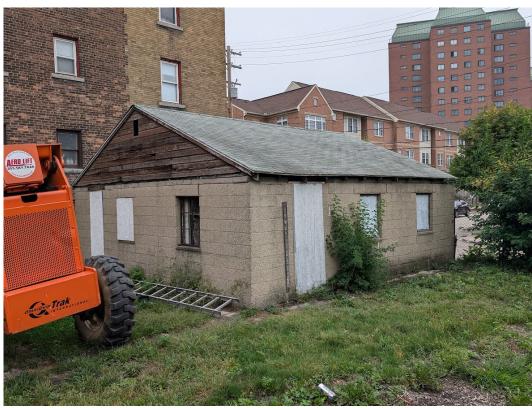
View to the northeast showing existing block garage. Note high density development in vicinity. Staff photo, September 30, 2024.

- Garage. As described above, staff assesses that the current garage is not a "contributing" building to the historic property/district. Should the Commission agree, its demolition would meet the Standards. As to the replacement, the architect has designed a very competent historically inspired building that would merge seamlessly into many historic contexts. Interestingly the first story of the garage/carriage house also incorporates salvaged cinder block from the current garage, adding additional block to match as required. This nod to context (and the existence of an earlier building) is a strong design move in any historic district, and will help to distinguish the building as contemporary construction. The garage is also designed with true wood siding and windows. Staff recommends that the Commission find the carriage house appropriate. Its size and architectural treatment is compatible with the scale and context of the Woodbridge Farm Historic District.

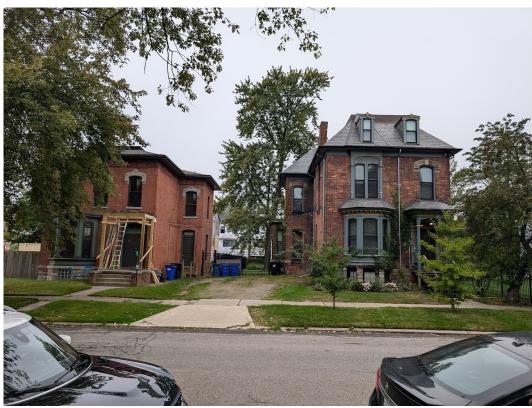
View across Lincoln to the west, showing 3627 Lincoln (c. 1875), which is called out in the HDAB report and shares similar features to the subject property. To the right is 3643 Lincoln. Staff photo, September 30, 2024.

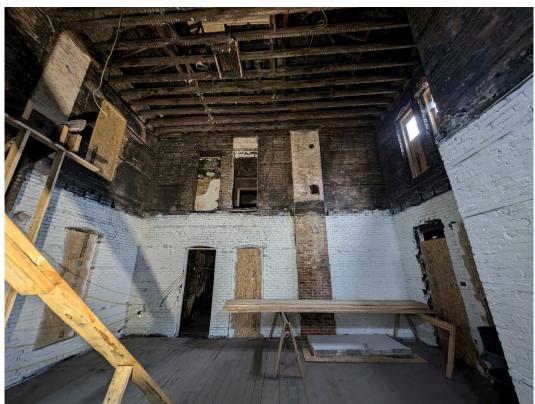
Opposite view of main house interior, looking east towards rear. Note complete two-story brick wall closing this portion off from the additions/wings. Staff photo, September 30, 2024.

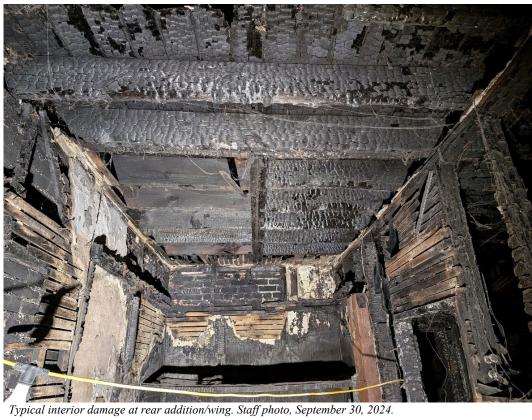
Typical damage at rear addition. Note condition of window. Staff photo, September 30, 2024.

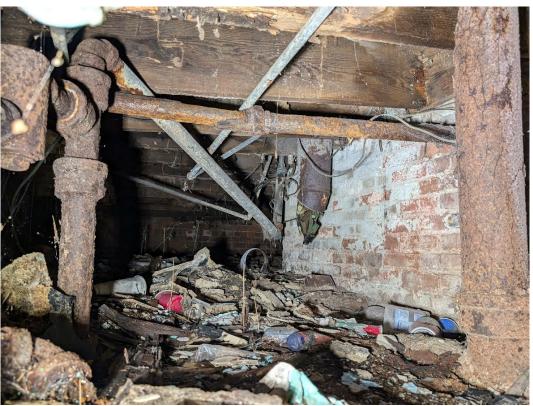
View of the crawlspace beneath the south-extending addition, taken from basement of main house. Staff photo, September 30, 2024.
