**STAFF REPORT: NOVEMBER 13, 2024 REGULAR MEETING      PREPARED BY: T. BOSCARINO**

**APPLICATION NUMBER: HDC2024-00609**

**ADDRESS: 932 EDISON**

**SCOPE: REPLACE WINDOWS (WORK STARTED WITHOUT APPROVAL), DOORS, REAR PORCH, AND SIDING, INSTALL POOL**

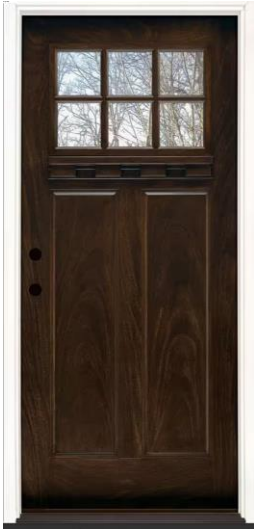
The applicant proposes to replace three exterior doors. Though the application does not provide exact specifications, the image provided depicts a Feather River molded fiberglass door with “chestnut mahogany” woodgrain appearance.

*Proposed door. Image from application.*

- The front door had already been replaced by a non-historic, modern door at the time the Boston-Edison Historic District was established (see designation photo on Page 2). Its replacement with a compatible door is appropriate.
