**STAFF REPORT:** FEBRUARY 12, 2025 MEETING  
**APPLICATION NUMBER:** HDC2024-00594 (garage), HDC2024-00709 (doors)  
**ADDRESS:** 19410 WARRINGTON  
**HISTORIC DISTRICT:** SHERWOOD FOREST  
**APPLICANT:** DEJUAN MCCLENDON  
**PROPERTY OWNER:** DEJUAN MCCLENDON  
**DATE OF PROVISIONALLY COMPLETE APPLICATION:** JANUARY 21, 2025  
**DATE OF STAFF SITE VISIT:** JANUARY 24, 2025

**SCOPE:** EXPAND/ALTER GARAGE, REPLACE FRENCH DOORS

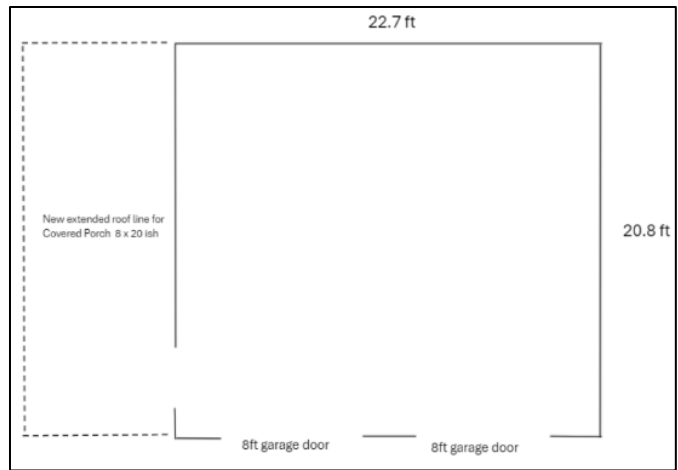
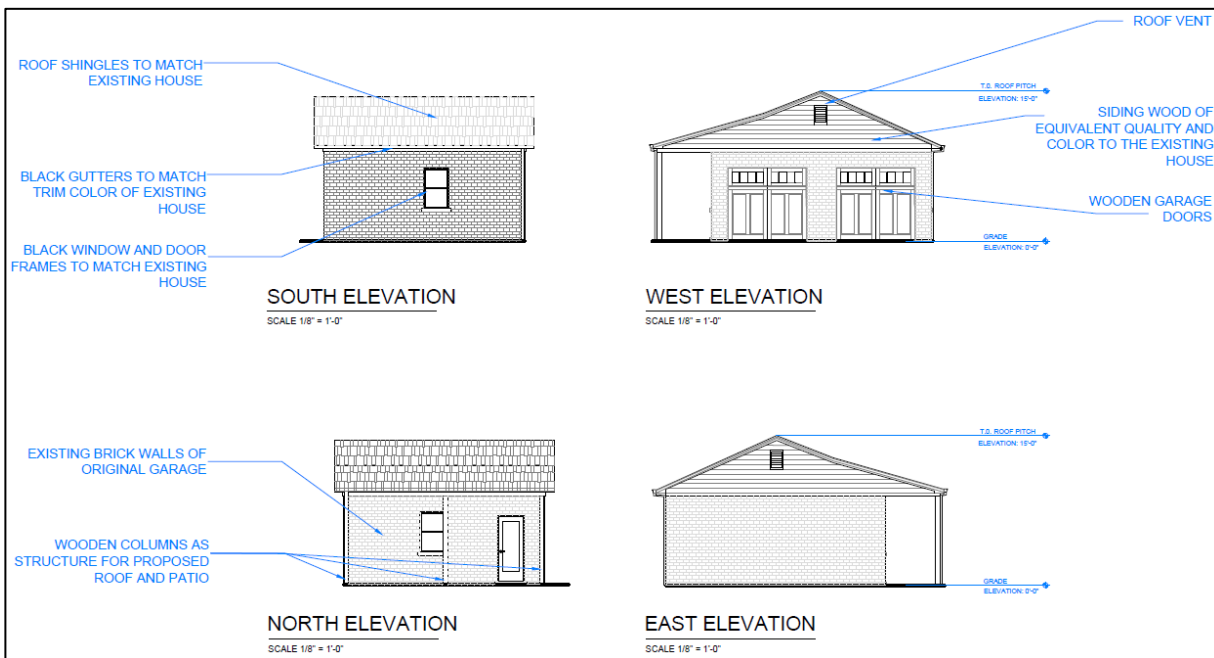
- Rebuild and expand the garage, which includes a raised, pitched roof that extends beyond the porch walls on one side to create a covered, open porch that will be supported by unadorned wood posts.
  - Two new single opening wood and glass paneled overhead doors will be installed, as will a wood frame/glass panel pedestrian door and one double-hung window on each side wall.
  - Two siding options for the gable walls were submitted: wood clapboard and wood shake.
  - Both options include asphalt roof shingles (matching the house), stained glass and wood panel overhead doors; trim, gutters, siding, pedestrian door and window sash will be painted black.

*Applicant drawings and renderings.*

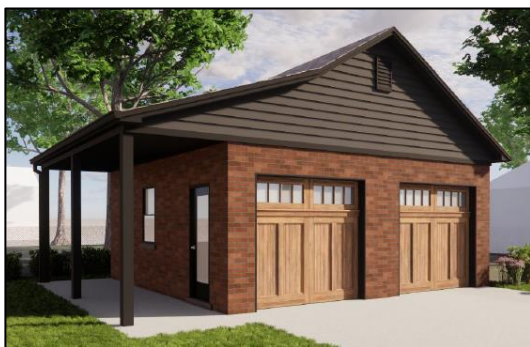
*Clapboard siding option*

- It is staff's opinion the smooth-faced clapboard siding is the most architecturally appropriate and compatible material for the garage and its visual connection to the dwelling.

- Smooth-faced clapboard siding is used on the garage's gable walls.
- The garage doors will be painted; the color will be submitted for review by HDC staff.
- The front door will be the stained wood door with arched leaded glass opening. Should another door be considered by the applicant, it will be submitted to staff for review.

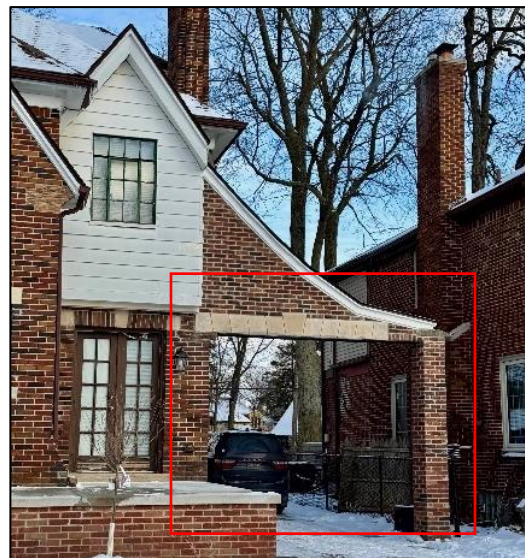
*Staff photo.*
