**STAFF REPORT: FEBRUARY 12, 2025 MEETING**

**APPLICATION NUMBER: HDC2025-00009 // VIOLATION NUMBER: 21-410**

**ADDRESS: 3470 CAMBRIDGE**

**SCOPE: REPLACE STEEL WINDOWS WITH VINYL-CLAD WOOD WINDOWS, REPLACE RAILINGS AND DOORS (WORK COMPLETED WITHOUT APPROVAL)**

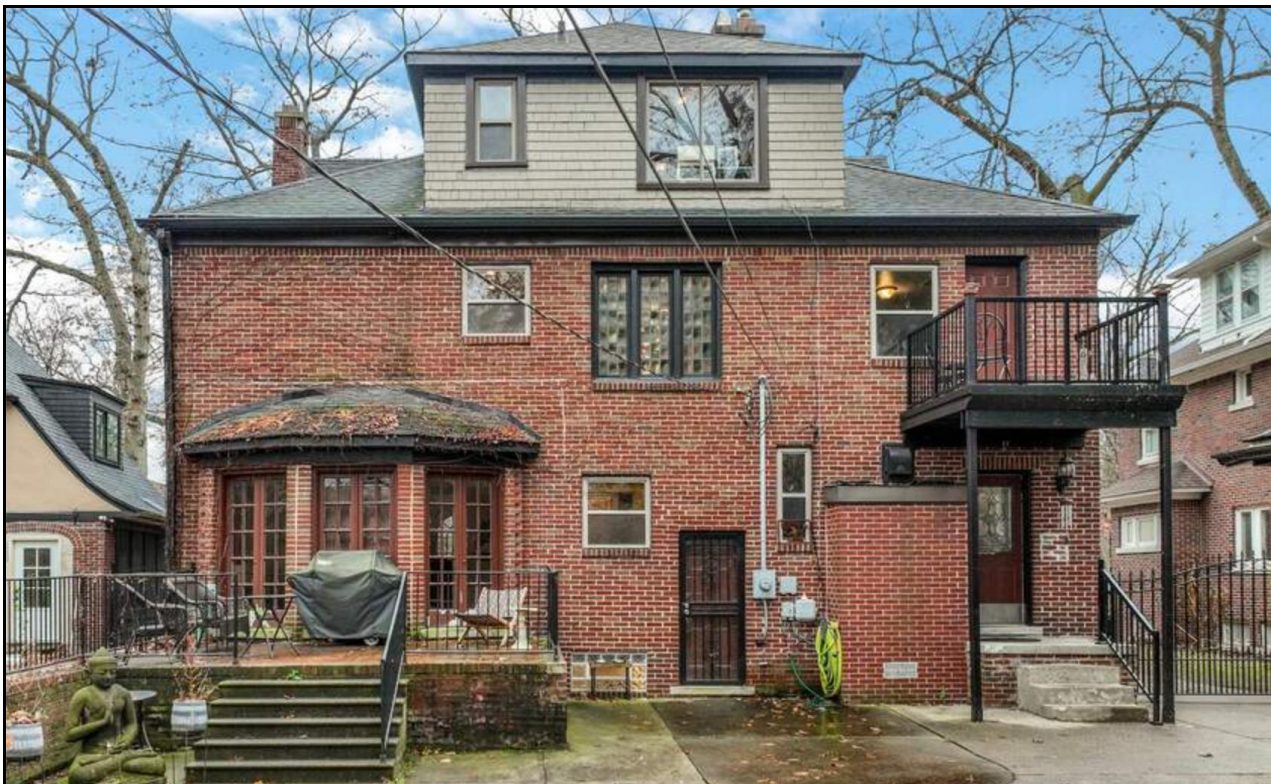
*Rear wall, applicant photo.*

The rear wall has a large shed dormer faced with wood shake siding and a raised patio extending from three sets of French doors. The historic wood French patio doors remain, as do the leaded glass fixed window sash in the triple window opening. The remaining windows are vinyl replacement units of double-hung or sliding operation. The three entrance doors have been replaced, a large second floor porch has been erected, and all the railings are new.

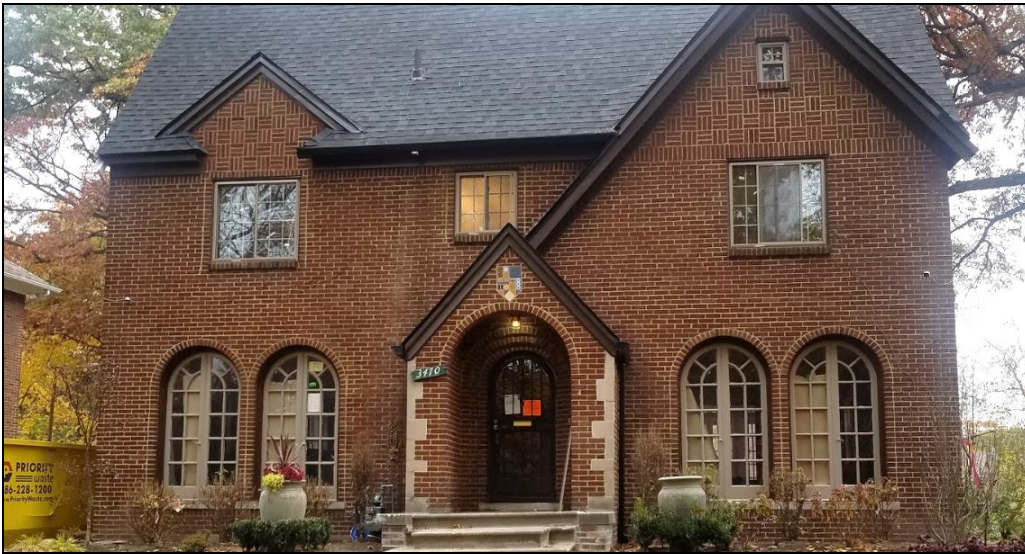
*The depth of the "before" steel windows is quite evident and clearly offers a relief from the masonry wall. The replacement windows are minimally set back in the window opening, and from a distance, appear to be in plane and a part of the exterior wall.*
