STAFF REPORT: FEBRUARY 12, 2025 REGULAR MEETING **PREPARED BY: T. BOSCARINO**
APPLICATION NUMBER: HDC2024-00700 (VIOLATION #24-891)
ADDRESS: 4340 GLENDALE
HISTORIC DISTRICT: RUSSELL WOODS-SULLIVAN
APPLICANT: KARINA LABARCA
PROPERTY OWNER: AFIWI LLC
DATE OF PROVISIONALLY COMPLETE APPLICATION: DECEMBER 10, 2024
DATE OF STAFF SITE VISIT: FEBRUARY 5, 2025

SCOPE: REPLACE WOOD WINDOWS (WORK COMPLETED WITHOUT APPROVAL) WITH ALUMINUM-CLAD WOOD WINDOWS

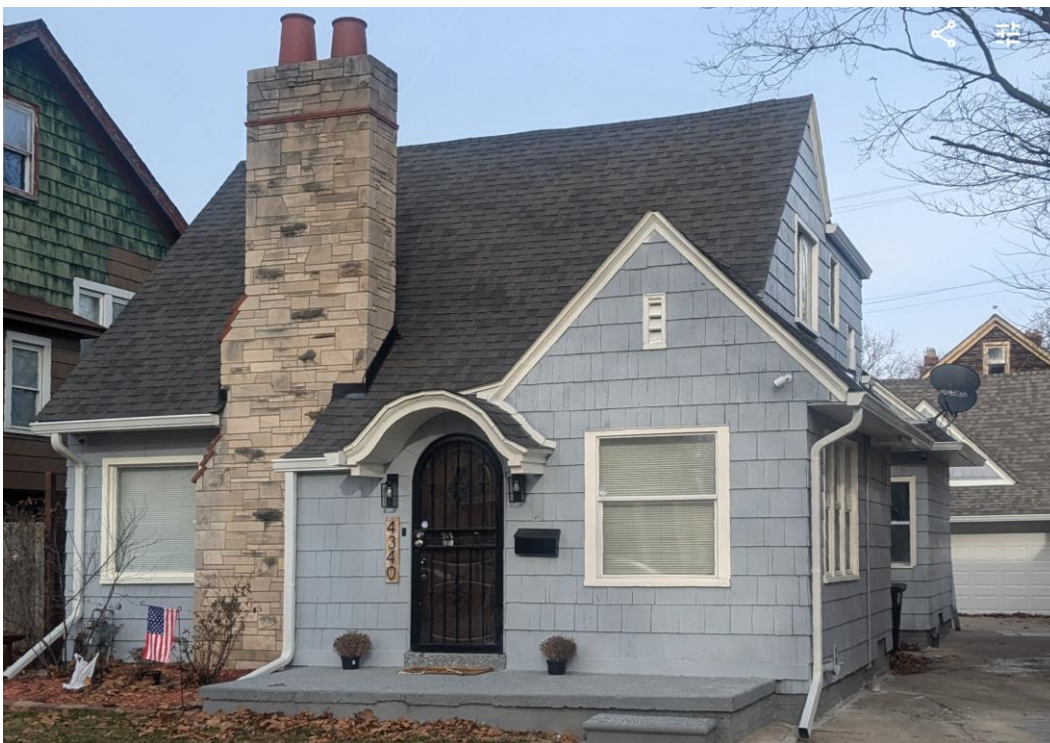
February 2025 photo by staff.

Most of the windows on the house have been replaced without approval from the Commission, as described in the following timeline:
