STAFF REPORT: MARCH 13, 2025, REGULAR MEETING **PREPARED BY:** T. BOSCARINO & J. ROSS
APPLICATION NUMBER: HDC2025-00010
ADDRESS: 3500 MCDUGALL (A.K.A. 3100 GRATIOT AVENUE)
HISTORIC DISTRICT: PRINCE HALL GRAND LODGE
APPLICANT/ARCHITECT: KATIE COOK, KRAEMER DESIGN GROUP
PROPERTY OWNER: PRINCE HALL GRAND LODGE
DATE OF PROVISIONALLY COMPLETE APPLICATION: JANUARY 21, 2025
DATE OF STAFF SITE VISIT: FEBRUARY 28, 2025

SCOPE: REPLACE VINYL, STEEL, AND WOOD WINDOWS WITH ALUMINUM WINDOWS; INSTALL WALL SIGNS

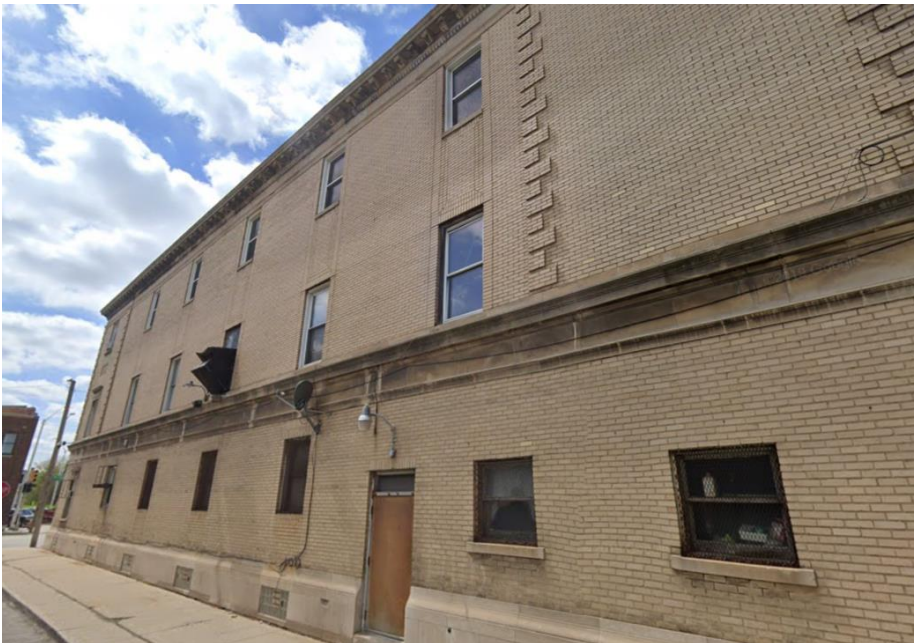
A third, treated facade faces Preston Street to the southeast. It has no storefronts, but otherwise similar materials and detail to the Gratiot facade. The rear of the building is common brick and unadorned.

Preston Street facade. 2019 Google Street View image.

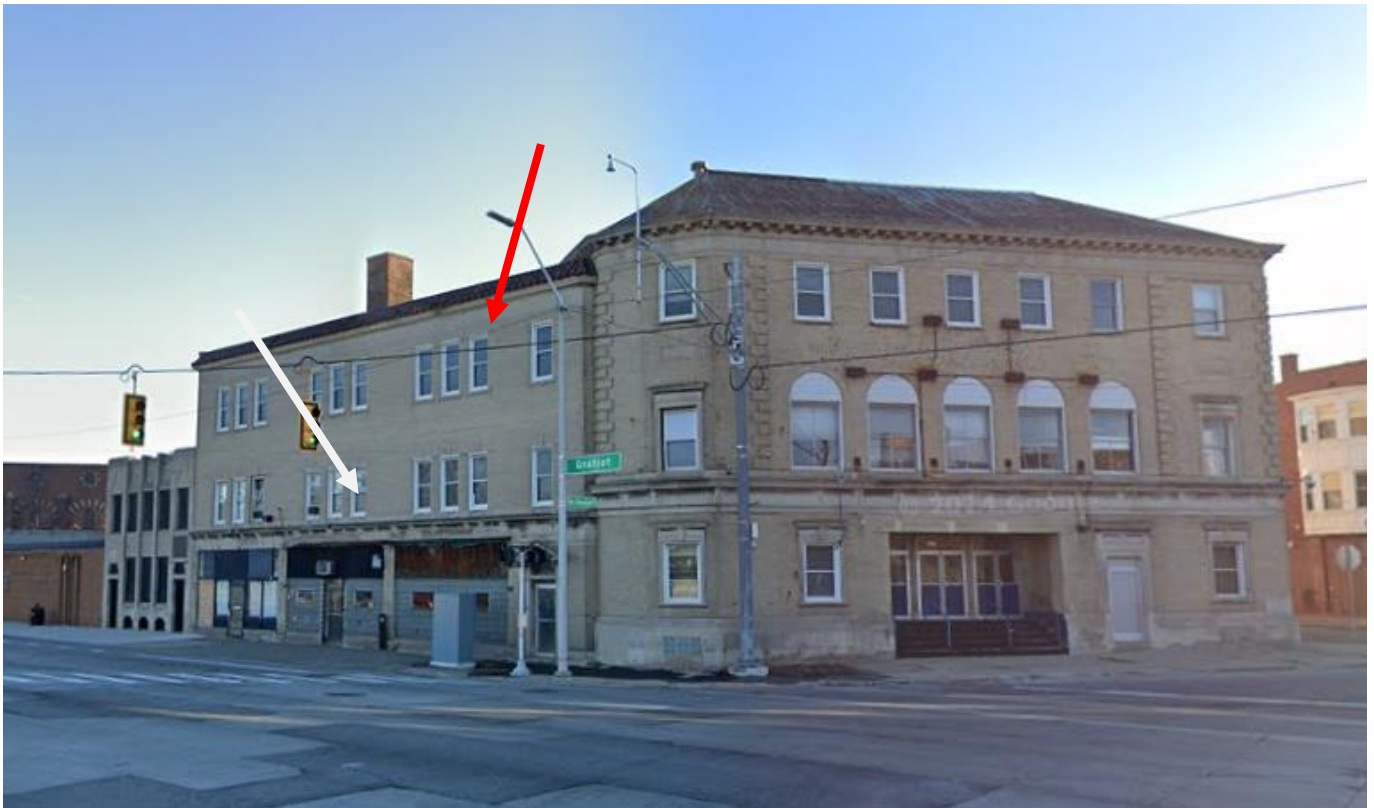
Note the three story addition which faces on to Gratiot was erected in 1931 (indicated by red arrow). The addition includes three storefronts which are topped by a masonry cornice (indicated by white arrow), echoing the design of the original two-story wing which once stood at this location. Google Streetview
