STAFF REPORT: APRIL 9, 2025 MEETING **PREPARED BY:** D. RIEDEN, T. BOSCARINO AND A. DYE
APPLICATION NUMBER: HDC2024-00626
ADDRESS: 1101 CHICAGO
HISTORIC DISTRICT: BOSTON-EDISON
APPLICANT: VICTOR SMOLYANOV, SMOLYANOV HOME IMPROVEMENT
PROPERTY OWNER: GRACIE BROWN
DATE OF PROVISIONALLY COMPLETE APPLICATION: OCTOBER 22, 2024
DATE OF STAFF SITE VISITS: NOVEMBER 27, 2024; FEBRUARY 28, 2025; MARCH 25, 2025
SCOPE: REPLACE CLAY TILE ROOF WITH ASPHALT SHINGLE ROOF

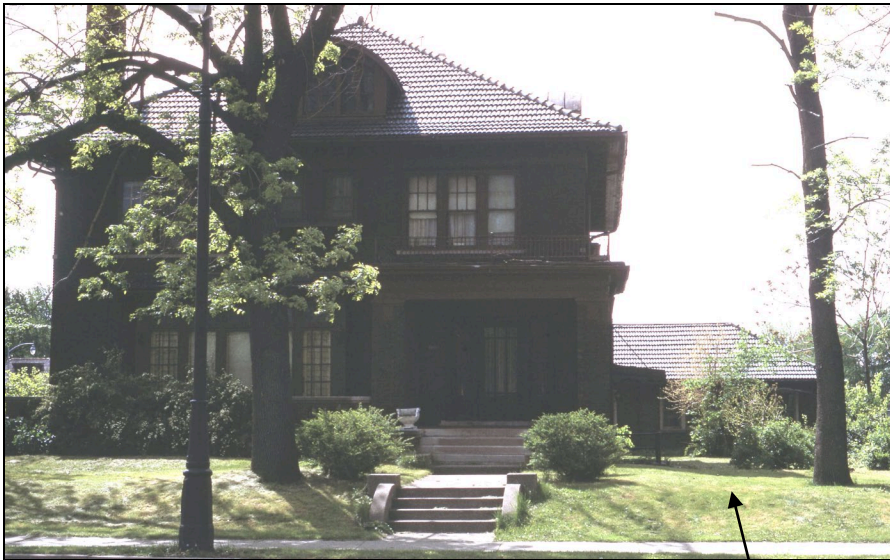
1974 photo by the Historic Designation Advisory Board. Note the garage with hip roof covered with tile.

Also present on the property is a garage (see photos above). At the time the Boston-Edison Historic District was established in 1974, the garage had a hip roof with green tile matching that of the house. The garage roof has since collapsed. There are no Historic District Commission approvals or other records associated with the garage.

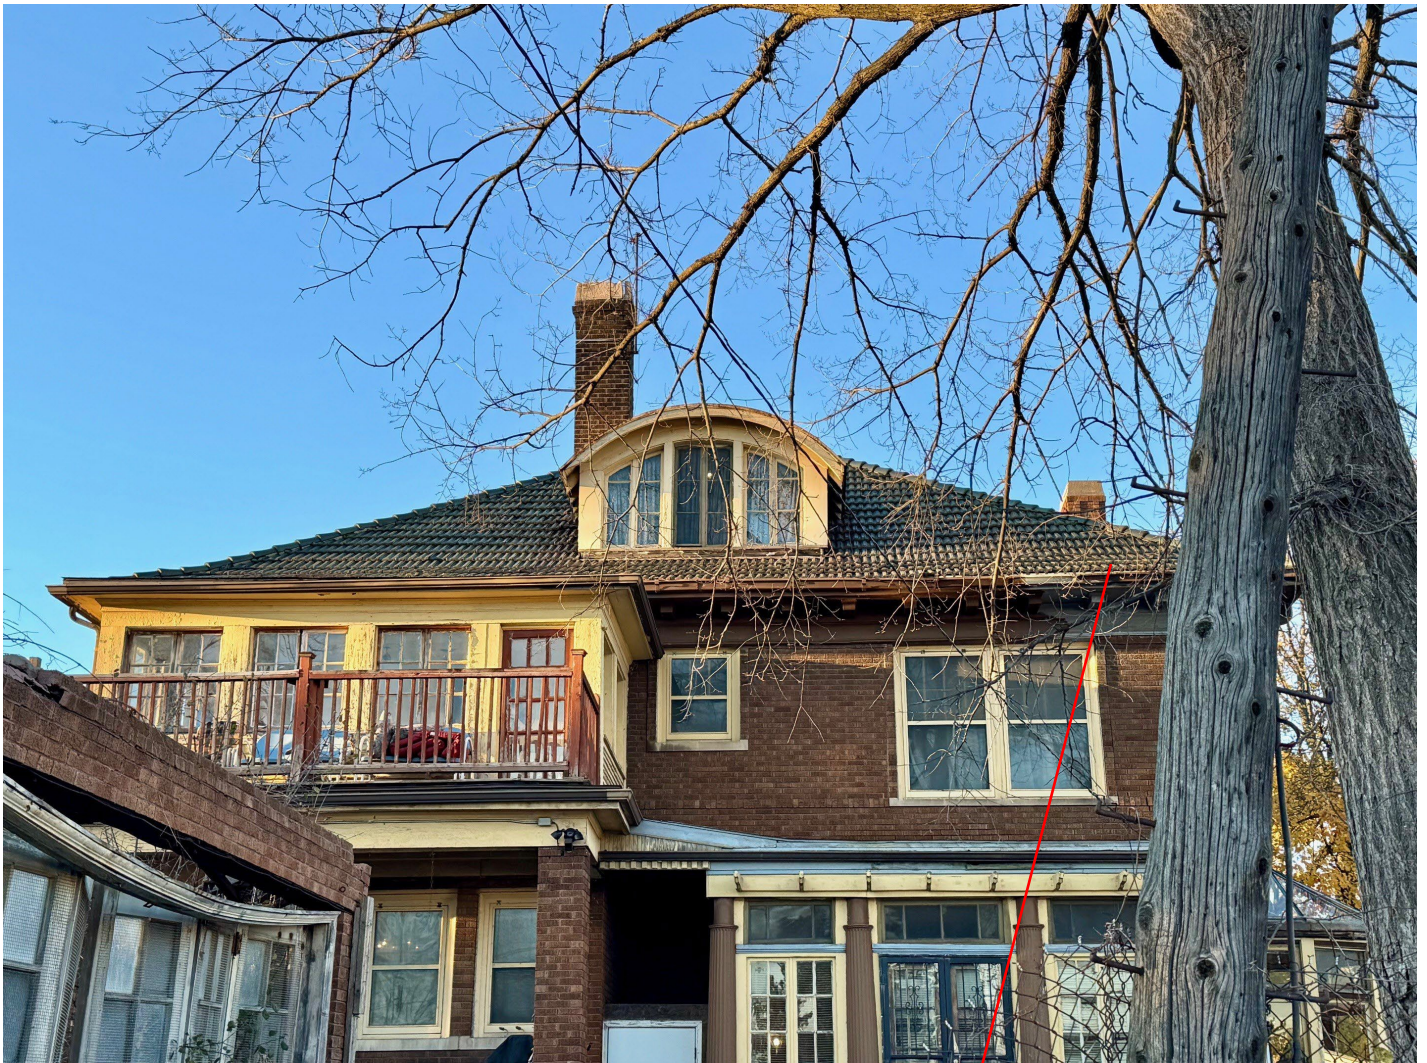
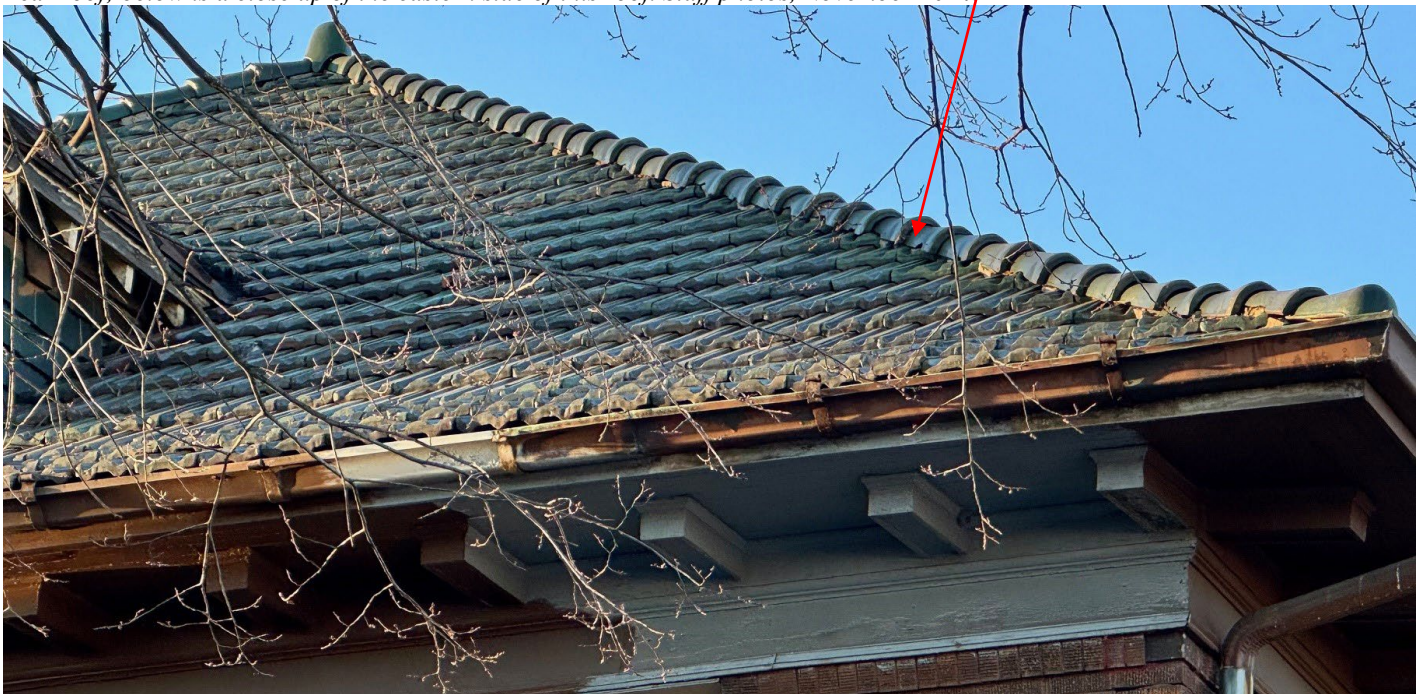
- The photos staff took from the ground, coupled with the photos supplied by the applicant, show that large sections of the tiles appear to be in good condition; and the number of broken tiles is small. The photos also show the distinctive profiles, depth of material and saturation of color that make tile roofs distinctive character-defining features that can only be matched by the installation of new tiles.

Applicant photo. This view captures a portion of the rear/south roof, which is also shown on the following page. The surfaces in most need of repair are the areas where the dormer roofs meet the tiles, as well as the standing seam metal covering the dormers.

Rear roof; below is a close up of the eastern side of this roof. Staff photos, November 2024

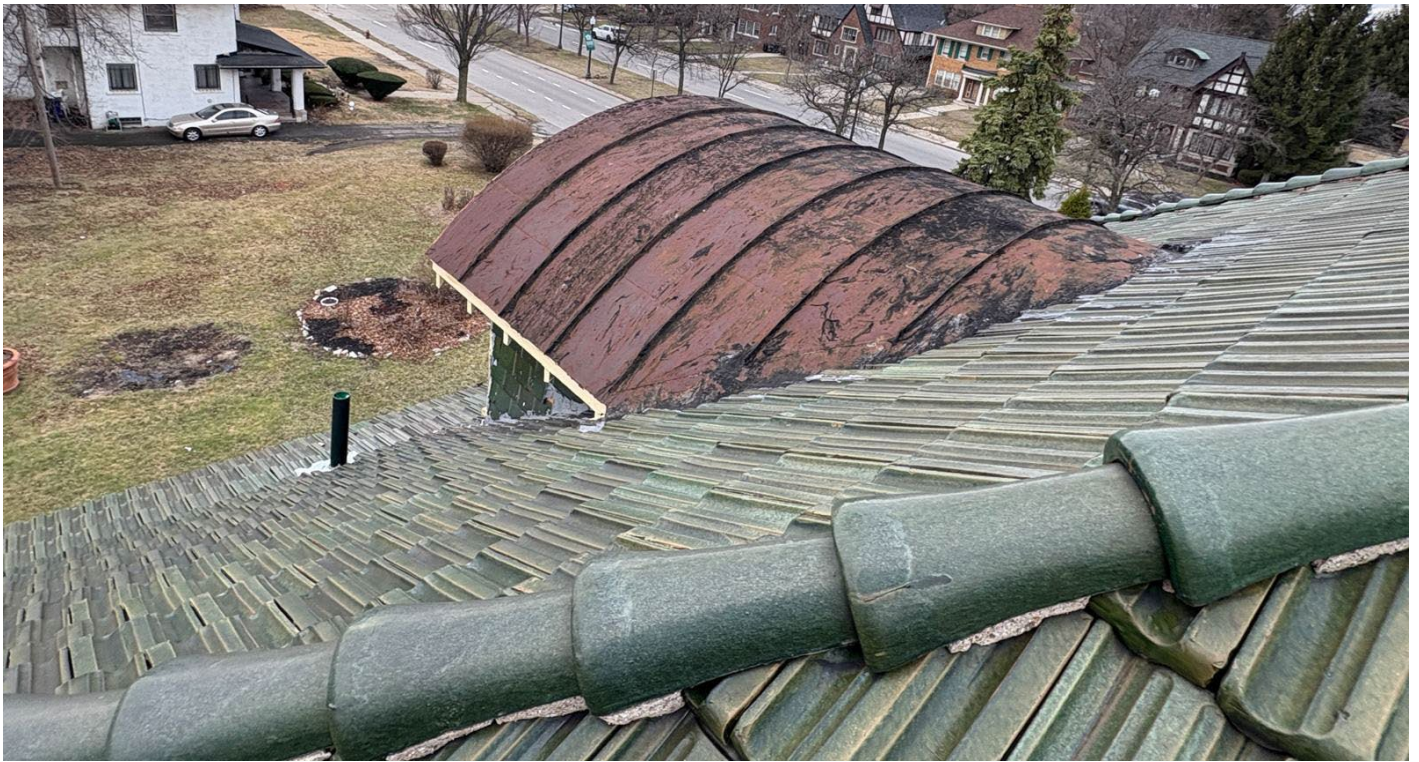
Applicant photo. This view is looking west.

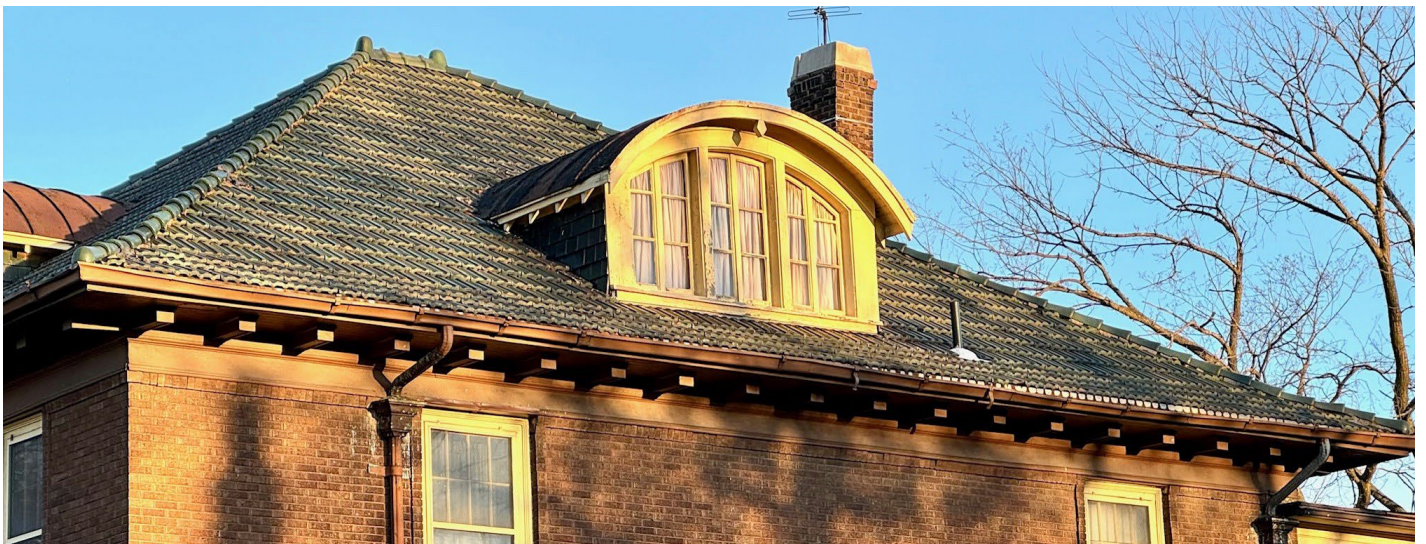
Staff photo of west side of roof, November 2024.
