**STAFF REPORT:** APRIL 9, 2025 MEETING  
**APPLICATION NUMBER:** HDC2025-00054  
**VIOLATION NUMBER:** 25-981  
**ADDRESS:** 1760 WABASH

**HISTORIC DISTRICT:** CORKTOWN

**SCOPE:** INSTALL LAP SIDING (WORK COMPLETED WITHOUT APPROVAL), ADD DETAILS TO HISTORIC AND NEW GABLE WALLS, INSTALL WINDOW AND RESIZE EXISTING WINDOWS ON FAÇADE, REBUILD WINDOW CASINGS-ALL SIDES, REMOVE SIDING FROM CHIMNEY

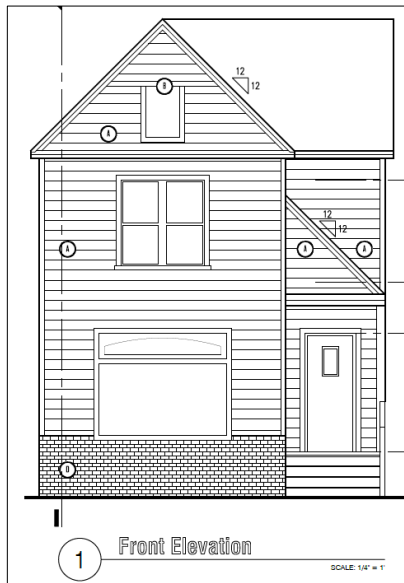
*Excerpt from Certificate of Appropriateness HDC2024-00031.*

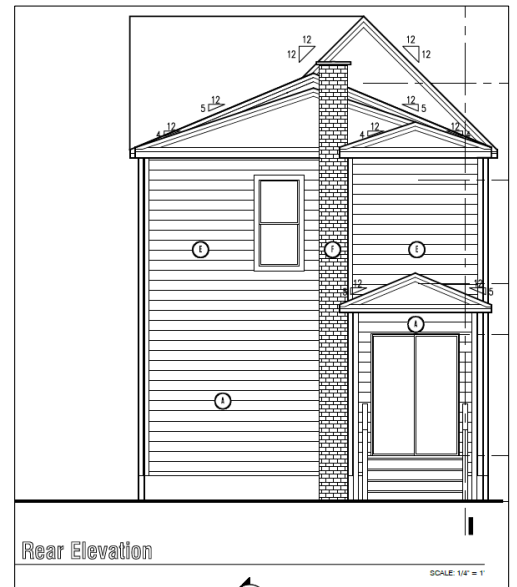
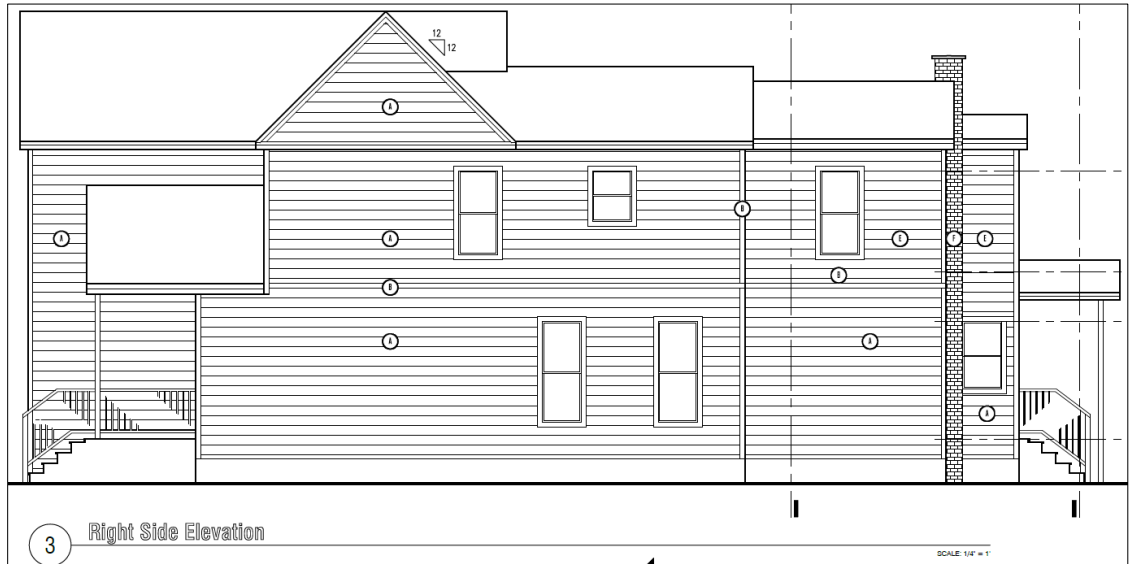
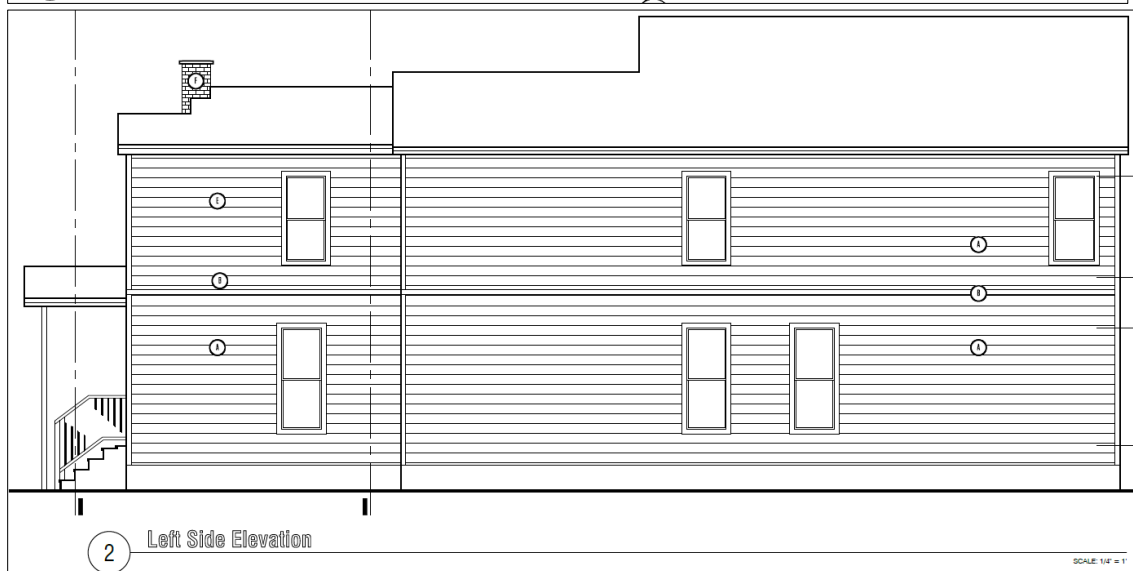
On April 29, 2024, staff reviewed and approved documents submitted to BSEED under permit RES2024-00103.  
ePlans elevation drawings.

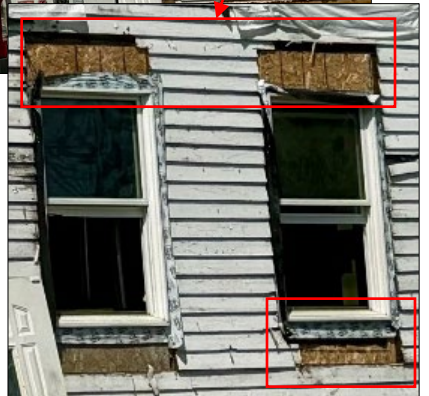
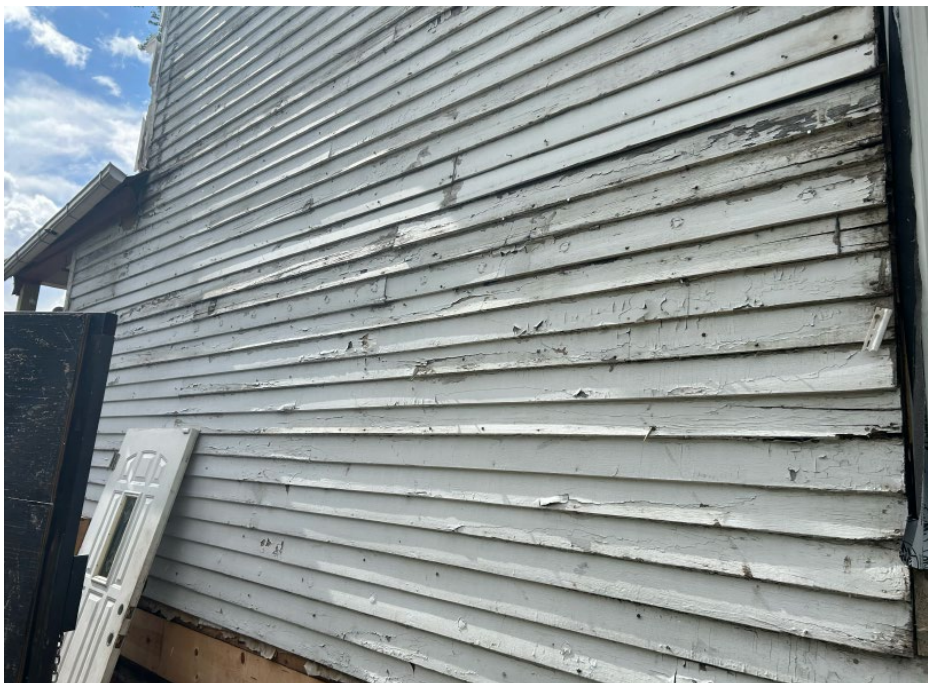
Applicant photo of the south side wall looking towards the 9 front porch.

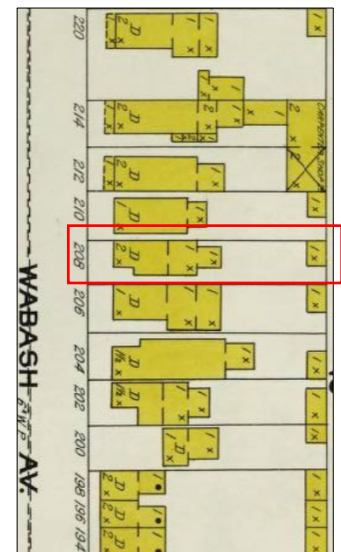
The historic address for 1760 Wabash was 208. The 1897 Sanborn map shows it in context to the neighboring dwellings.

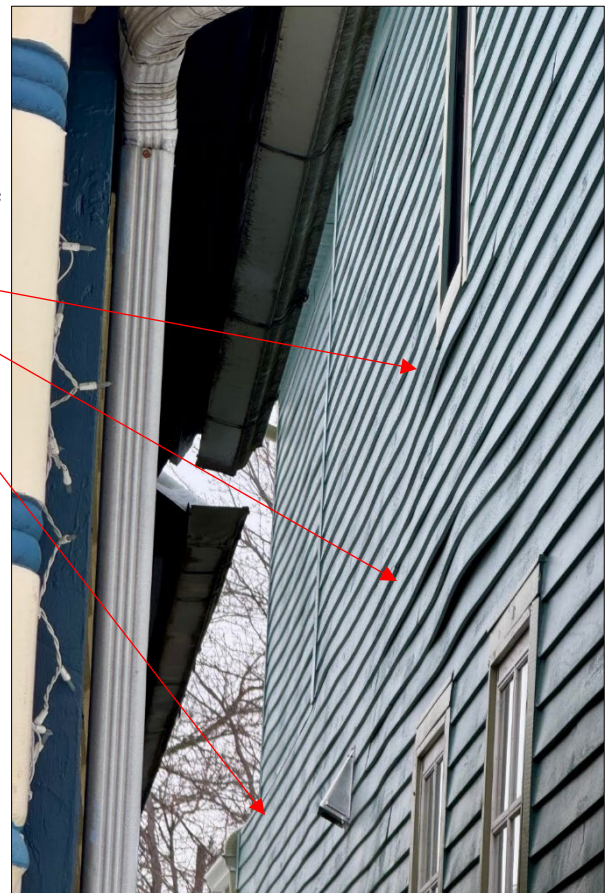
- Comparing the same window “before and after” staff counts a different number of rows of siding, going from 14 to 15.
- Another concern with the installed lap siding are the multiple gaps on the north side wall, and general waviness.

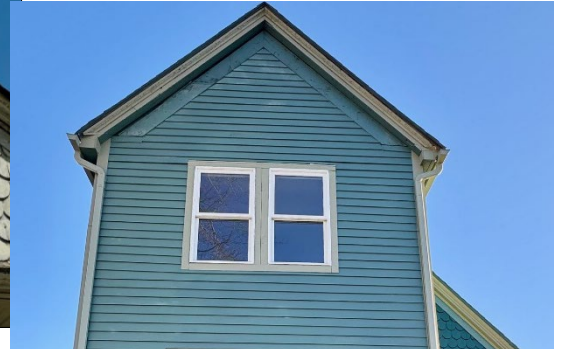
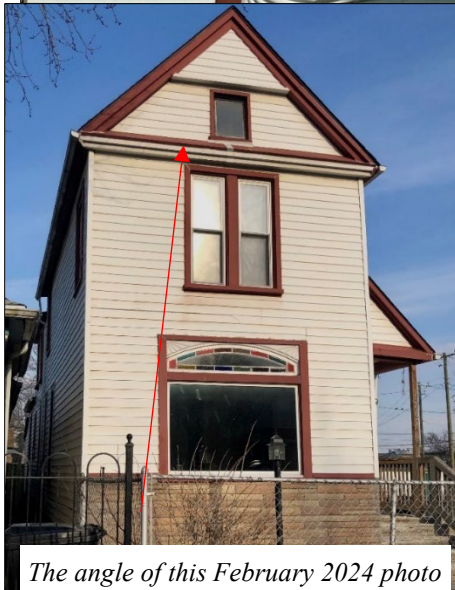
*The angle of this February 2024 photo offers a better view of the pent roof.*

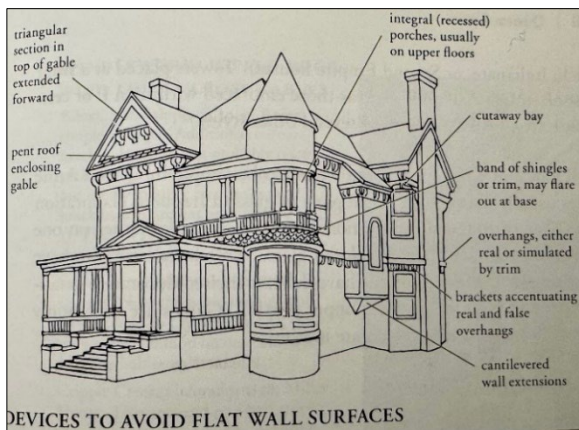
*This drawing of a Queen Anne house offers an idea of the type of ornamentation that may have originally been applied to this property's front-facing gable. A Field Guide to American Houses, Virginia Savage McAlester.*

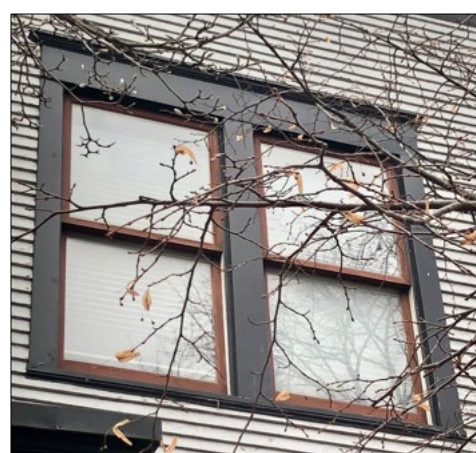
- The window within the gable was lost, and dimensional changes were made to the second floor windows – they are shorter in height and wider in width, the dimensional mullion was removed, they are placed forward in line with the window trim (rather than recessed like the previous replacement windows), and dimensional window casing/trim was removed and replaced with flat trim.
- A common feature on 19<sup>th</sup> century houses are tall, narrow double-hung windows. Multiple windows were joined by structural wide, flat mullions. Additional distinctive features that clearly identify dwellings of 19<sup>th</sup> century construction are the window casings: butt joints, a header with a small overhang at the top, equal-sized side trim, and a narrower, protruding sill. The February 2024 photo shows the protruding sill was still in place, covered with aluminum.

Second floor double-window opening at façade of 1760 Wabash.      16  
 Left: February 2024.      Right: March 2025.

Example of a historic mullied window opening on a house of similar age (1423 Sixth Street). The dimensions of the window trim at this location are different than at 1760 Wabash, but the dimensional relationship between the four sides of trim should be the same. Staff photo, November 2023.

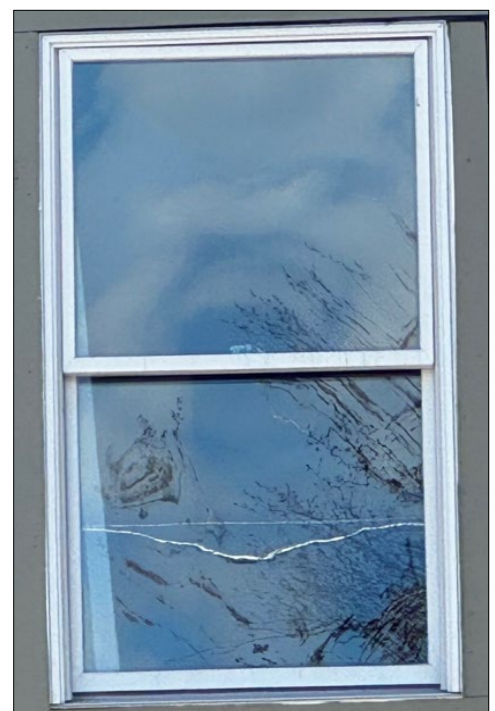
*Right: Existing replacement window in one of the new windows openings on the rear wall.*

*The dimensions and depth of framing of the Anderson window is more compatible with the dimensions and profile of a historic wood window.*

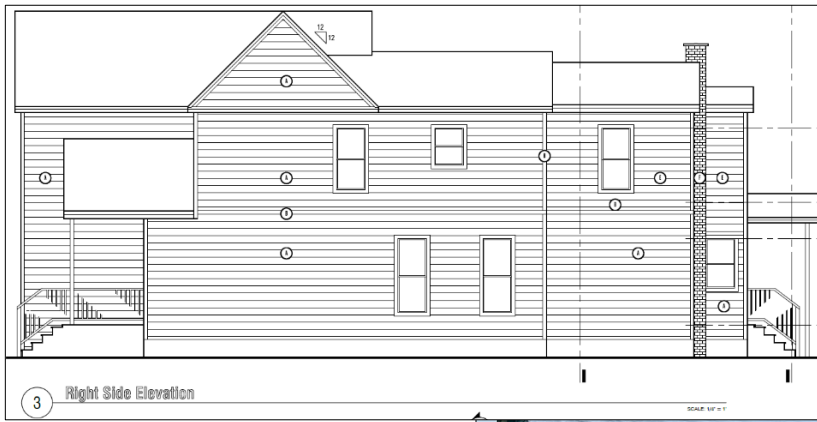
*Above: Approved drawing for south-side wall. During BSEED ePlans permit review, staff approved one additional window opening at the first floor rear, under staff authority for minor revisions to an HDC approval.*

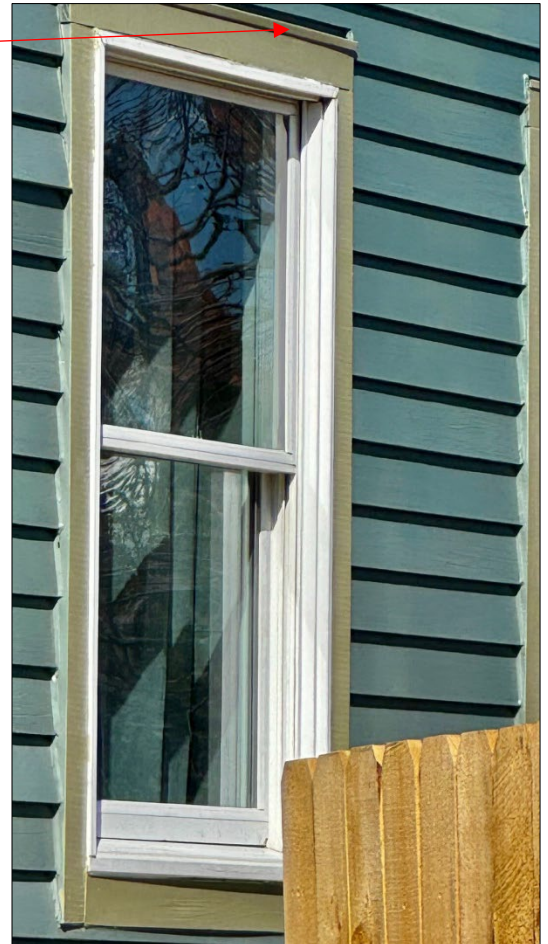
- As first identified on page nine, while reviewing photos for this staff report, staff noticed that at least one window opening doesn't fully fit the cut opening on the south-side wall.
