**STAFF REPORT: APRIL 9, 2025 MEETING**

**APPLICATION NUMBER: HDC2025-00117**

**ADDRESS: 3470 CAMBRIDGE**

**SCOPE: REPLACE STEEL AND WOOD WINDOWS WITH VINYL-CLAD WOOD WINDOWS (WORK COMPLETED WITHOUT APPROVAL)**

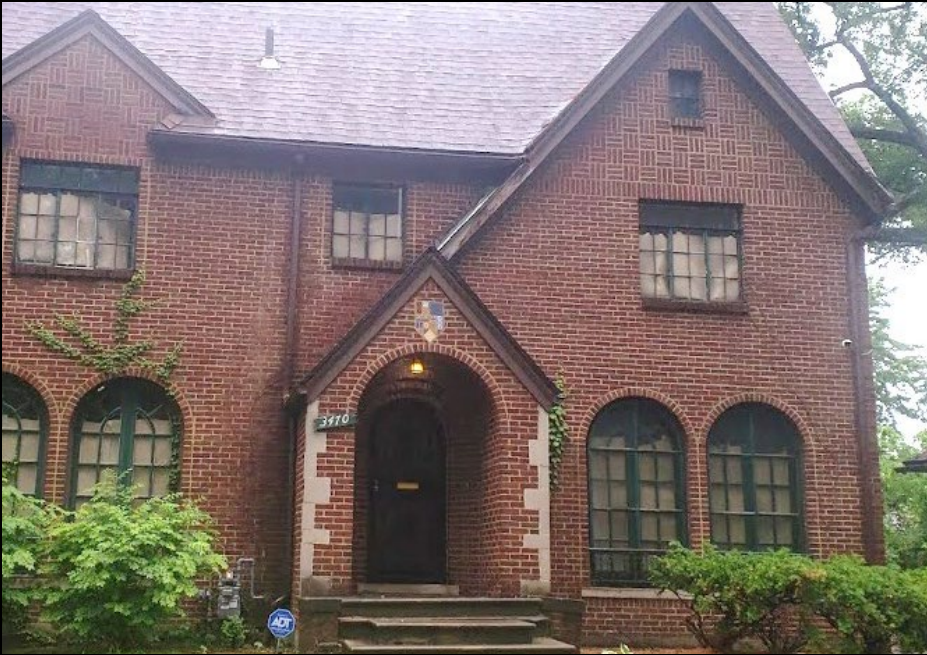
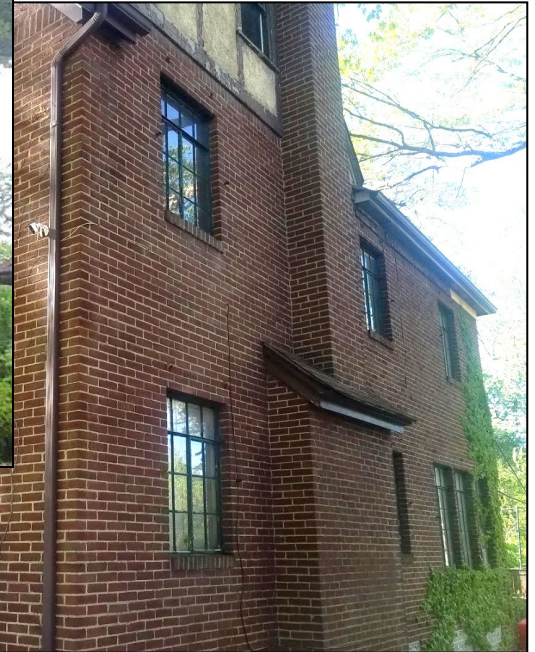
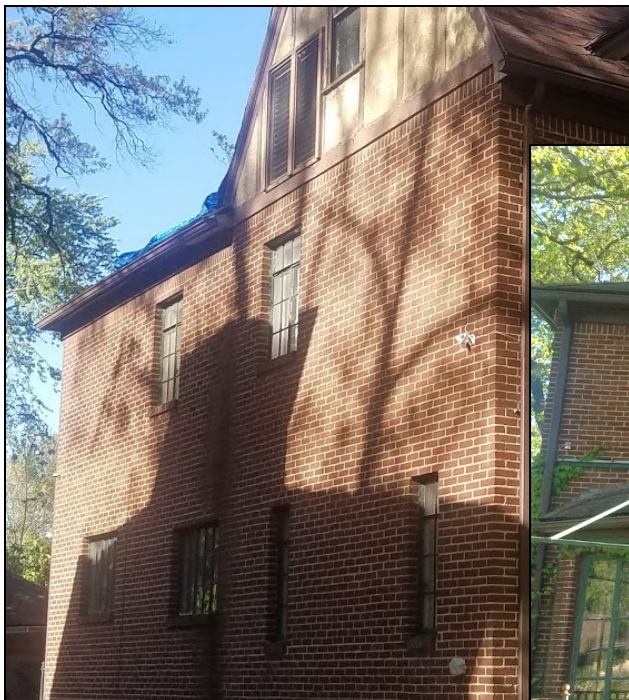
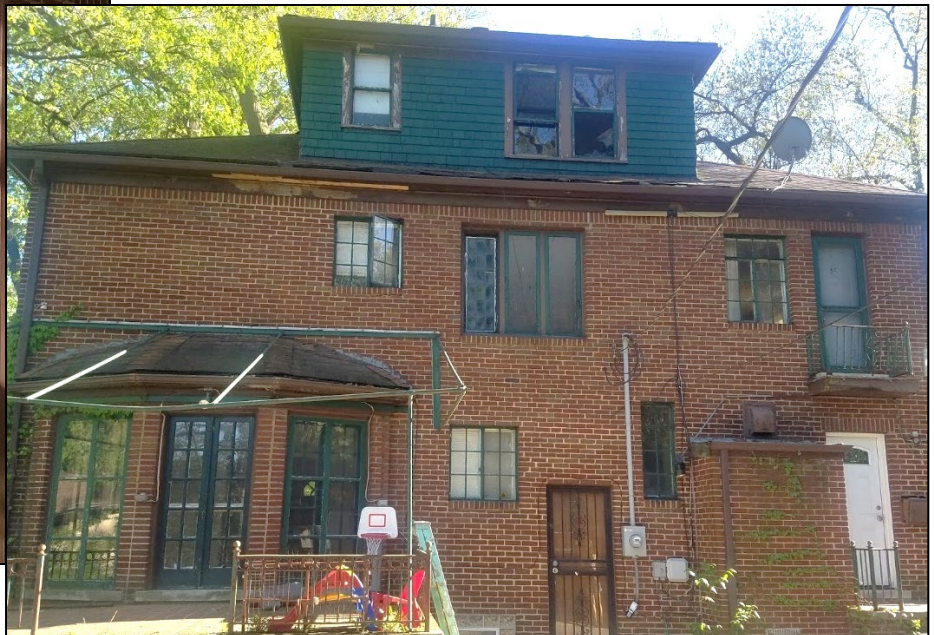
*Above: Façade.*

*Right: SE corner – façade and east side walls.*

*Below right: Rear wall.*

*Below: West-side wall.*

- The original windows were removed without HDC approval; the scope of work that would meet the requirements of the historic ordinance (Section 21-2-59(e)) is the fabrication and installation of new steel-framed windows with an identical pattern and operation as the historic windows, and wood one-over-one double-hung sash at the third floor, with dimensions and placement that match the historic windows.

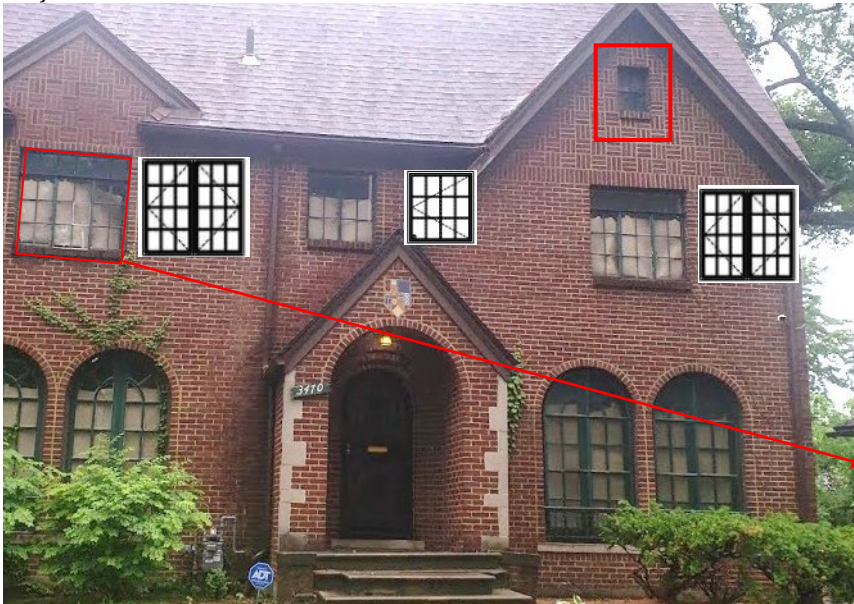
### Façade

Second Floor: 80 – Front Bedroom, 75 – Upstairs Bath, 90 – Master Bedroom
