ADDRESS: 4340 GLENDALE

APPLICATION NO: HDC2025-00116

HISTORIC DISTRICT: RUSSELL WOODS-SULLIVAN

SCOPE: REPLACE WOOD WINDOWS WITH ALUMINUM-CLAD WOOD WINDOWS

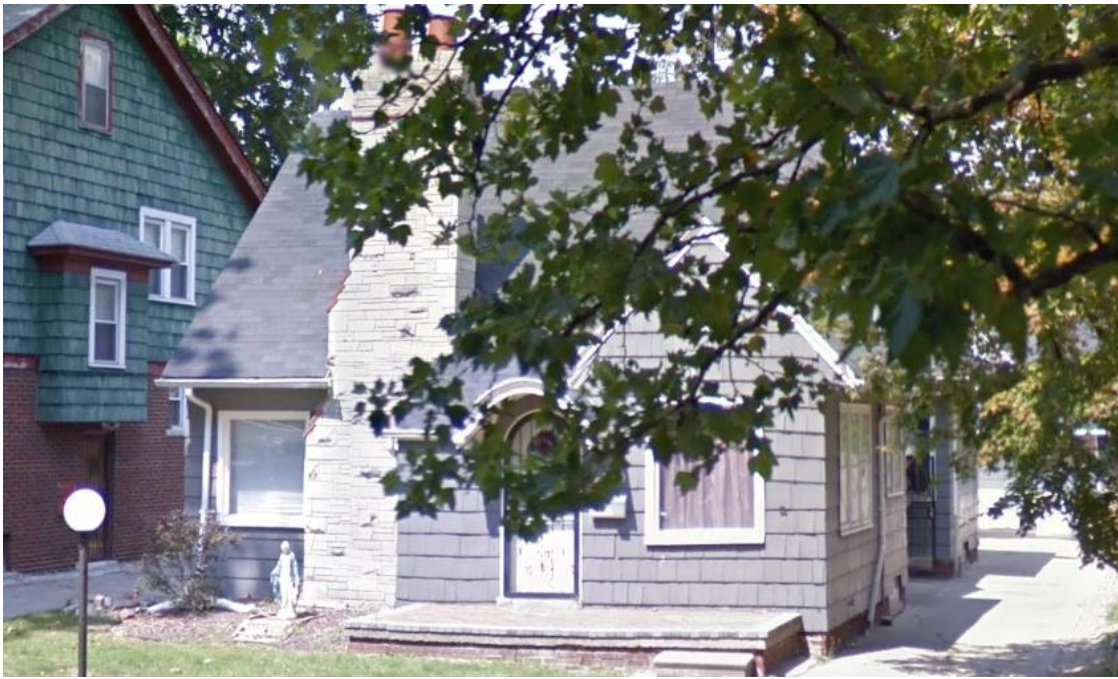
Appearance in 2013. Source, Google Streetview

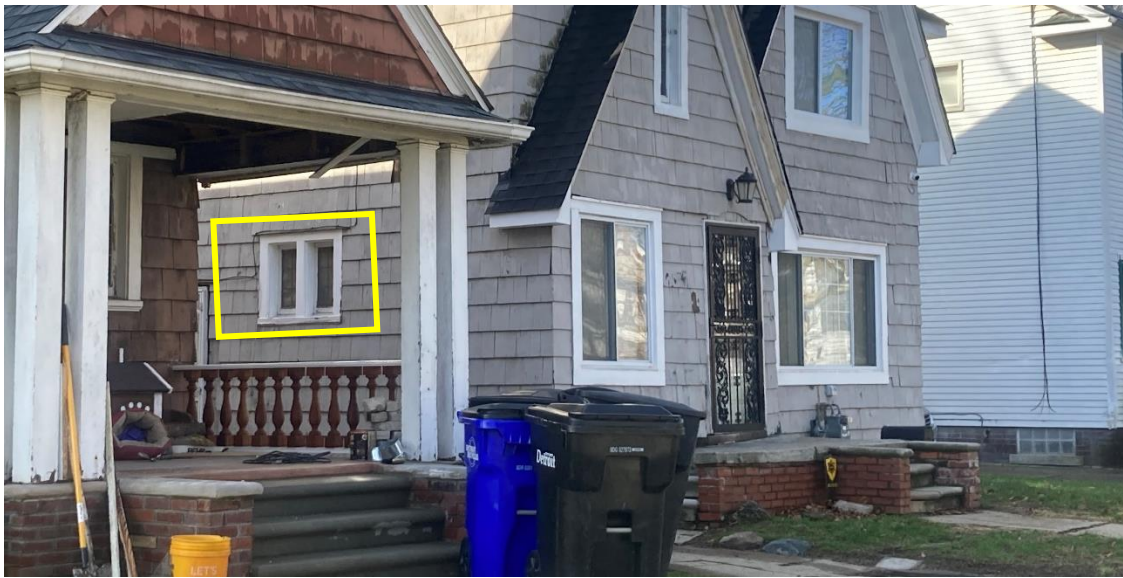
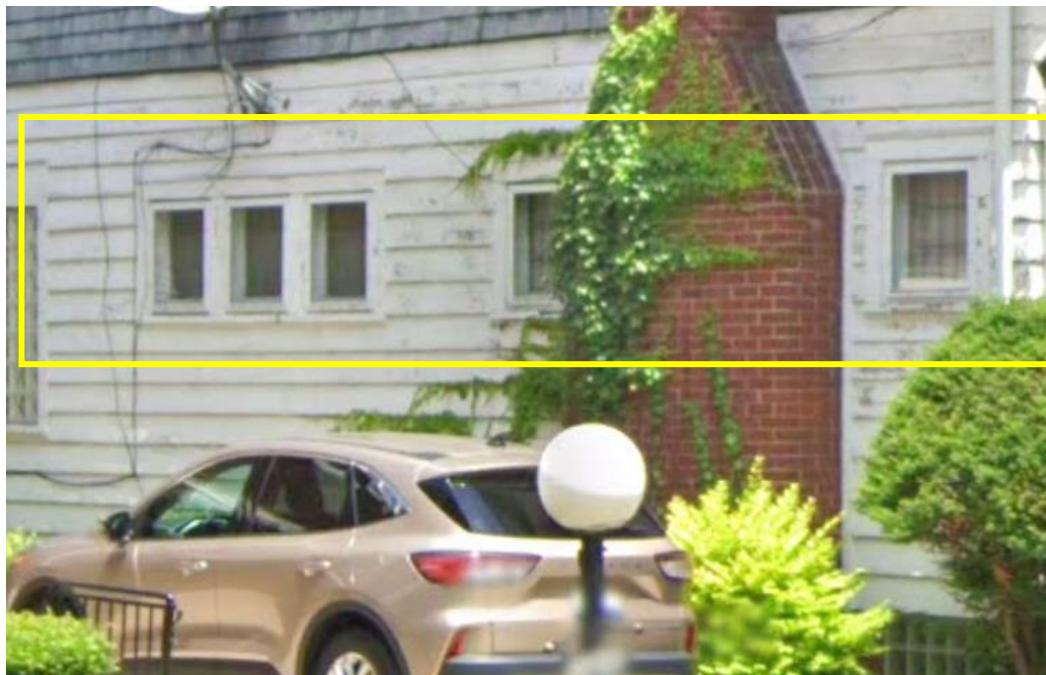
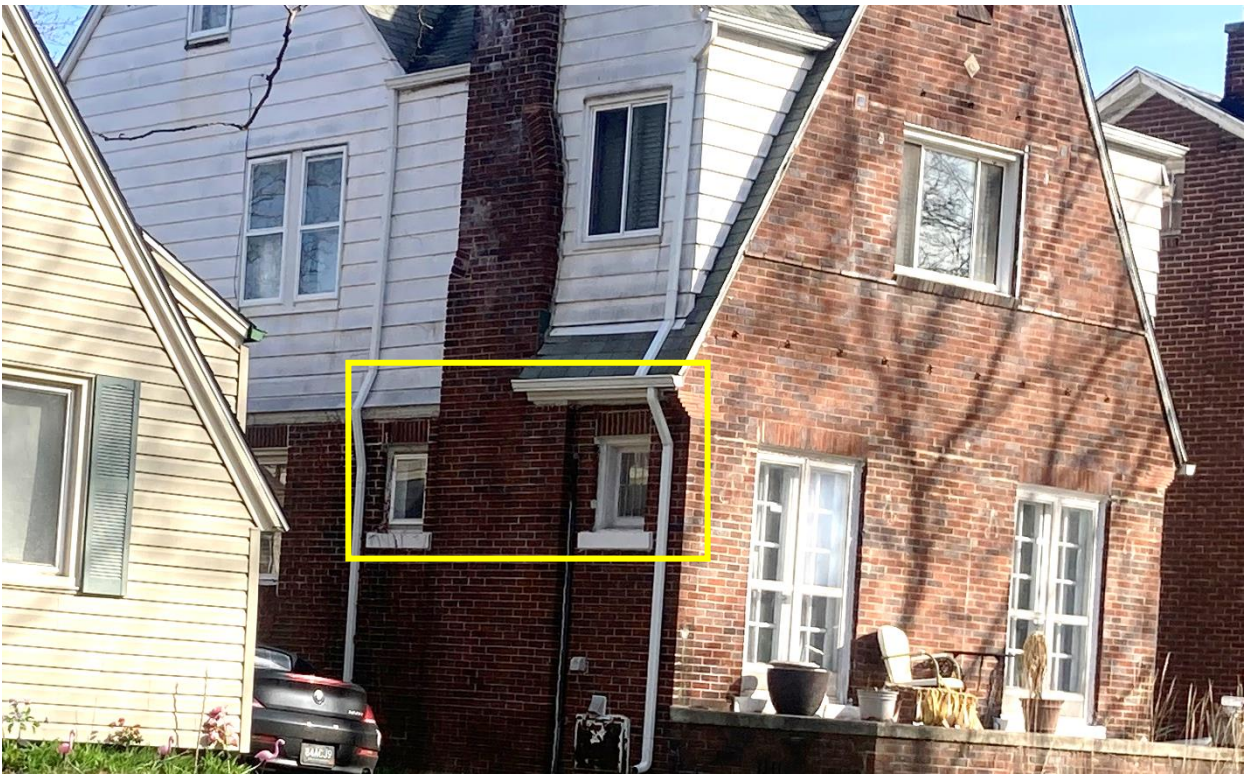
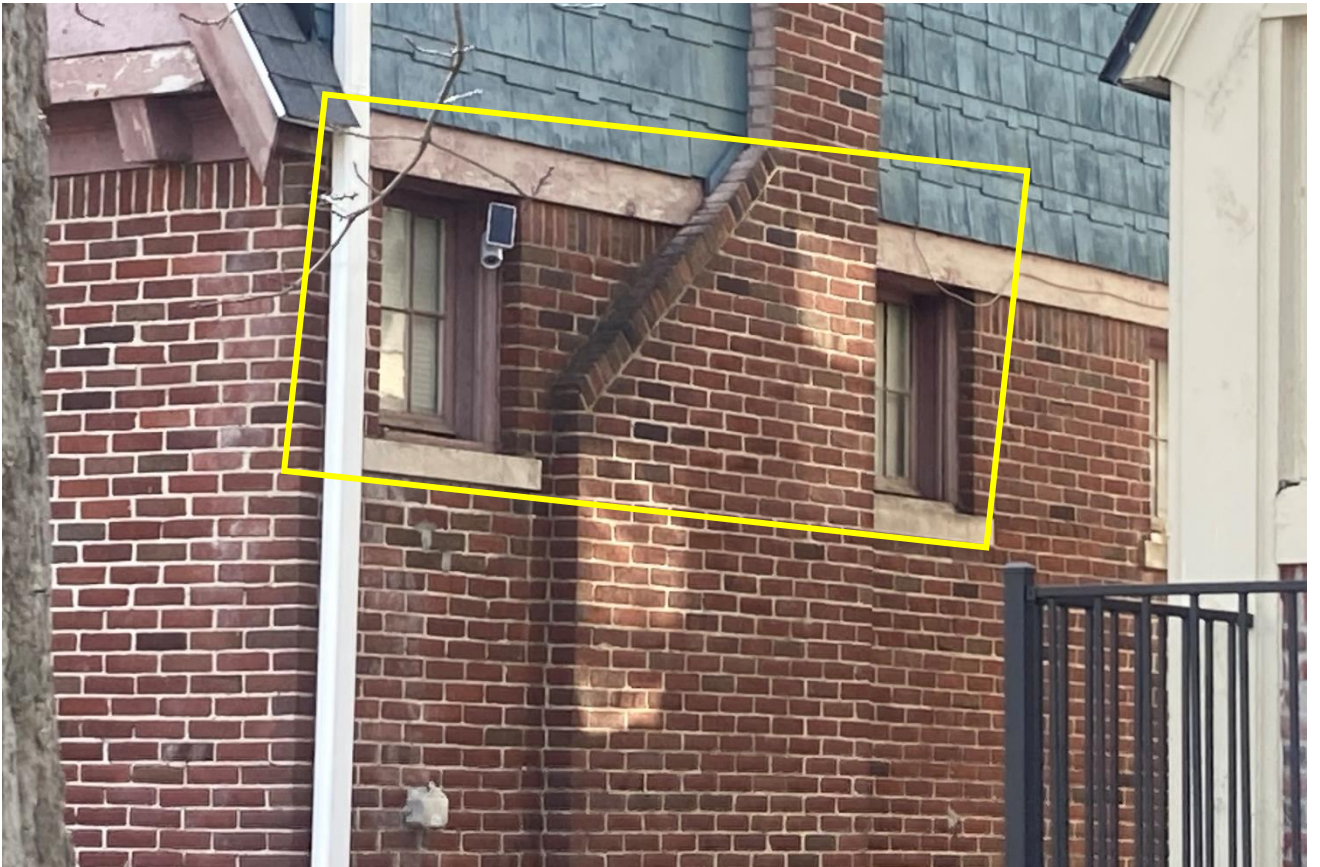
information on the appearance of the historic windows. Specifically, historic 4/4, wood windows were discernable at the front façade in the 1999 designation slide. Also, a set of paired 4/4, double-hung wood windows were visible at the rear façade in the July 2024 application materials. The original operation and lite configuration of any other windows is unknown. However, staff concludes the proposal to match the operation and lite configuration of the original front and rear windows is a reasonable approach for all of the windows with the exception of the two kitchen windows at the east side's, first story (labeled as "Line 25 and "Line 30" in the above photos). As the window opening is shorter and wider than the others, the proposed new windows will present an incongruous appearance if configured as 4/4 paired double hung units. Rather, multiple-lite, casement units (with a true wood mullion) within this opening would be more appropriate to the house's historic character, in staff's opinion. See the below Google Streetview images of nearby houses/on the same block as 4340 Glendale which serve as precedents (windows outlined in yellow):
