STAFF REPORT: 04/09/2025 MEETING
APPLICATION NUMBER: HDC2025-00062
ADDRESS: 15150 WARWICK

HISTORIC DISTRICT: ROSEDALE PARK
APPLICANT / PROPERTY OWNER: ERIC DANIEL
DATE OF PROVISIONALLY COMPLETE APPLICATION: 03/16/2025
DATE OF STAFF SITE VISIT: 03/29/2025

SCOPE: REPLACE WOOD WINDOWS WITH VINYL WINDOWS

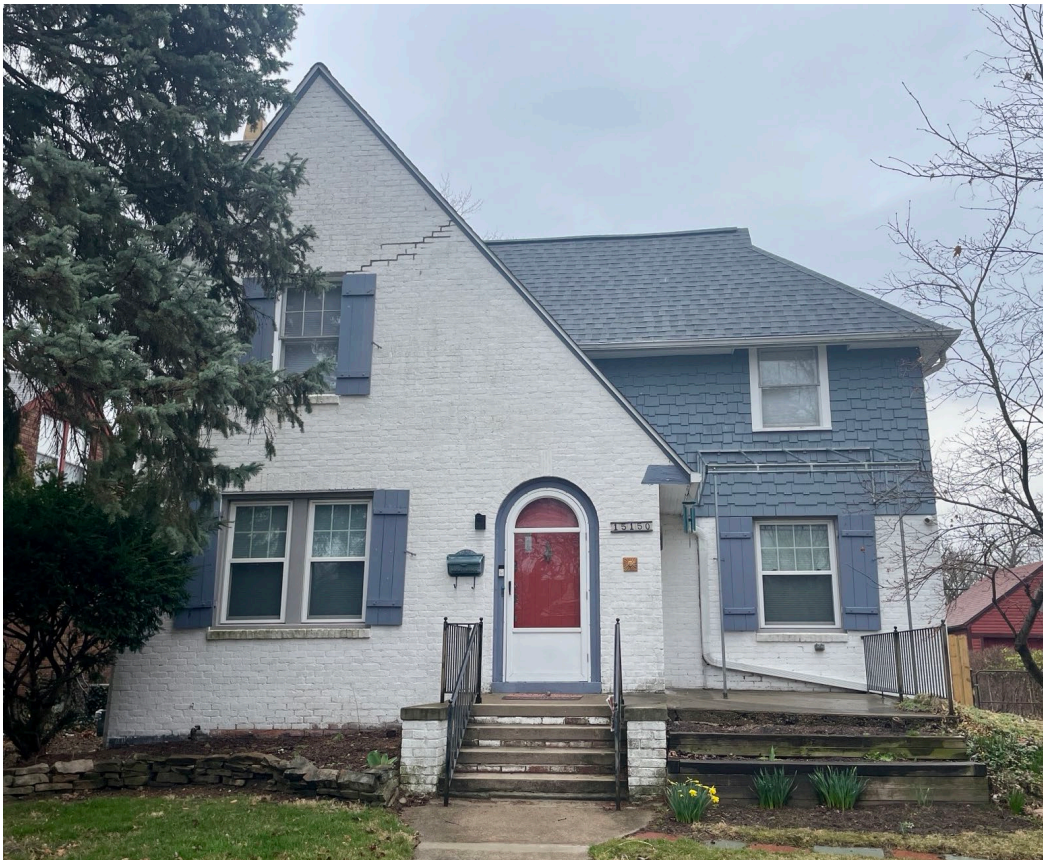
Staff photo, 03/29/2025

The dwelling at 15150 Warwick was built in 1924, showcasing the Tudor Revival style. The dwelling has a hipped roof that intersects with a front-facing gable, framing a rounded-top front door. The lower half and gable side of the structure are finished with painted brick, while the upper floor of the main section is adorned with wood shake cladding. Most of the first-floor windows, with the exception of set of casement windows on the south elevation, are vinyl replacements. On the second floor, double-hung wood windows with a mix of six-over-one, three-over-one, and one-over-one.

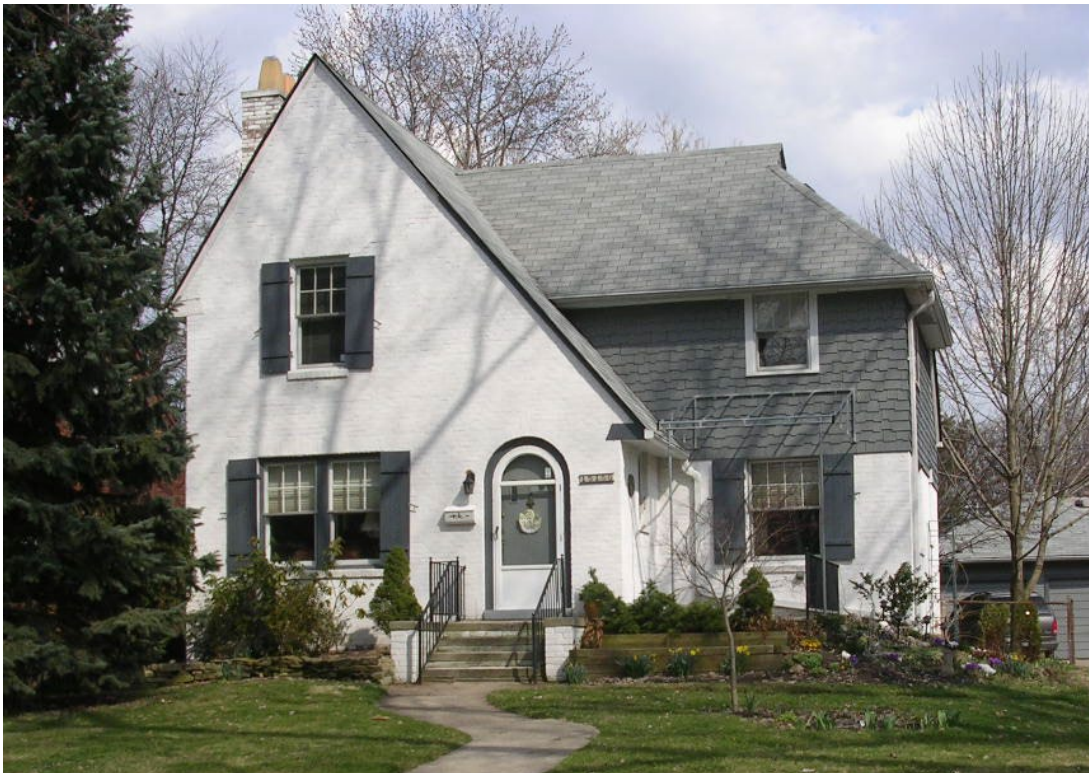
Designation photo, 2007

- The first floor windows, with exception of one pair of casements, have been replaced by the previous owners (not the current owner / applicant) without approval from the Commission in 2016.
