STAFF REPORT: 05/14/2025 MEETING

ADDRESS: 1624 EDISON

APPLICATION NO: HDC2025-0200

SCOPE: REHABILITATE DWELLING AND GARAGE (WORK COMPLETED WITHOUT APPROVAL)

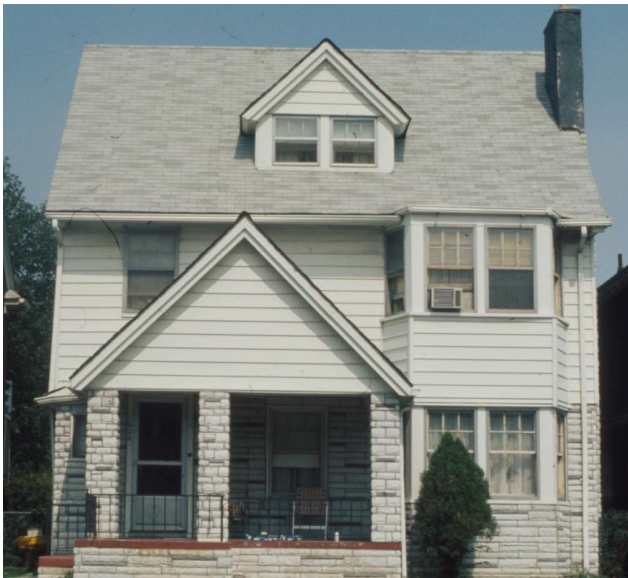
- The Boston-Edison Historic District was designated in 1973
- Please see the appearance of the house at the time of the district’s designation to note that exterior walls were clad with non-historic aluminum siding and Permastone/synthetic stone. The chimney, porch deck and columns were also clad with non-historic Permastone. However, note that the original 6/1 wood windows and wood brickmould remained, and the roof’s original wood fascia/soffits were present despite the presence of the non-historic siding.

Designation slide, taken in 1974. Source, Detroit HDAB

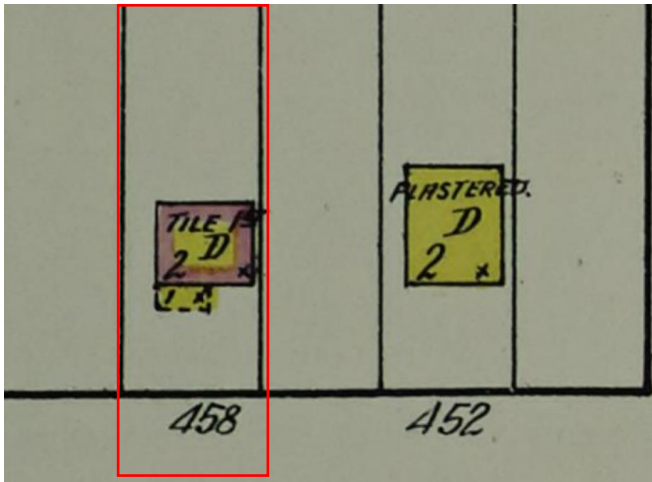
- See the below Sanborn Map from 1915, indicating that the house was constructed of structural clay tile at the first story. Such tile was typically finished or clad with stucco or brick:

Sanborn Fire Insurance map, 1915. 1624 Edison (outlined in red) was addressed as 458 Edison in 1915 per the above.

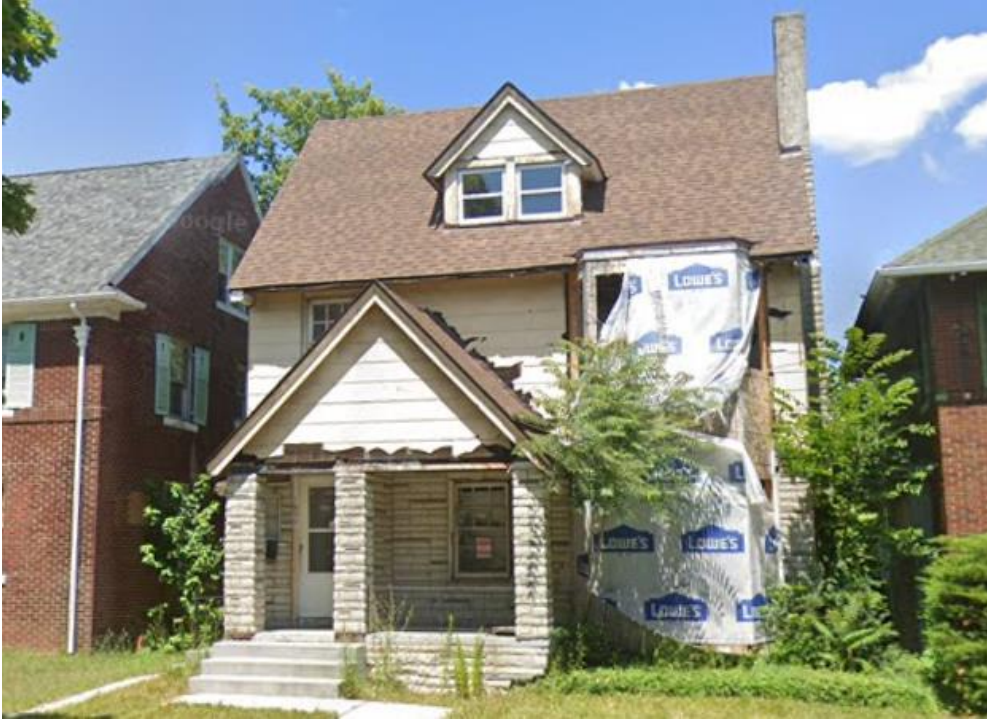
- Google Streetview images indicate that the following conditions existed in 2022/the following work had been undertaken without HDC approval (see below photo):
 - The aluminum siding had been removed, revealing the synthetic shingle siding underneath.
 - New front porch steps had been installed
 - Original windows at the front dormer had been replaced with vinyl
 - Original windows and siding at the front two-story bay have been completely removed

Conditions in 2020, per Google Streetview

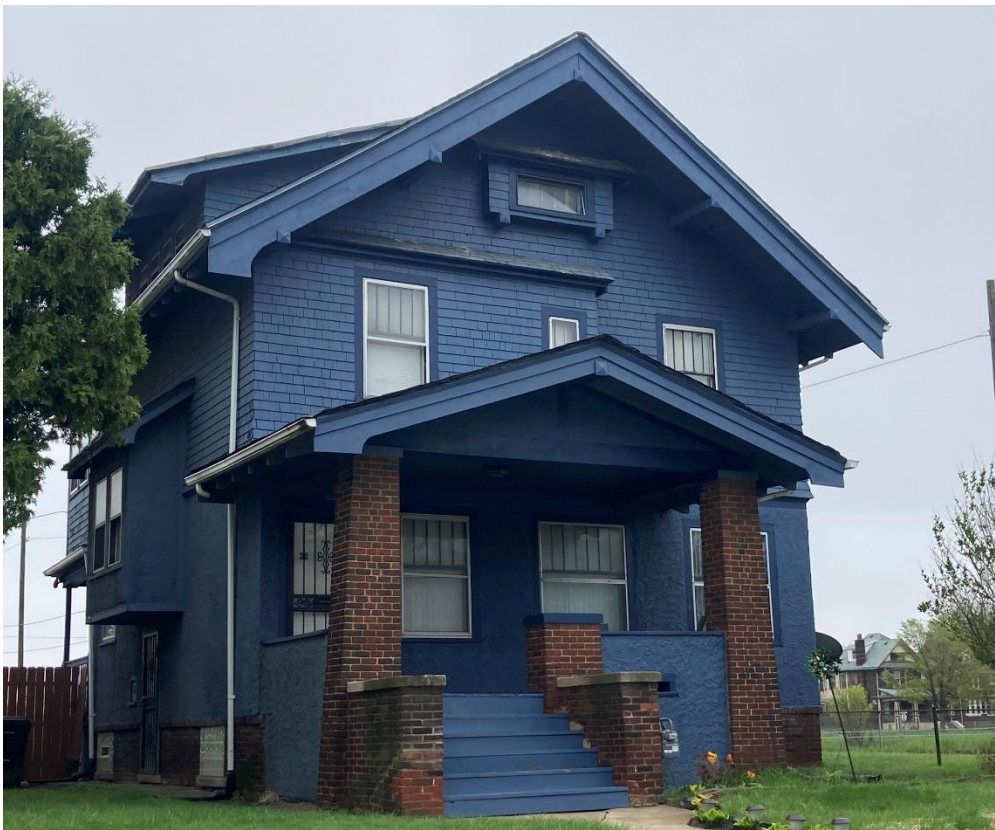
Stucco at the first story, wood shake at the second. Staff photo taken on 5/5/2025. 900 block of Edison Street

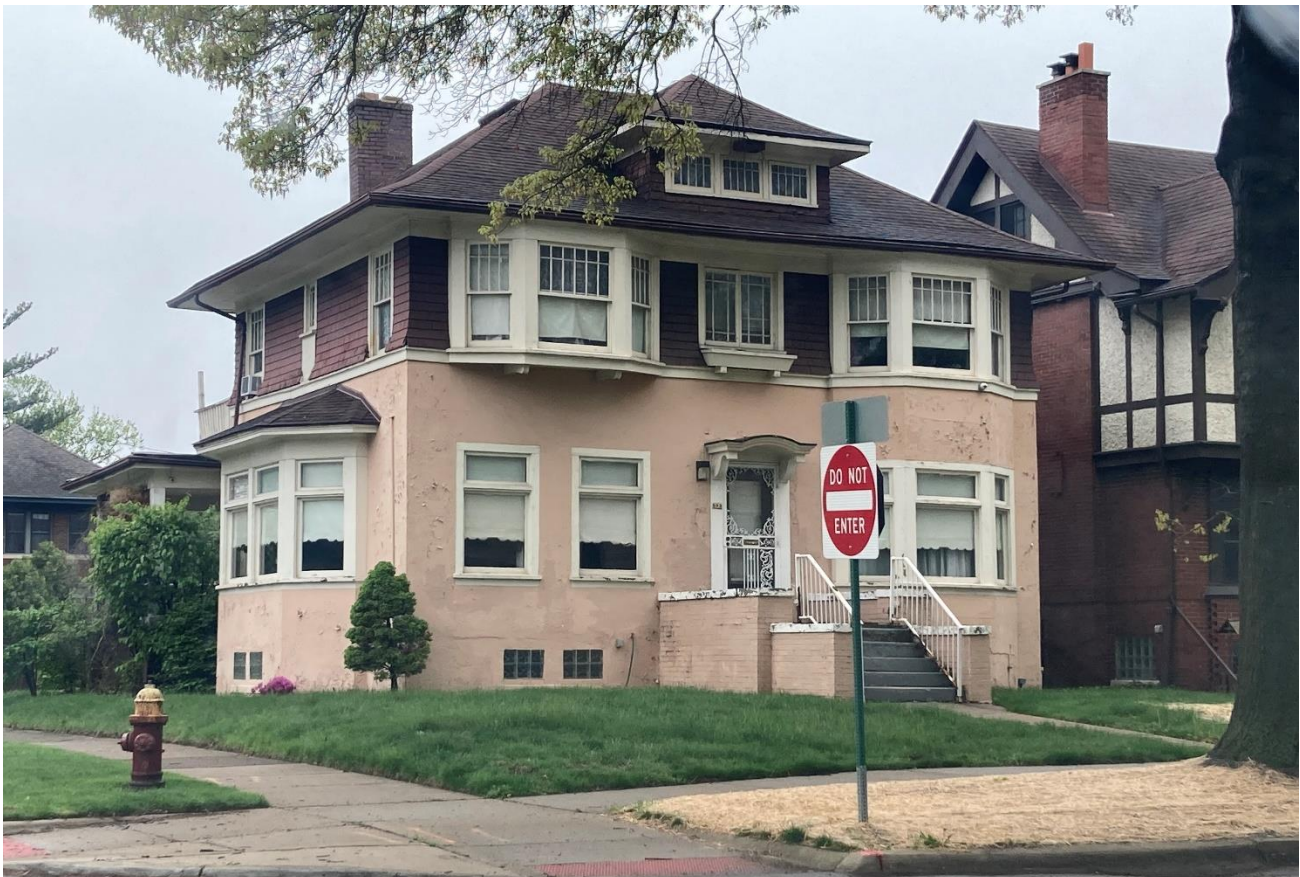
Stucco at the first story, wood shake at the second Staff photo taken on 5/5/2025. 803 Longfellow Street

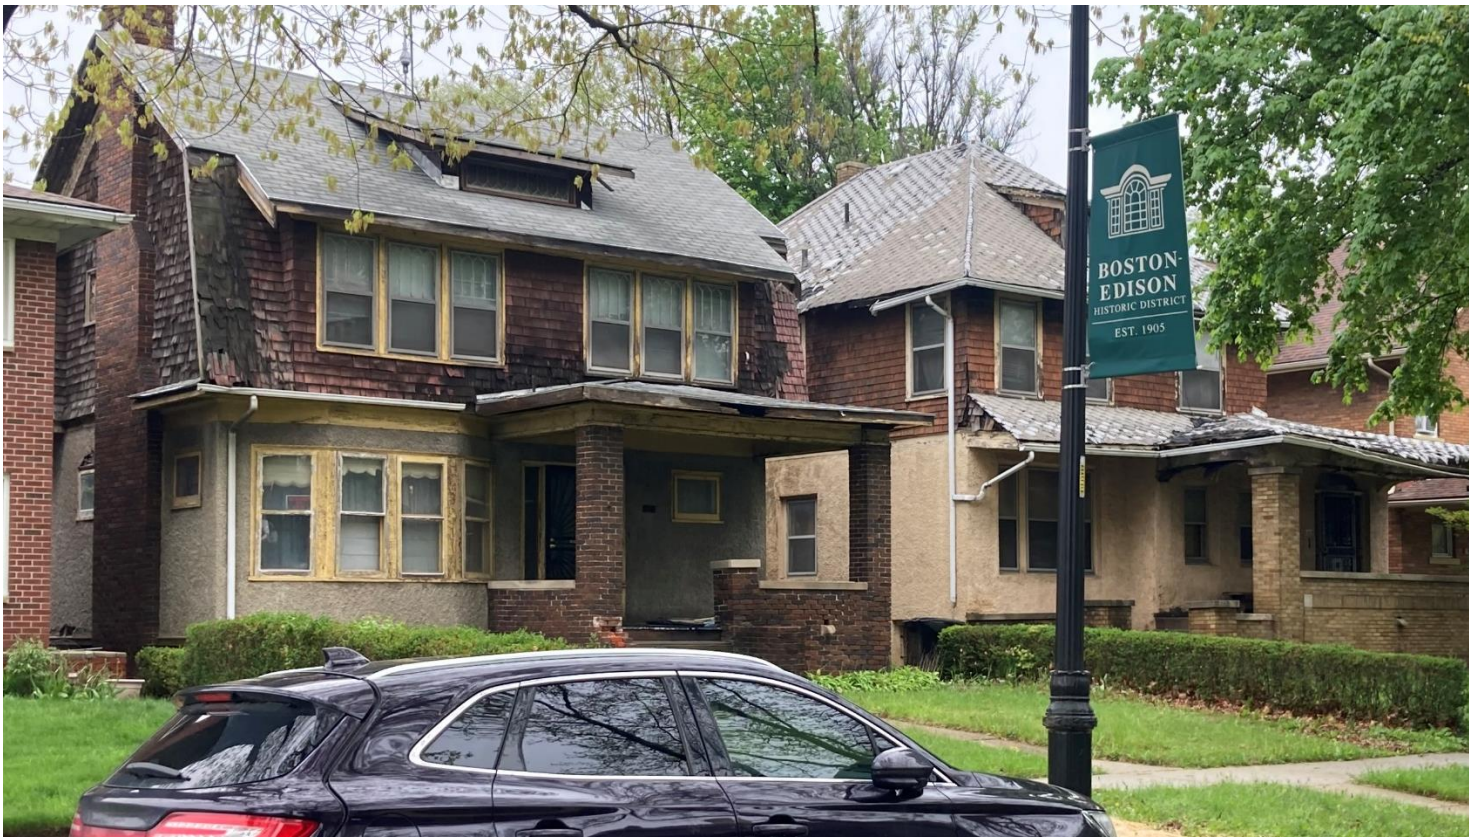
Stucco at the first story, wood shake at the second, both houses. Staff photo taken on 5/5/2025. 900 block of Longfellow Street

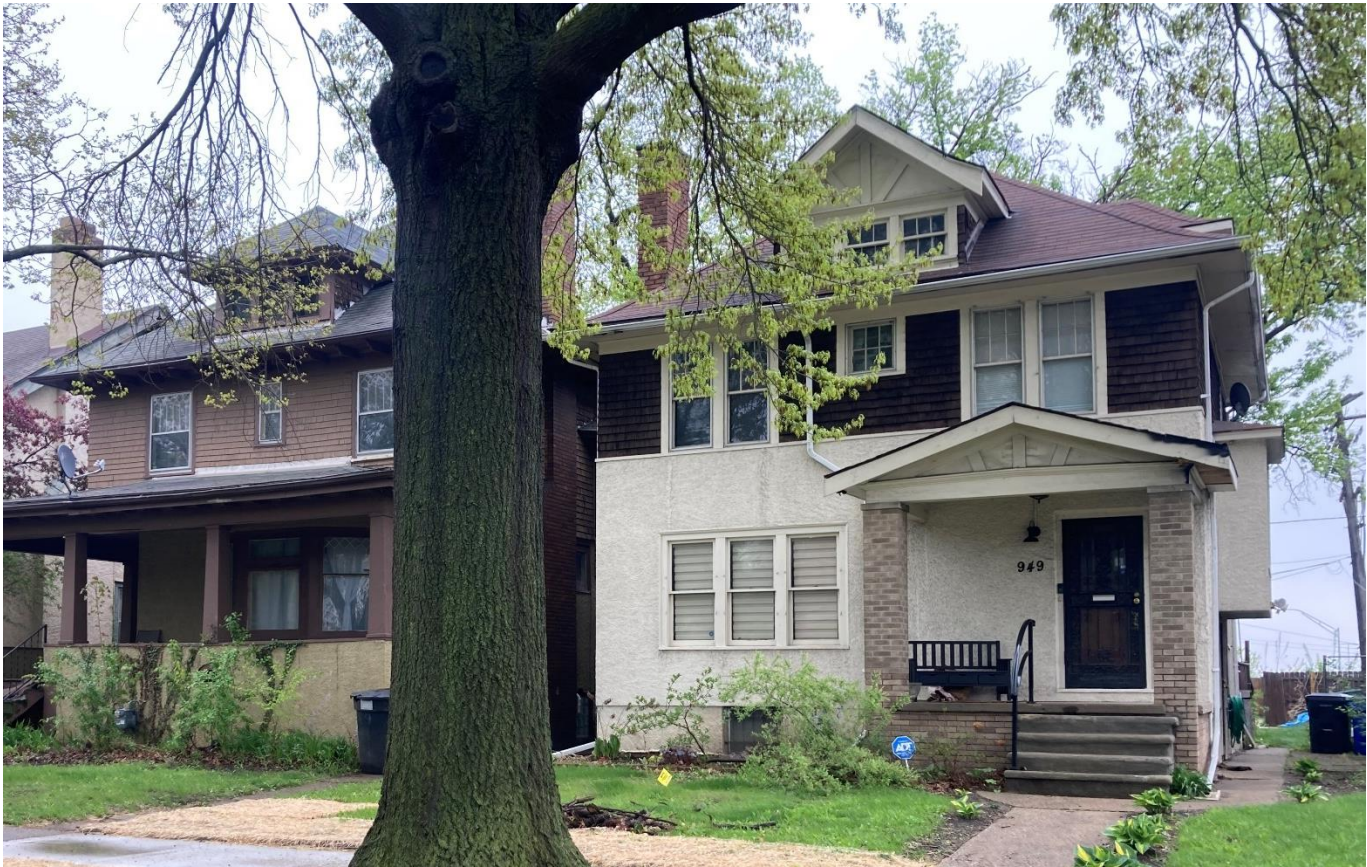
Stucco at the first story, wood shake at the second , both houses. Staff photo taken on 5/5/2025. 900 block of Longfellow Street

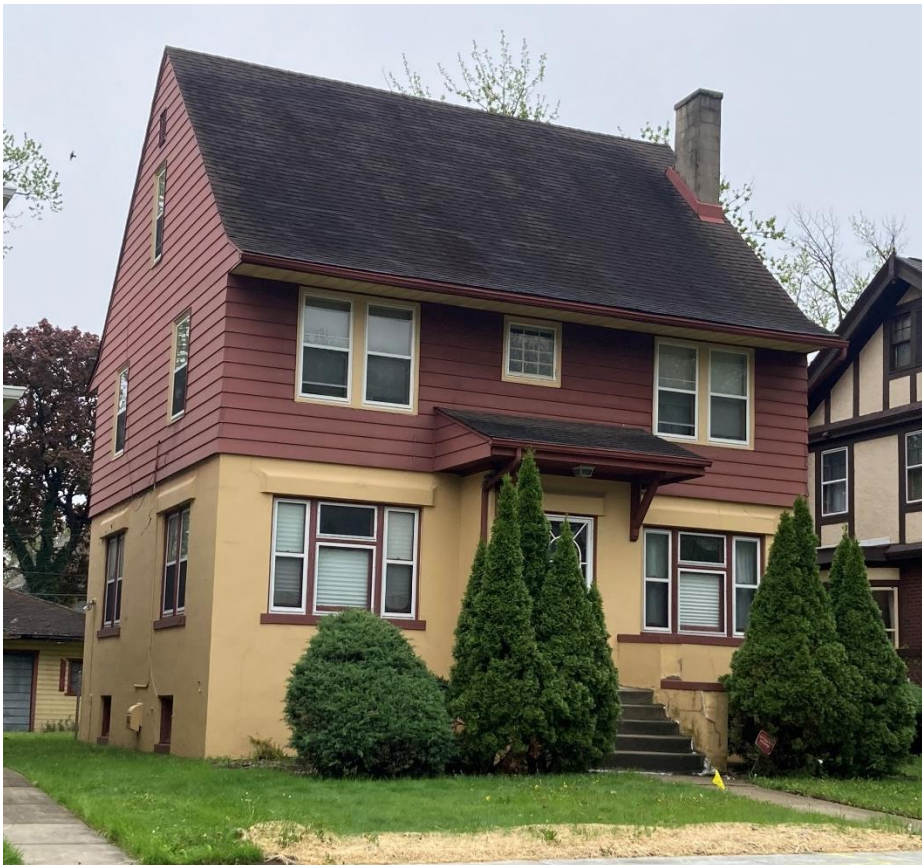
Stucco at the first story, lapped wood siding at the second. Staff photo taken on 5/5/2025. 821 Edison

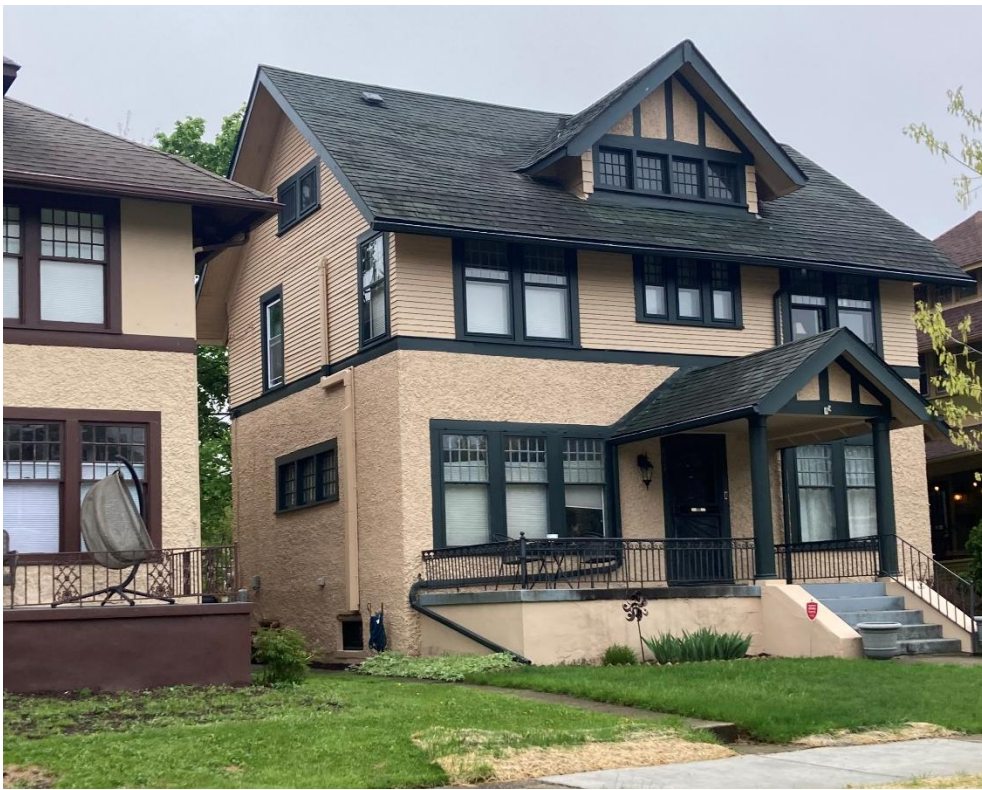
Stucco at the first story, lapped wood at the second. . Staff photo taken on 5/5/2025 800 block of Edison Street
