**STAFF REPORT: MAY 14, 2025 MEETING**

**APPLICATION NUMBER: HDC2025-00114**

**ADDRESS: 2233 PARK AVENUE (AKA IODENT BUILDING)**

**SCOPE: REPLACE WOOD WINDOWS**

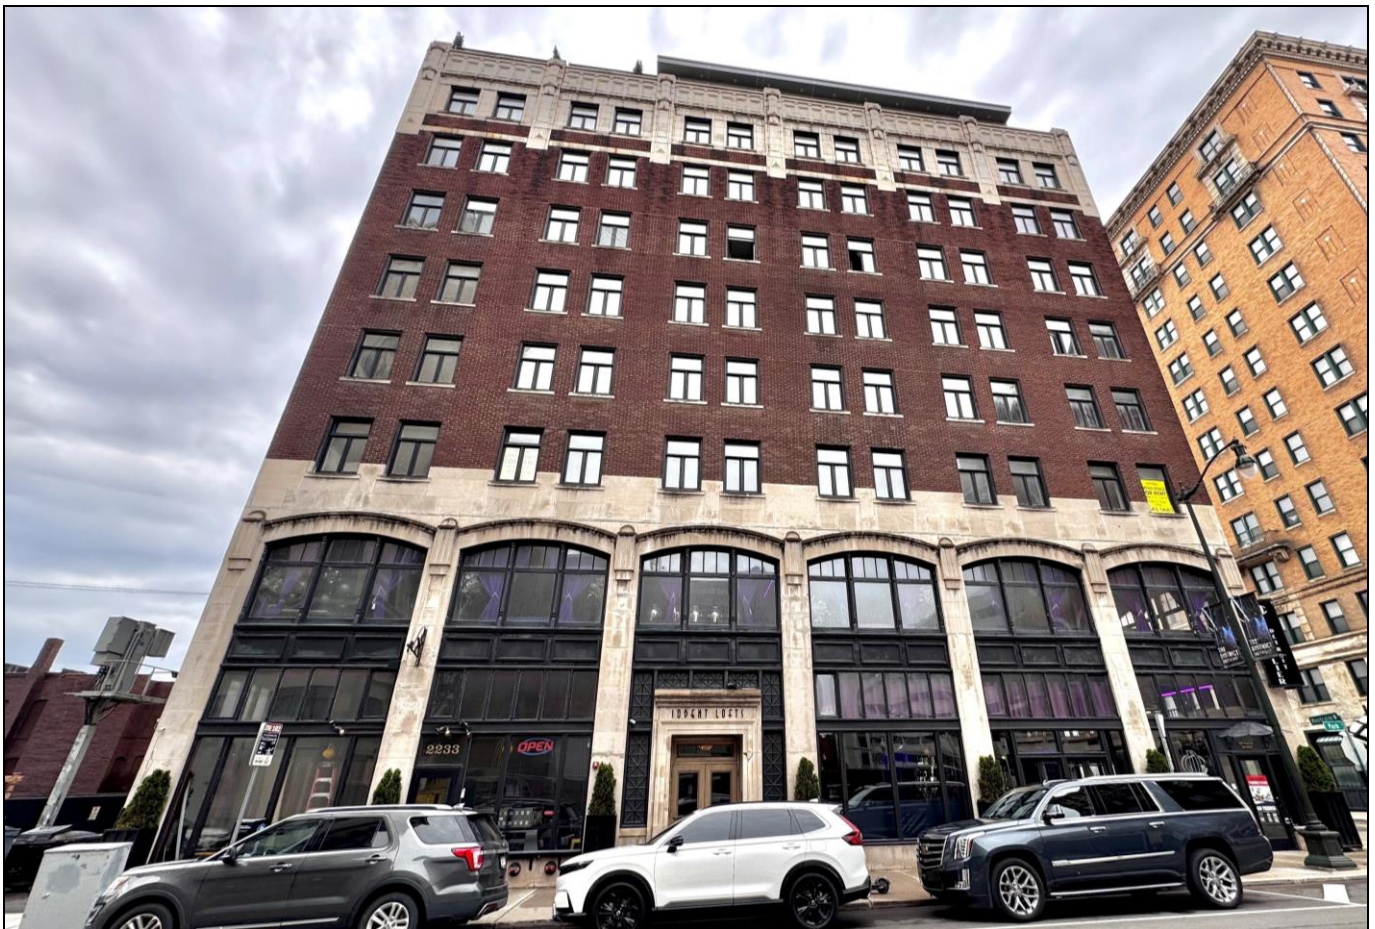
*Facade of building, facing Park Avenue. Staff photo, May 2, 2025.*

The five-bay wide design of the façade is accentuated at every floor, but most dramatically through the vertical limestone columns spanning the first two floors, and the vertical limestone detailing that extends downward from the 9<sup>th</sup> and 8<sup>th</sup> floors.

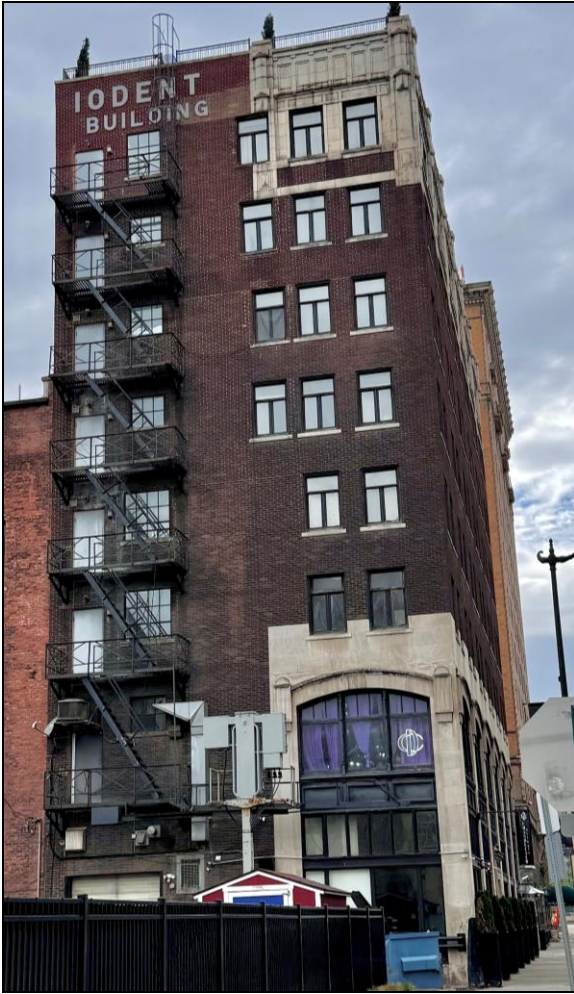
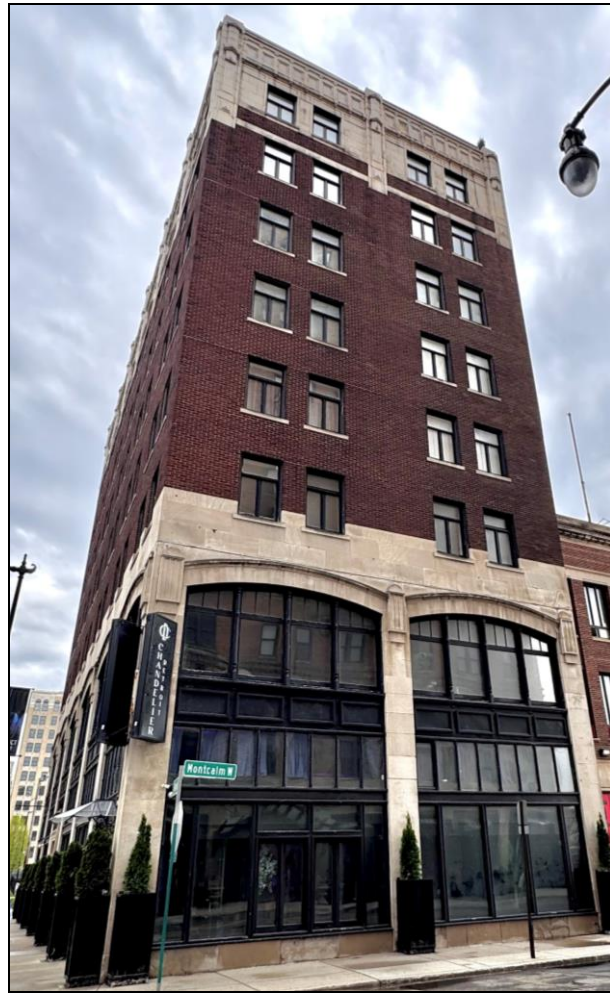
The limestone wraps the north and south side walls; however, different percentages of the side walls were architecturally articulated, based on their street-facing location. The north wall faces Montcalm, while the south wall is adjacent an alley.

*Left: South wall.*

*Right: North wall.*

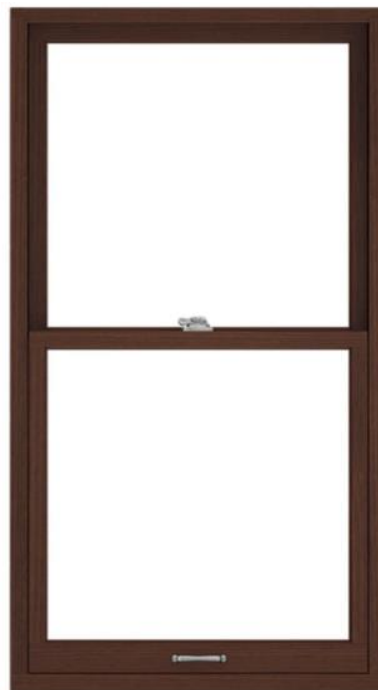
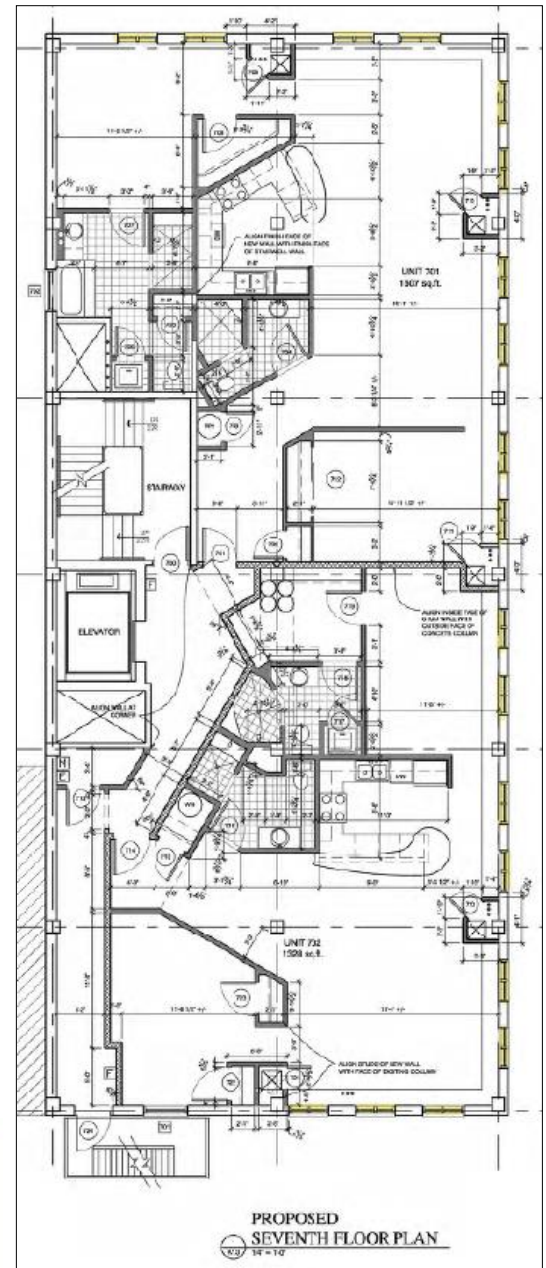
Above: and far left: Applicant materials. The yellow on the floor plan indicates windows to be replaced.

Left: Photo from Pella's website of a Pella Reserve Traditional window. It is offered with a wood or aluminum-clad, wood frame. This double-hung unit is the visual provided by Pella on their website as well as by the applicant. However, this is not the window specified within the application.

Far left: As shown within the applicant's project description, the cottage-style window is a single-hung window, so only the lower sash is operable.

- While the review of replacing the existing windows is premature, staff can offer comments on the selected replacement window. The application proposes to install “cottage-style” windows from the third through eighth floors on three sides of the building. The installation of this new window type would obliterate the distinctive, character-defining feature of the existing windows and would alter the features that characterize this building.
- Additionally, the proposal is to remove or cover all remaining details, including the profiled wood brick mould. The brick mould is one of the most visible components of a window opening due to its proximity to the masonry wall. Aluminum trim cannot be bent in such a way as to match the highly profiled wood brick mould. The flatter surface and sheen of aluminum is not compatible with a building erected in the early 20<sup>th</sup> century.

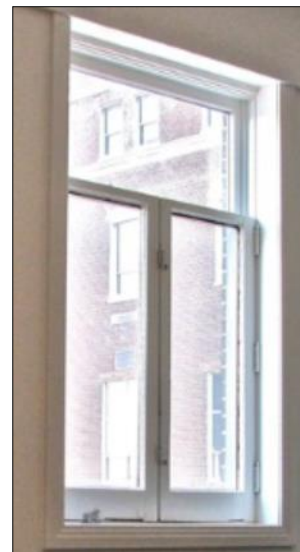
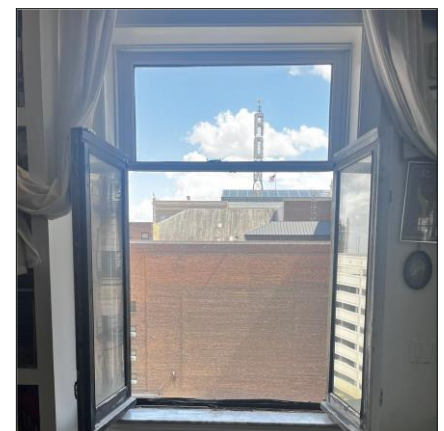
The windows at 2233 Park are unique in design and operation and are a distinctive character-defining feature of the building. With the windows closed and viewed from a distance, it appears that each opening is comprised of a double casement window with an undivided transom above.

The interior photos demonstrate the design and function of the lower window sash. The operable window is called a “French window”. They are like standard casement windows and are attached by a hinge to the window frame on one side, but they differ from casements in that they don’t have a central post or mullion. This allows for one large opening, eliminating structural elements from obstructing the view from the window.

Left: Historic photo.  
Above and right:  
Applicant photos.
