**STAFF REPORT: JUNE 11, 2025 MEETING**

**APPLICATION NUMBER: HDC2025-00203**

**ADDRESS: 4069 STURTEVANT**

**SCOPE: REPLACE ASPHALT ROOF WITH METAL ROOF, INSTALL GUTTERS/DOWNSPOUTS, REPLACE REAR PORCH ENCLOSURE, (WORK COMPLETED WITHOUT APPROVAL), INSTALL RAILING AT FRONT PORCH**

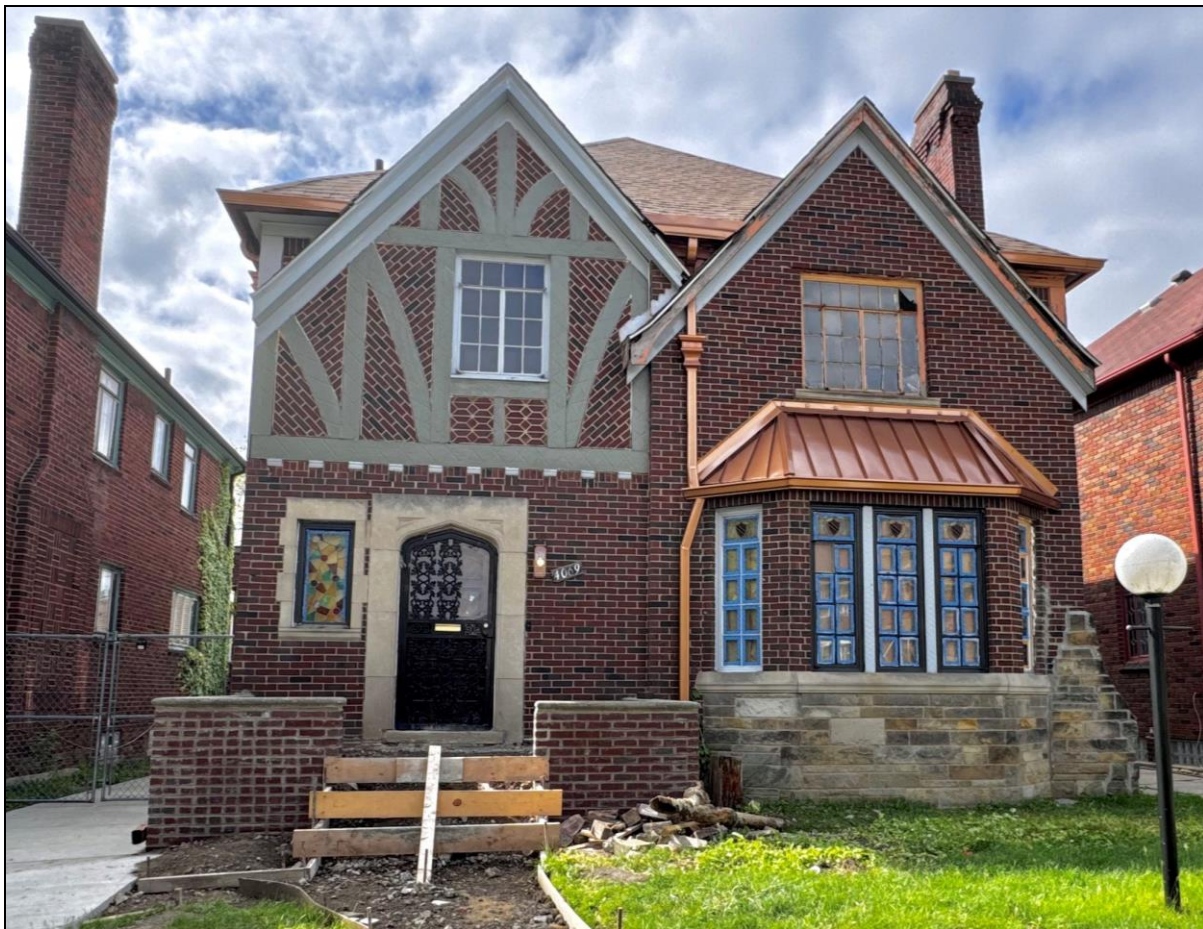
The raised front porch, whose concrete platform/floor is enclosed with a low masonry wall, is currently being rebuilt. New concrete steps and front walk are also in the process of being completed.

*Façade. HDC staff photo, May 2025.*

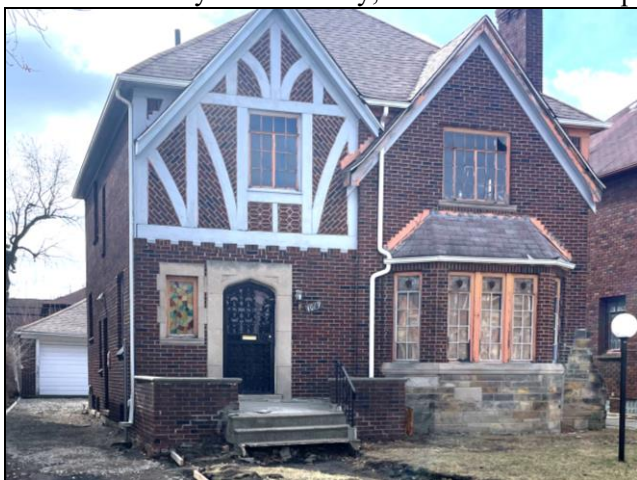
- March 22, 2025 – SeeClickFix notice submitted to HDC staff, reporting work being completed at 4069 Sturtevant.
- March 25, 2025 - Staff site visit, photos taken document the beginning of exterior painting, removal of concrete driveway and walkway, and removal of one porch railing.

*HDC staff photo, March 25, 2025.*

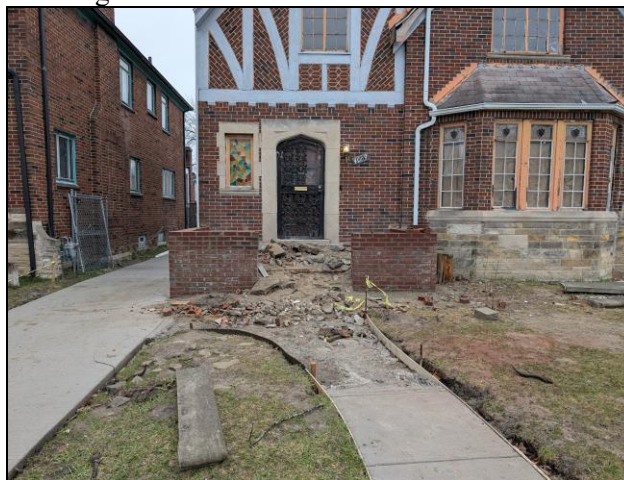
*HDC staff photo, April 10, 2025.*

- April 8, 2025 SeeClickFix notice submitted to HDC staff, reporting removal and rebuilding of front porch.
- April 10, 2025 HDC staff site visit, documenting new driveway, partially completed walkway and partially erected new masonry porch.

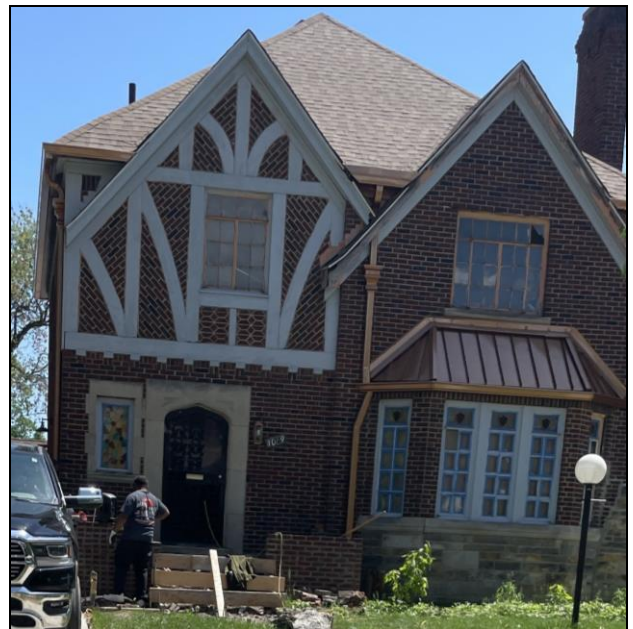
*HDC staff photo, May 16, 2025*

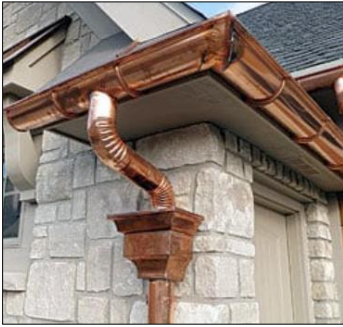
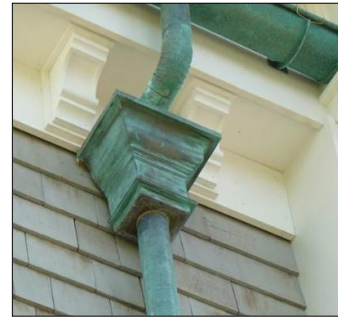
- Staff appreciates the selection of finely ridged downspouts, and detailed and appropriately-scaled collector boxes. The challenge with the installed components is the “coppertone” color. When real copper components are installed, they are brilliant in color and have an exceptionally shiny finish, similar to the products used at this property. However, the bright shiny finish is temporary (for a few years); the long-term finish is achieved through oxidization – when copper forms a coating that turns dark gray and eventually develops the distinguishing and highly identifiable patina of a deep rich green color. Painted/coated metal (i.e., aluminum/steel) components conversely will never change color and will retain the bright and shiny “copper” color. This unchanging contrast of color and finish is not compatible for this English Revival dwelling, where the overall color palette is generally muted and with matte finishes.

*Left: Copper components newly installed*

*Right: Copper components once oxidized with the patina.*

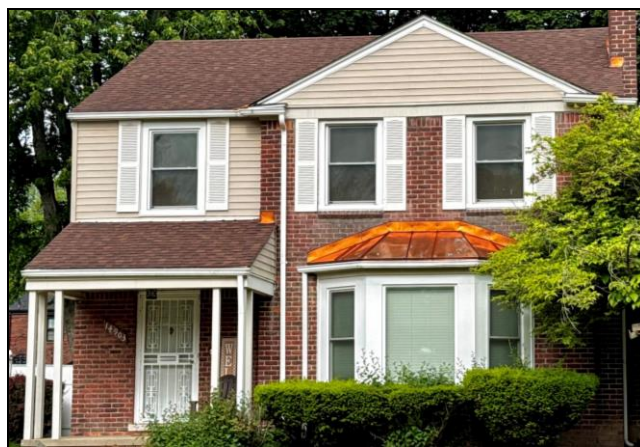
*Copper roof, patina not yet developed*

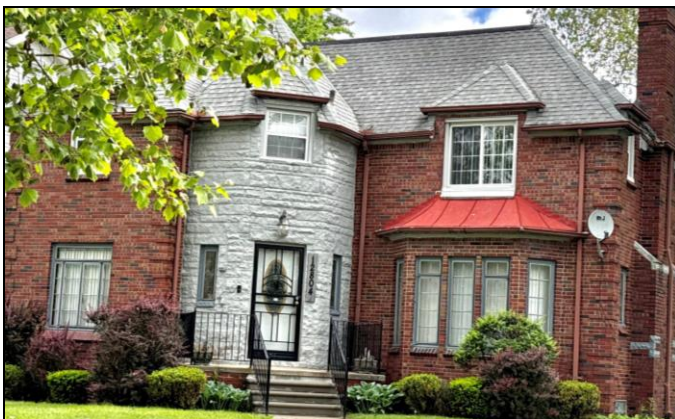
*Historic-age painted metal roof*

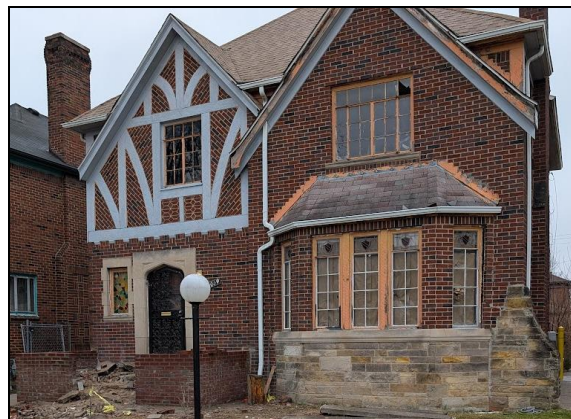
- Staff has a similar concern with the finish of the metal roof installed at the bay window and has additional concerns with the specific metal used due to the highly dimensional surfaces. The material, color and dimensionality causes this roof to be the dominant feature on the front of the house, rather than being one of collection of decorative features. Staff offers a visual comparison of the installed metal roof, an installed copper roof (located on a property in Rosedale Park), a historic metal roof (located on a property in Russell Woods) as well as the asphalt shingle roof that was previously in place at this bay window.

*Asphalt shingle roof (previous condition), 4069 Sturtevant*

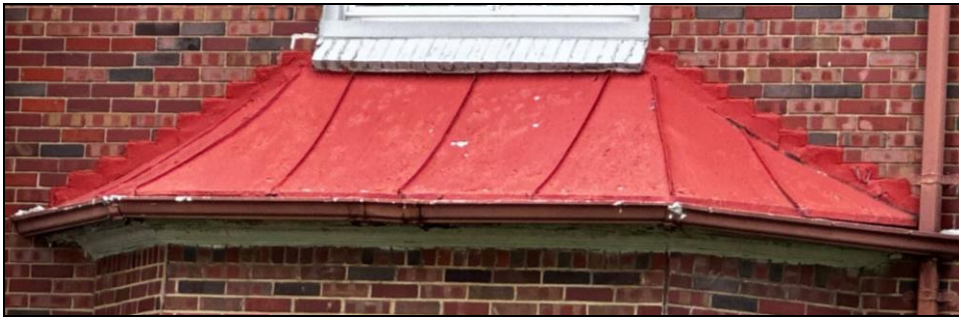
*Close-up comparison of the two example metal roofs show similar, minimally visible joints, and relatively flat flashing against the masonry walls. The copper should oxidate to create a similar matte finish as the painted metal roof.*

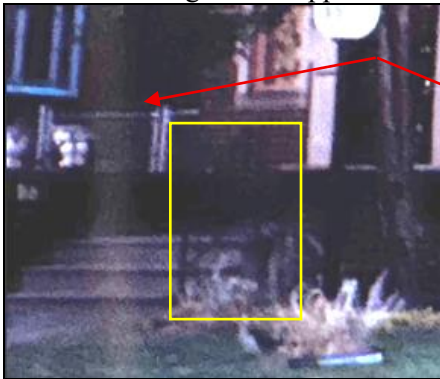
- Regarding the proposed front porch railing, it appears a black metal railing was in place at time of designation (as was the chain-link driveway gate). The main issue staff has with the proposed railing is the stated 45" height. A 36" railing would be appropriate and proportional for the stairs. The applicant should confirm in writing that no railing will be applied to the low masonry walls.

*Designation photo*

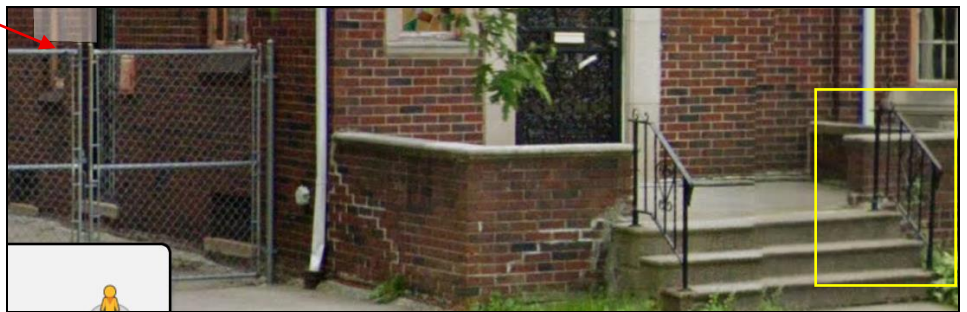
*Google street view, 2019.*

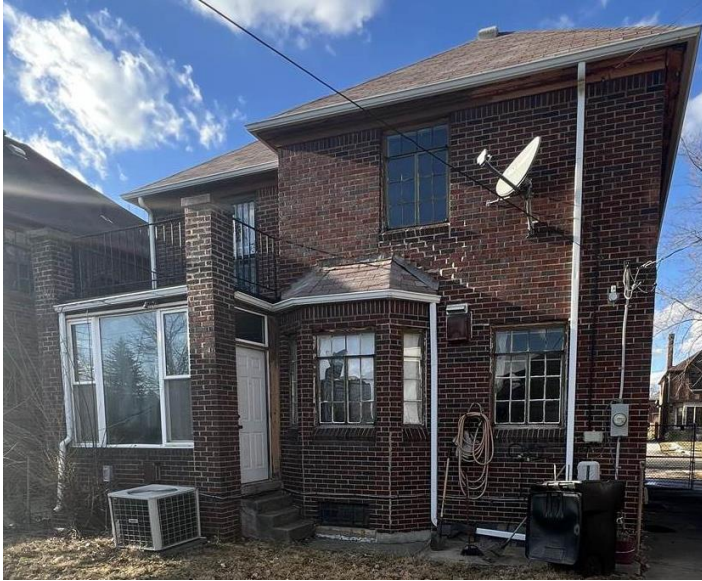
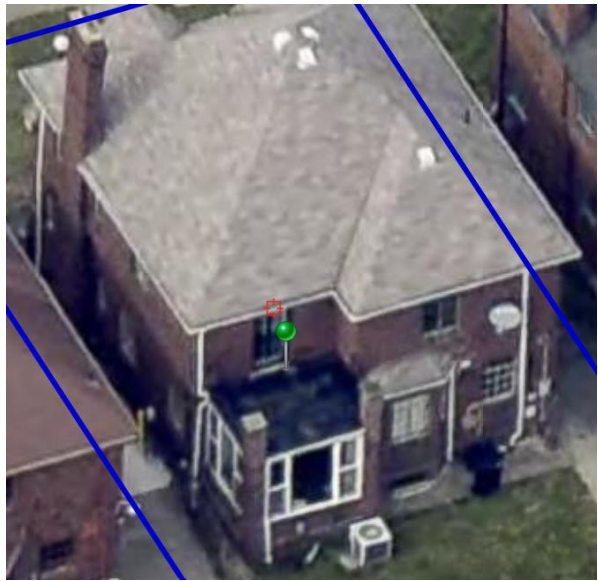
- Staff couldn't locate a Sanborn map to confirm the porch's original condition, but as the corner masonry columns extend the height of the two-story porch, and the sill height at the first floor is about one-third of the distance between the floor and ceiling, it is staff's opinion it was likely erected as an open, or screened, porch.
- The applicant provided a photo documenting the previous condition; fixed and operable vinyl windows extended the entire width and height of the masonry opening. This window design was in place in 2006 (the earliest photo staff could find of the rear of the house), so it is possible this porch enclosure was in place at the time of the district's 1999 designation.

*Applicant photo, undated.*

*Eagle View aerial image, April 2024.*

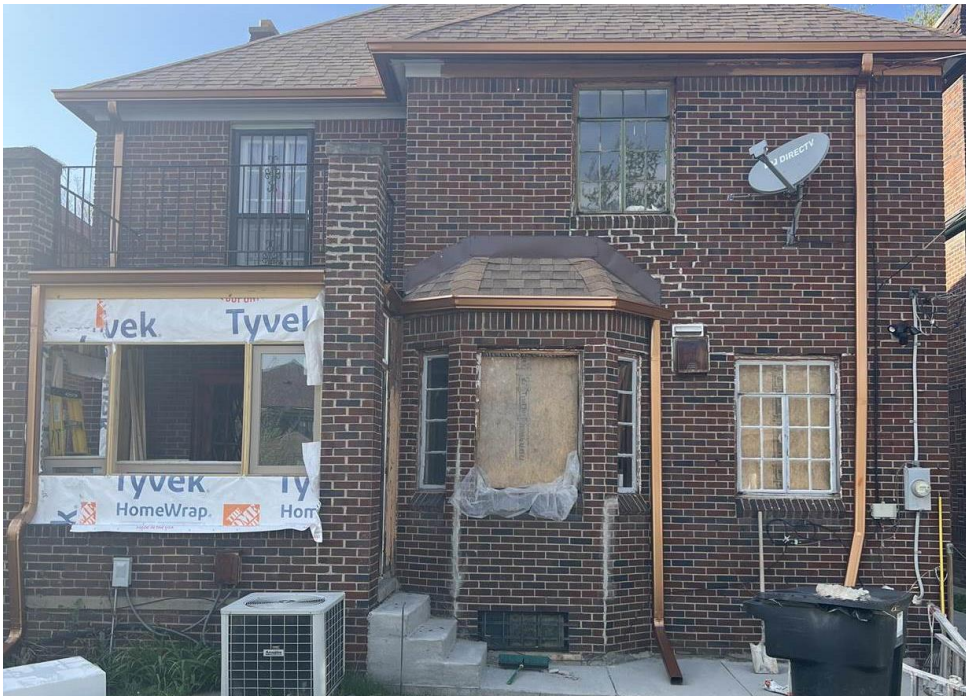
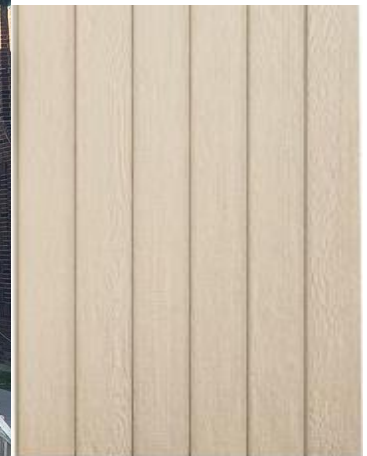
*Applicant photo submitted April 29, 2025.*

- The current design of the first floor rear porch, as partially constructed, encloses the porch further through the installation of shorter windows and erection of small sections of walls below and above the windows. The three-unit grouping of fixed and operation windows is similar to the previous condition: a wide, central fixed window is flanked by narrow operable windows; however, the operational windows changed from double-hung to casement.

- It is staff's opinion that the previous enclosure using windows that extended the full opening was a compatible solution for three-season living space and the current proposal of windows and walls is not appropriate as it alters the features, massing and proportions of the rear porch structure and does not meet the following Standards:

- The new windows are vinyl framed units and replace vinyl windows. Although the previous non-historic windows were within a non-historic opening, the rear porch structure is an original or historic-age component of the house and any changes/alterations proposed for must be appropriate and compatible with the early 20<sup>th</sup> century house. It is staff's opinion, through limits of fabrication and material, vinyl windows are not appropriate for historic districts.

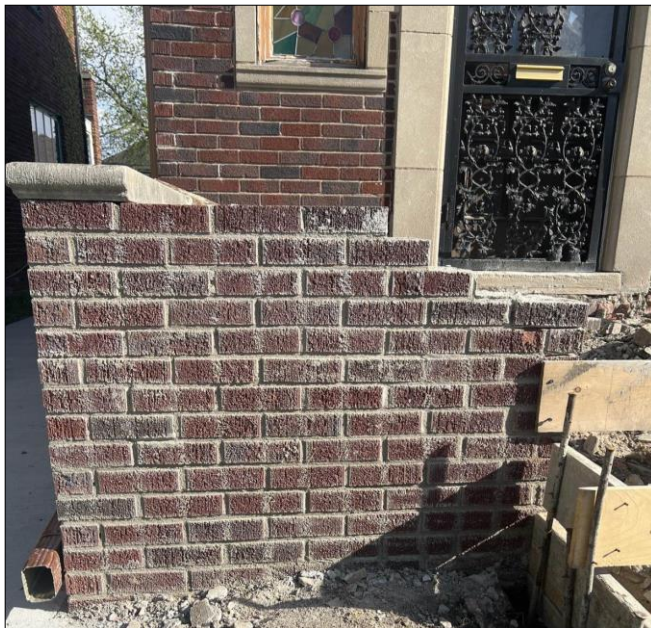
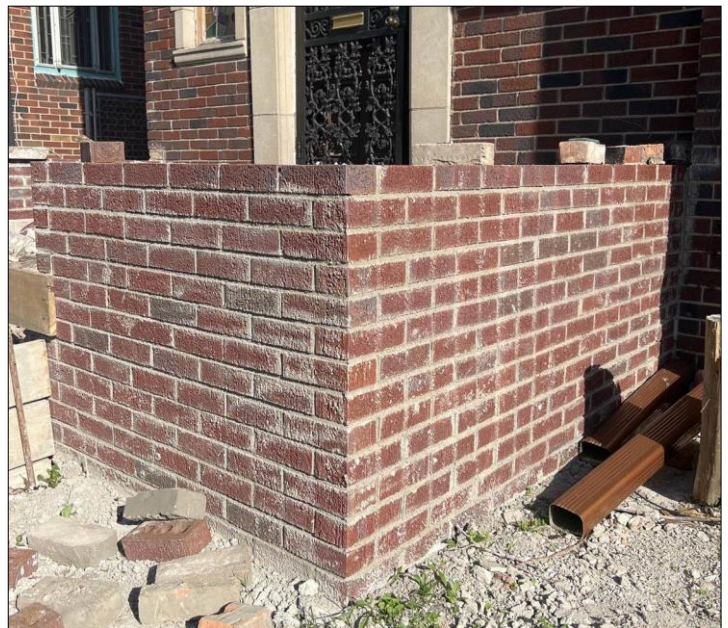
- Strangely, the photos submitted by the applicant one month earlier as part of the staff review application show different masonry walls. A running bond pattern used on both walls, and the mortar joints appear to be consistent within the new construction and closer in dimension to the thin mortar joints on the house. The existing condition shown in the May 29 photo does not meet the approved scope of work listed in the Certificate of Appropriateness.

*These applicant photos of the rebuilt masonry porch walls were submitted on April 29, 2025 as part of the application for staff review (against which the COA was issued). The bond patterns and mortar joints on both sides of the porch match.*
