**STAFF REPORT:** 06/11/2025 **REVISED**  
**APPLICATION NUMBER:** HDC2025-00192  
**VIOLATION NUMBER:** 25-1005  
**ADDRESS:** 3751 LESLIE

**HISTORIC DISTRICT:** RUSSELL WOODS-SULLIVAN  
**APPLICANT / PROPERTY OWNER:** KAYODE ADEKOYA  
**DATE OF PROVISIONALLY COMPLETE APPLICATION:** 05/05/2025  
**DATE OF STAFF SITE VISIT:** 05/27/2025

**SCOPE:** REPLACE HISTORIC WINDOWS, MULTIPLE EXTERIOR ALTERATIONS

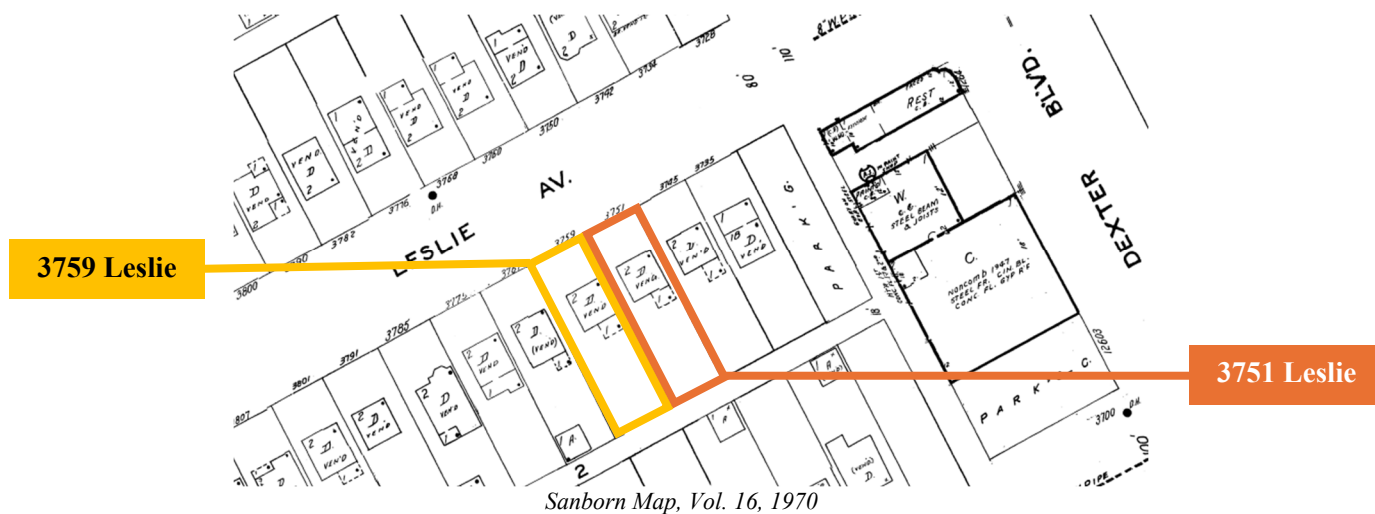
BSEED permit cards

3751 Leslie	387 Lot No.
11687	8-11-53 Date
Use dwelling	
Cons. brick veneer	
Remarks \$12200.	O.K.

3751 Leslie	OK	387 Lot No.
39795	6-7-60	Date
Use Dwelling		
Cons. Brick Veneer		
\$1,000.00		
Remarks	O.K.	
Erect 20x16' family room as per plan.

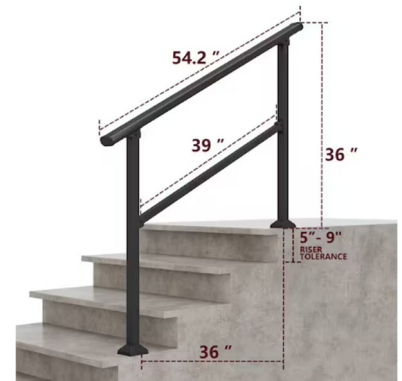
- It is staff's opinion that the proposed railing is appropriate due to its compatibility in minimal design, dimensions, and color. Additionally, the installation of the railing does not result in the replacement or removal of existing historic features.
