**STAFF REPORT:** 06/11/2025

**APPLICATION NUMBER:** HDC2025-00154

**ADDRESS:** 4282/4284 WAVERLY

**SCOPE:** REPLACE WINDOWS, ADD WINDOWS TO EXTERIOR OF EXISTING WINDOW, INSTALL WINDOWS WHERE CURRENT WINDOWS ARE MISSING

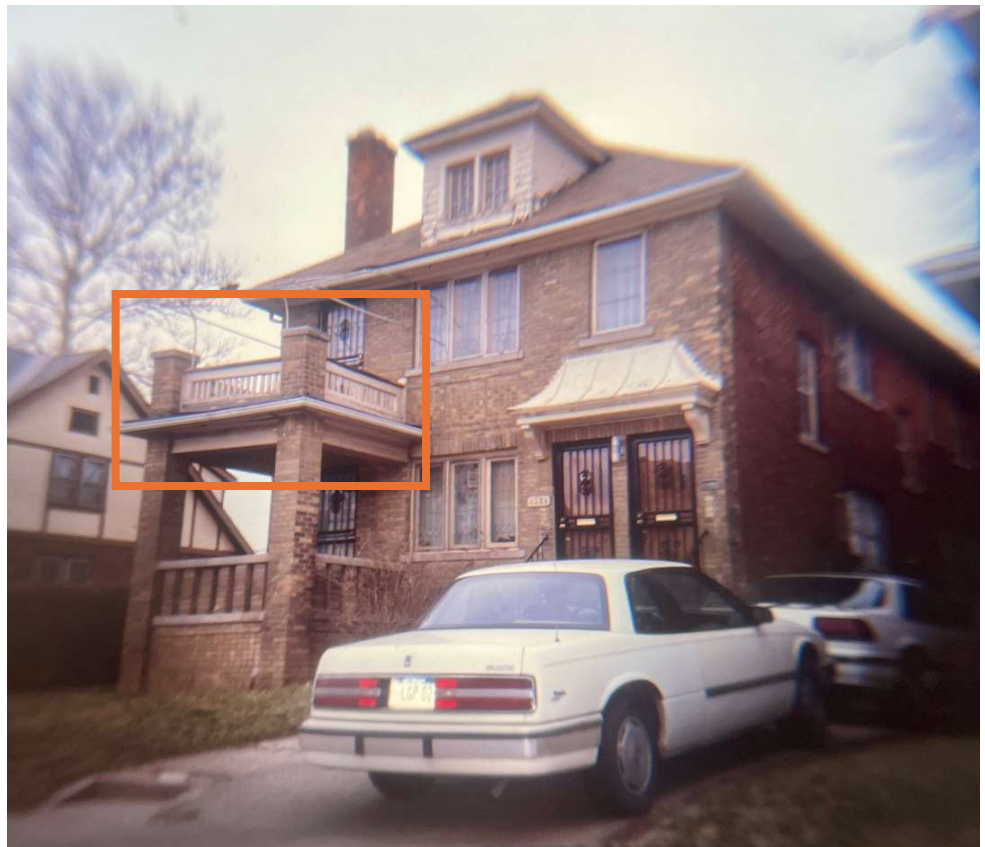
*Designation photo, 1999*

- The second level porch railing was replaced sometime between 1999 and 2009. At this time, staff doesn't have confirmation of review and approval and will follow up with property owner as necessary.

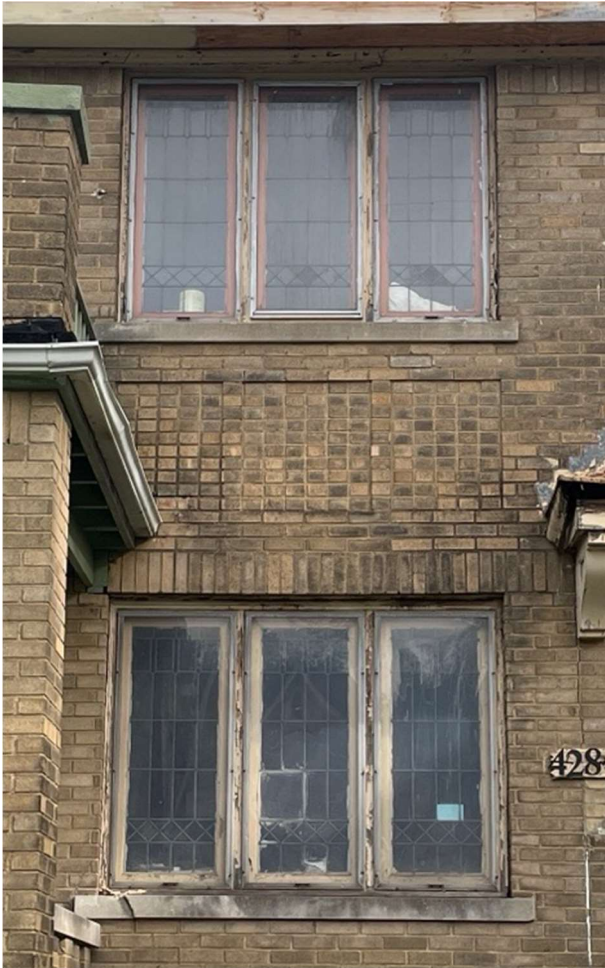
- The windows proposed to be covered are historic and unambiguously character-defining as they are leaded glass, and as described in the Elements of Design, “create considerable interest” when referencing the relationship of textures.

- The installation of the proposed composite windows does not follow [NPS guidelines for new windows](#), as the proposed windows are not “compatible with the overall historic character of the building.” Specifically, referencing the factors to consider in evaluating the match of a window:
