STAFF REPORT: 07/09/2025 MEETING
ADDRESS: 141 W. BOSTON BOULEVARD
APPLICATION NO: HDC2025-00338
VIOLATION NO: 1023

HISTORIC DISTRICT: BOSTON-EDISON
APPLICANT/OWNER: DEREK AND SANDHYA BERK
DATE OF STAFF SITE VISIT: 4/30/2025, 5/25/2025 & 6/27/2025
DATE OF PROVISIONALLY COMPLETE APPLICATION: 6/16/2025

SCOPE: REMOVE HISTORIC CLAY TILE ROOF,* INSTALL ROOF

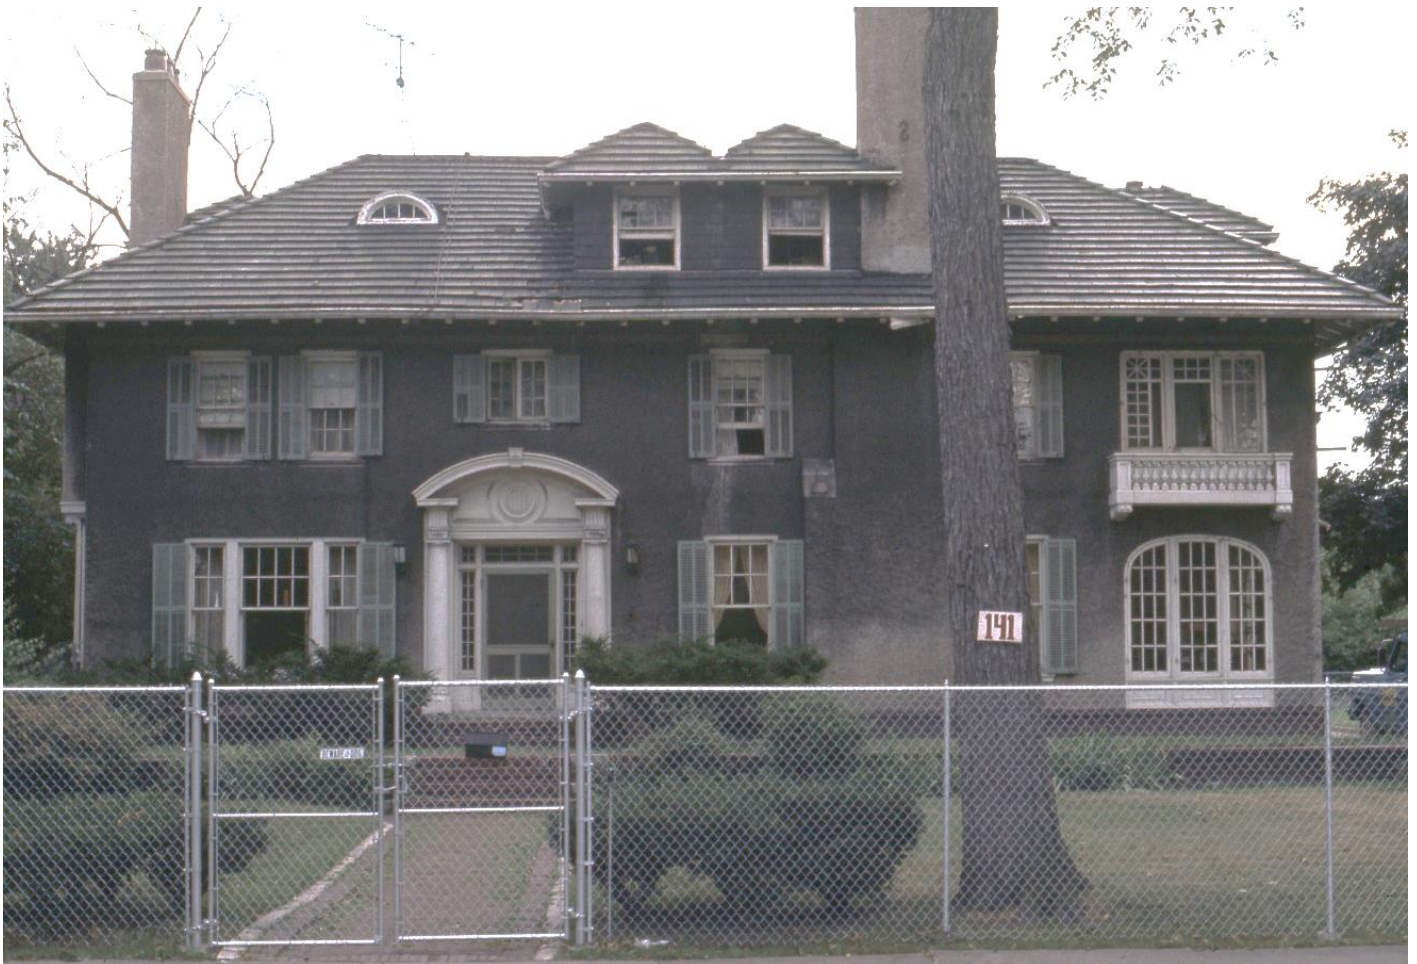
141 W. Boston. Condition at time of the district's designation/in 1974. Photo by HDAB

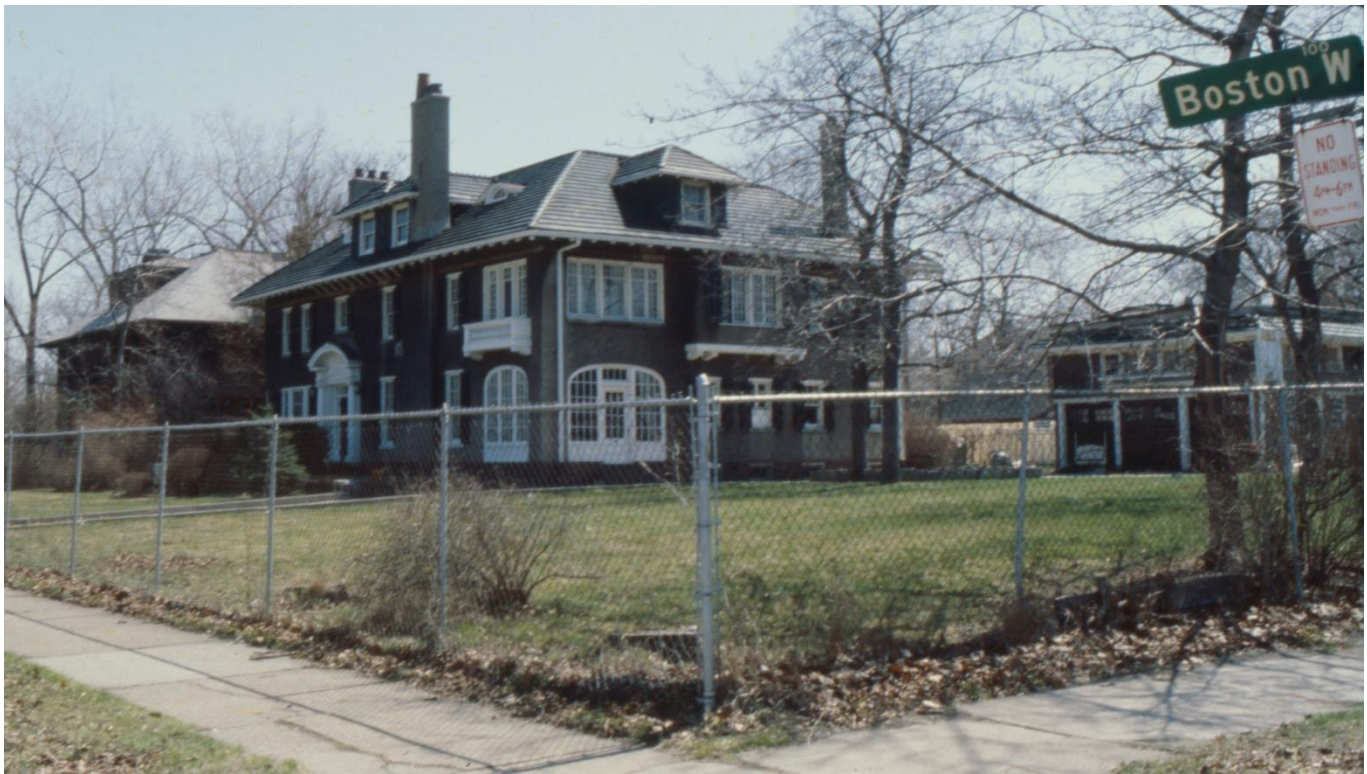
141 W. Boston. Photo taken in 1982 by HDC staff. Showing condition of the roof and the garage/carriage house to the rear
