**STAFF REPORT: JULY 9, 2025 MEETING**

**APPLICATION NUMBER: HDC2025-00**

**ADDRESS: 1676 CHICAGO BLVD**

**SCOPE: REPLACE ROOF, REPLACE SOFFITS\***

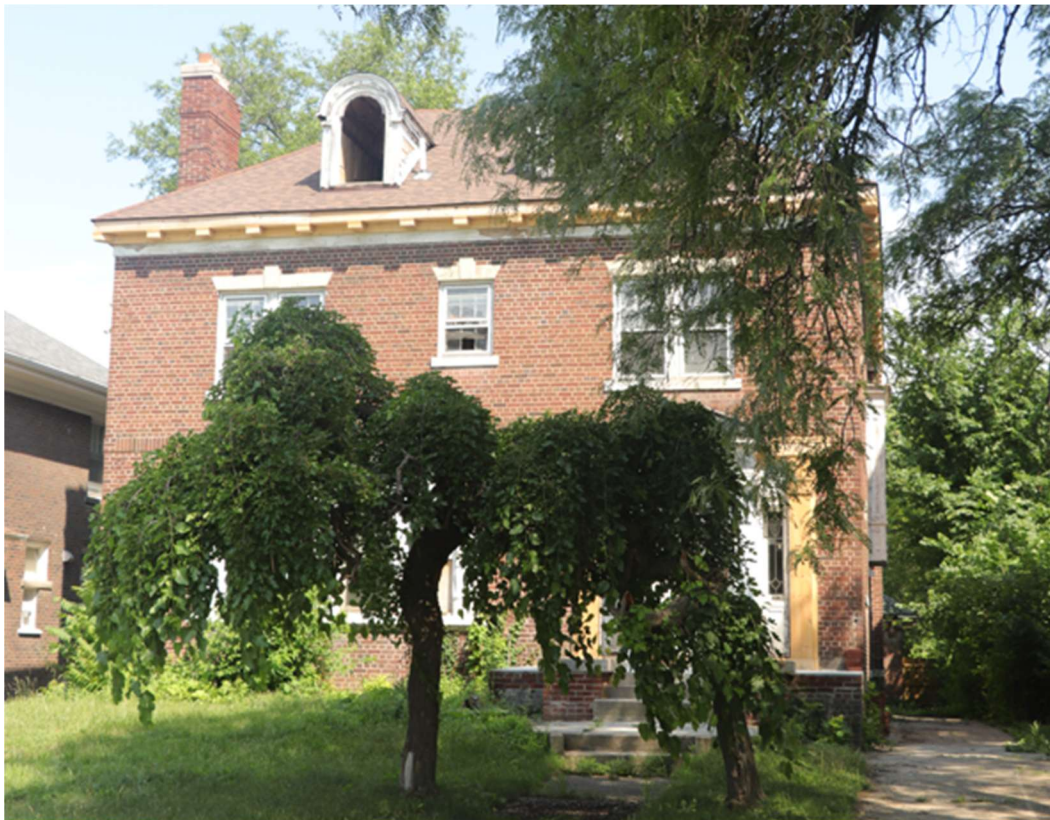
*1676 Chicago Street View. Photo taken by staff 06/26/2025*

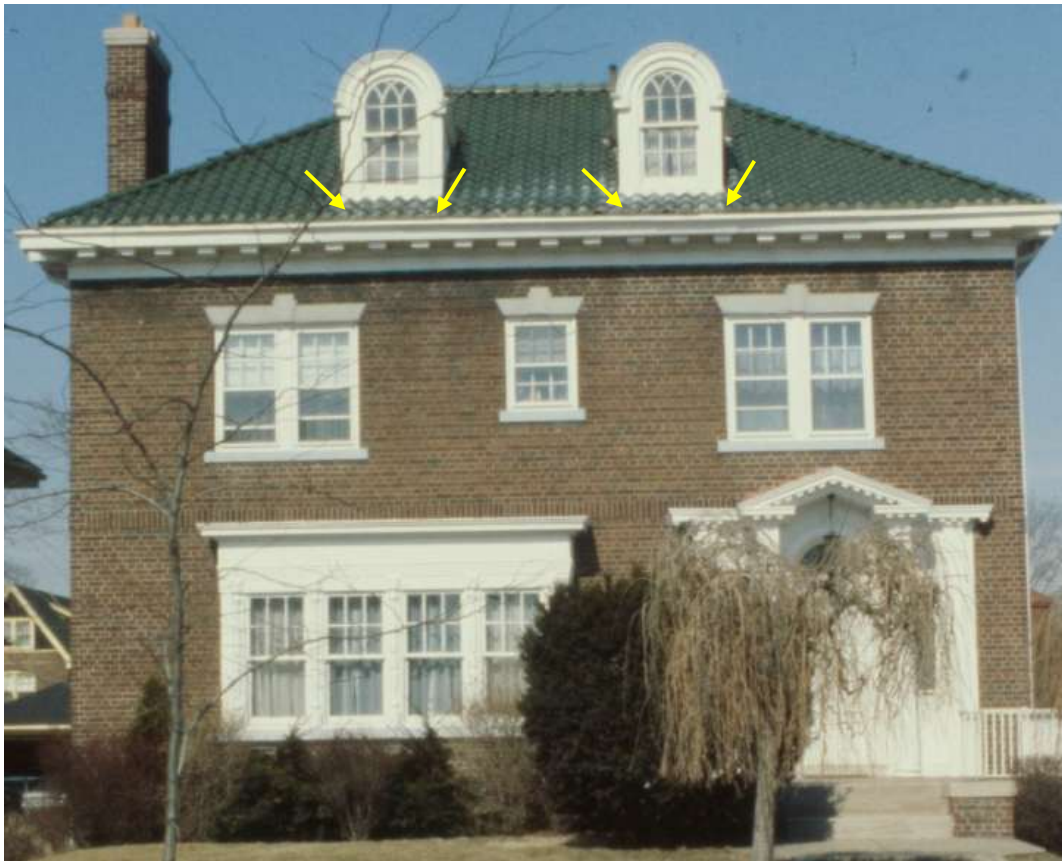
*Designation photo taken in 1980*

- Despite the replacement of areas of deteriorated soffit and the internal gutter system with external, hanging gutters in 2002, between 2008-2014, the appearance of roof's dentiled soffit/eave area is consistent with the appearance of soffit at the time of the district's designation.

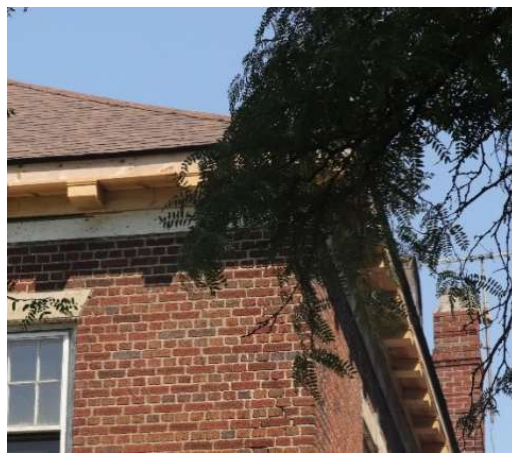
*Photo of existing conditions.*

- While undertaking recent fieldwork, staff did note additional unapproved exterior work which is in process. The property owner has elected not to add these items to the current application. See the below historic photo in addition to current photos to note these violations. As this work is not yet complete, staff does not recommend to the applicant that they refer to the provided historic photo to use as a guide to assist in the development of an application for any outstanding/necessary repair of deteriorated exterior historic character-defining elements.

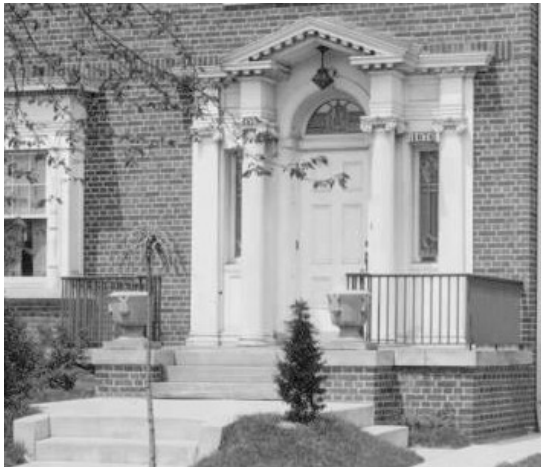
*Original photo 1676 Chicago, built 1921.*

*The elaborate, front-facing, portico has accrued significant deterioration in this century old house. **Please note:** While this is not included in the current application, staff asks that the applicant submit an additional application in replacing the portico and dormer windows.*
