STAFF REPORT: JULY 9, 2025 MEETING
APPLICATION NUMBER: HDC2025-00295
ADDRESS: 2814 OAKMAN BLVD

HISTORIC DISTRICT: OAKMAN BOULEVARD
APPLICANT: GREG TITTLE, TITTLE BROTHERS CONSTRUCTION
PROPERTY OWNER: VOLNA CLERMONT
DATE OF PROVISIONALLY COMPLETE APPLICATION: JUNE 18, 2025
DATE OF STAFF SITE VISIT: JUNE 23, 2025

SCOPE: REPLACE ROOF; WRAP/COVER FASCIA, SOFFITS, AND FRIEZE BOARD

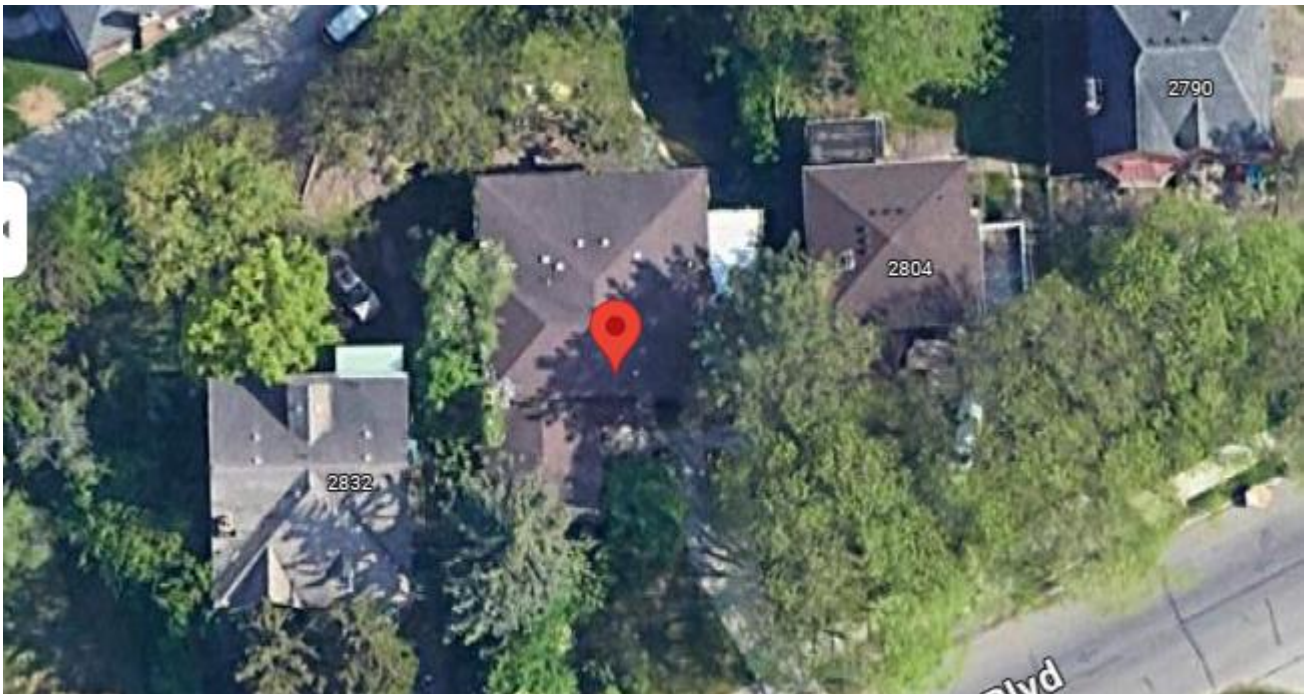
Aerial view of 2814 Oakman from Google maps, 2025. The entry volume is visible here on the house's front (south) side and larger than staff imagined from the sidewalk. The house appears to have a scattering of square roof vents toward the rear (approximately 6 vents perhaps).

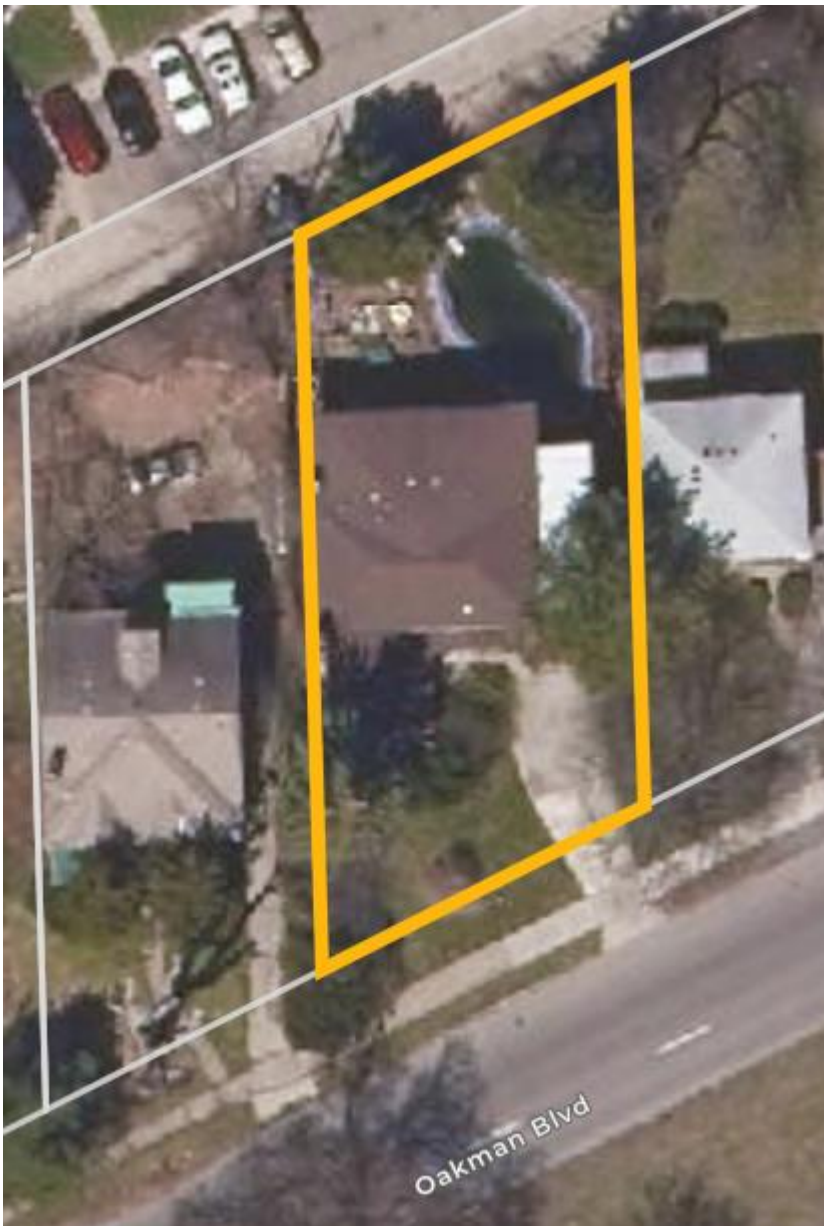
City of Detroit Parcel Viewer, the subject parcel, 2814 Oakman Blvd, outlined in yellow. The house faces south with its attached garage to the east and that garage is not very visible here under the tree cover. A narrow rectangle is visible next to the house and behind the garage and that addition to the east that appears to have a bright white roof is the two-story addition staff believes was permitted in 1970 and that peers over the garage.
