STAFF REPORT: 7/9/2025 REGULAR MEETING
APPLICATION NUMBER: HDC2025-00407-8057
VIOLATION NUMBER: 651
ADDRESS: 691 W. CANFIELD
HISTORIC DISTRICT: WEST CANFIELD
APPLICANT/ PROPERTY OWNER: ROSANNE AND DOUG PATTISON
DATE OF PROVISIONALLY COMPLETE APPLICATION: 6/17/25
DATES OF STAFF SITE VISITS: 6/23/25

SCOPE: MULTIPLE EXTERIOR ALTERATIONS

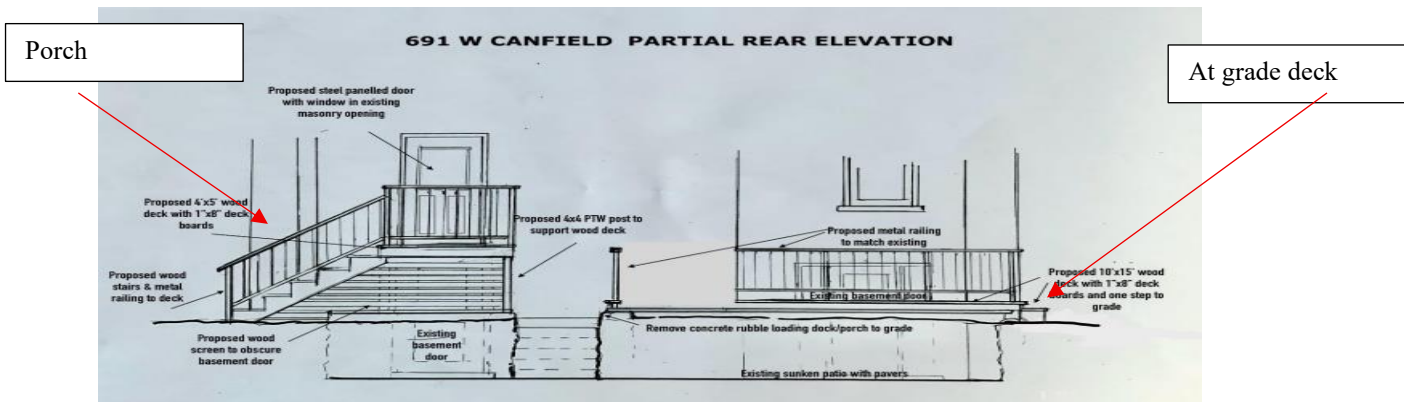
Figure 3. Applicant-provided proposed rear (south) elevation. Deck and Porch are shown, along with the concrete steps that go down to the basement level

Wood (1" x 8" deck boards) with black metal rail. Steps: 1" x 8" deck boards and metal handrail. Access from the boarded-up door shown in *Photo 7*. A new **door for that opening** is proposed to be a steel door that has a window in half the door and two raised panels below the window. Door is proposed to be painted to match the door with sidelights to the sunken patio near the house's southeast corner.
