STAFF REPORT: 07/09/2025 REGULAR MEETING

APPLICATION NUMBER: HDC2025-00230

ADDRESS: 1039 SEYBURN

SCOPE: MULTIPLE EXTERIOR ALTERATIONS

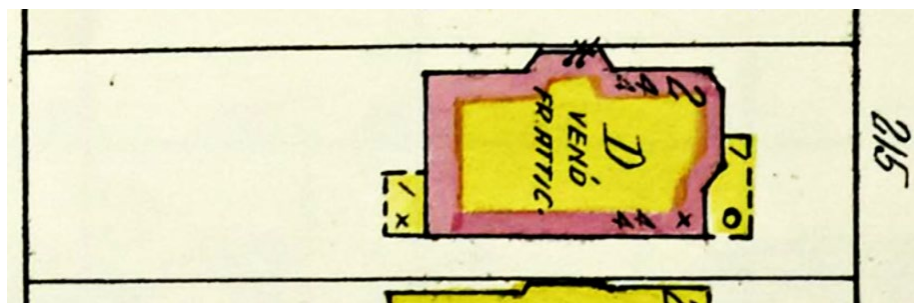
Sanborn Map, Vol. 8, 1910

- The West Village Historic District was enacted in 1983.
- The Sanborn Map identifies the entire dwelling as frame construction (yellow) with a brick veneer running the perimeter of the house on the first and second story (pink/red).

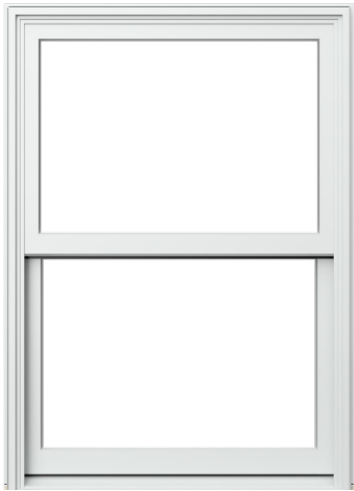
PROPOSED

- Jeld-Wen W-3500 aluminum-clad wood windows with black exterior cladding.
- New double-hung windows to match profile and sizing to the rough opening of existing windows, including being cased with new brick molding.

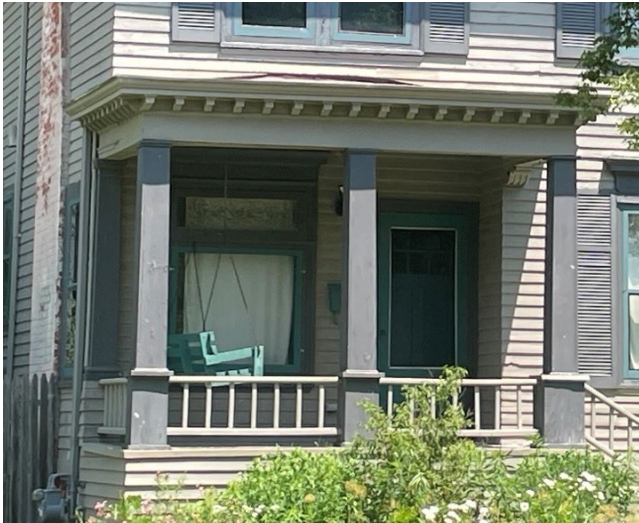
1030 Seyburn, staff photo 06/27/2025

- The current application lacks a dimensioned floor plan for the rear porch/deck.
 - With respect to the front porch, it is staff's opinion that the proposed height (42") and design and materiality of the railings (likely metal balusters) is not compatible with the property's historic appearance. A simple wood railing with square balusters of an appropriately lower height is recommended. Also, while the replication of the original porch roof is not required since it was destroyed by the fire, staff does recommend that the new porch roof borrow some design cues from the original porch to ensure that it is compatible with the historic character of the house and the contemporaneous houses within the district. It is staff's opinion that the current design presents a wholly modern appearance that is not appropriate for a front porch of a Queen Anne style house. See the photos below of examples of front porches in the near vicinity and note that multiple houses on Seyburn between E. Lafayette and Agnes still showcase historic porch detailing at the cornice combined with simple, thick wood posts.
