STAFF REPORT: 08/13/2025 REGULAR MEETING

APPLICATION NUMBER: HDC2025-00489

ADDRESS: 2733 SECOND AVENUE (AKA CASS PARK)

SCOPE: REHABILITATE PARK, REVISE INTERNAL PATH LAYOUT

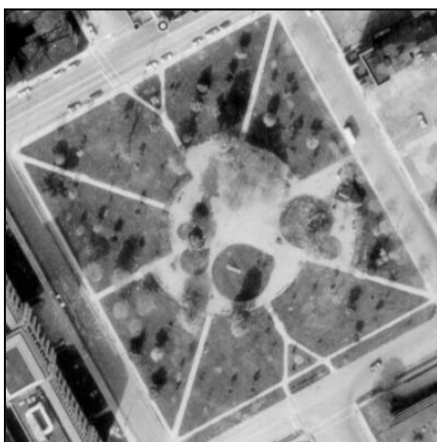
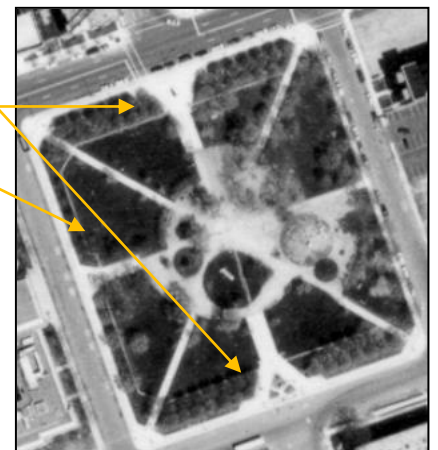
Comparing the 1981 (left) and 1997 (right) aerial photos, staff noticed the widening of the north, west and south entry paths, the planting of two rows of trees at the north and south ends of the park, and the introduction of a perimeter path (north, west, south). The applicant identifies the rows of trees as Bradford trees, an invasive species which are also in poor condition. The Bradford trees are proposed to be removed, and native and non-invasive varieties will be spaced and planted based on the proposed path design. DTE photos.

- The topographical changes made between 1981 and 1997 were compatible with the design and use of the park.

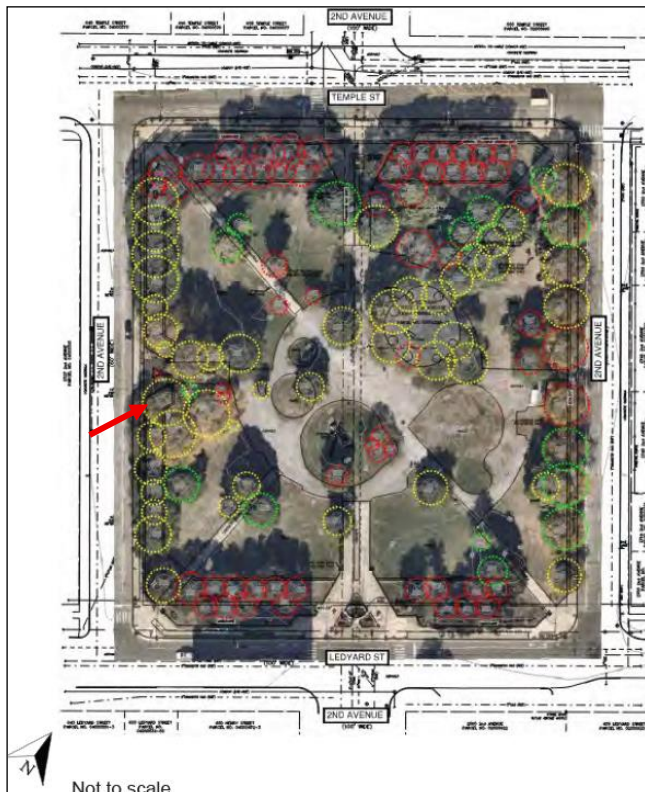
- TREE, POOR CONDITION (-59)
- TREE, FAIR CONDITION (46 TO REMAIN)
- TREE, GOOD CONDITION (16 TO REMAIN)

NOTE: PROPOSE PLANTING OF 60+ NEWER TREES

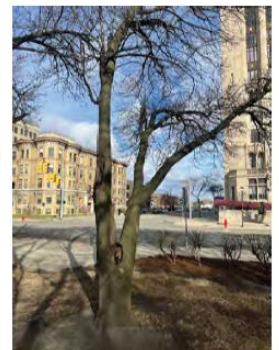
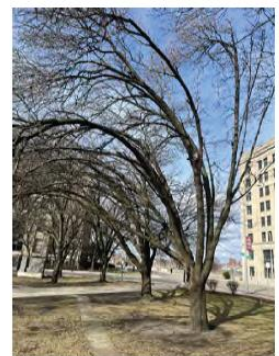
INVASIVE BRADFORD PEAR

Excerpt from page 22 of applicant's document.

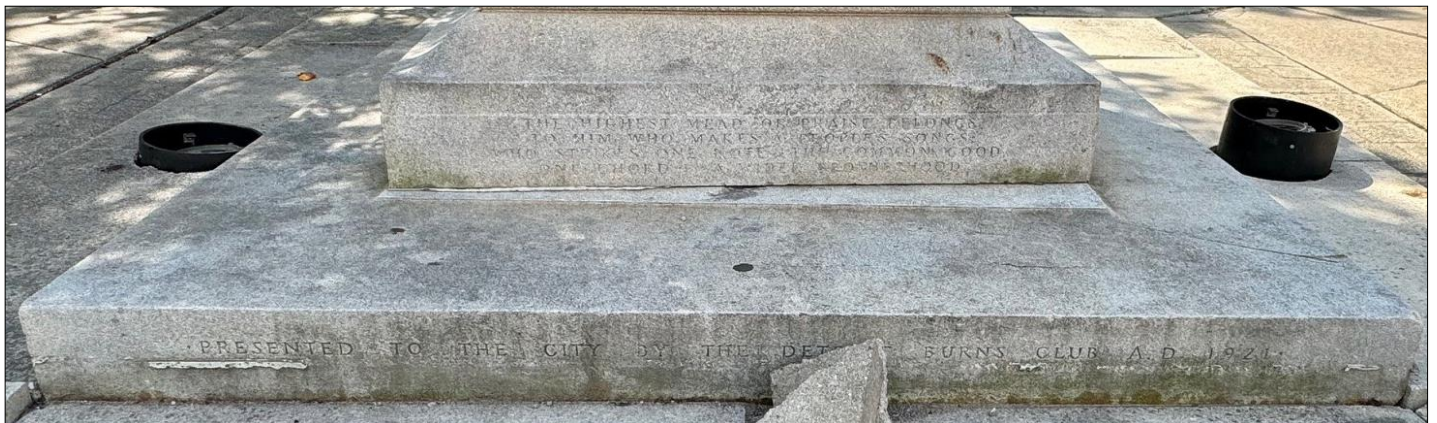
Staff: Staff noticed the shift of the monument on its base and highlights this issue in the photos below. The base is inscribed and is one of many components that comprise the statue, which is distinctive character-defining feature of the park. A detailed, bulleted scope of work for the “minor repairs” must be submitted for staff review prior to work taking place.

Evidence of monument movement is highlighted. On page 13 of the applicant's Cass Park Engagement document, it is stated the monument has been hit by cars. Staff photos.

The base inscription says: “Presented to the City by the Detroit Burns Club A.D. 1921”. Staff photo.
